VICTA AVIATION DIVISION

SERVICE LETTER No. 65/2.

METHOD OF REPAIR, BAG TYPE FLEXIBLE FUEL TANKS.

INSPECTION OF NOSE LEG STRUT.

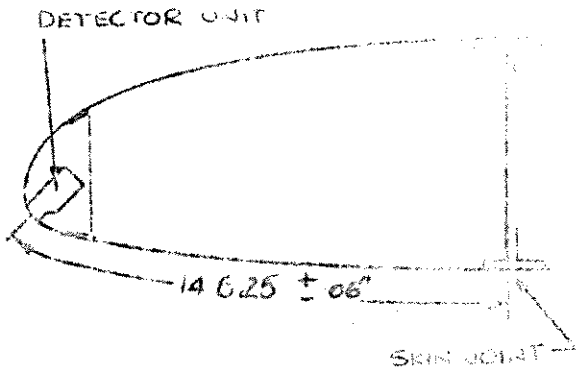
Fig. 1

1. A check on the position of the detector vane around the profile may be obtained by measurement along the contour between the bottom edge of the vane and the skin join on the bottom surface at the spar, refer Fig. 1.

Ensure that the detector is at the mid-point of its adjustment when measuring. The position of the skin join is not jigged, however, production techniques are such that it may be used as a reliable and easy check on the method to position the detector as shown on Victa Drg. No. 02-03075.

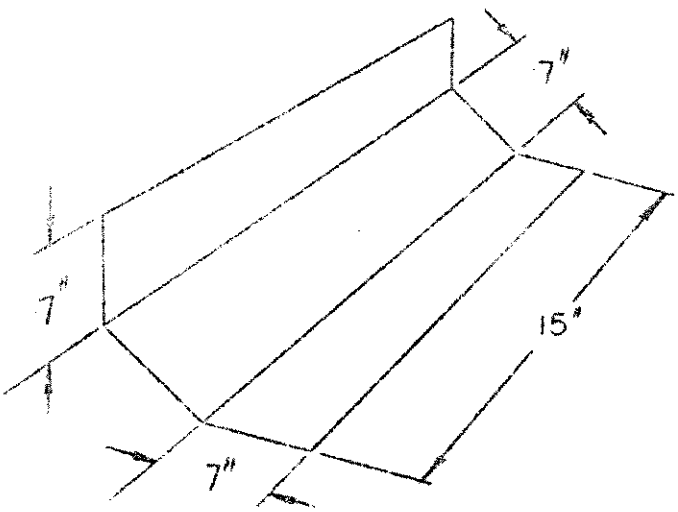
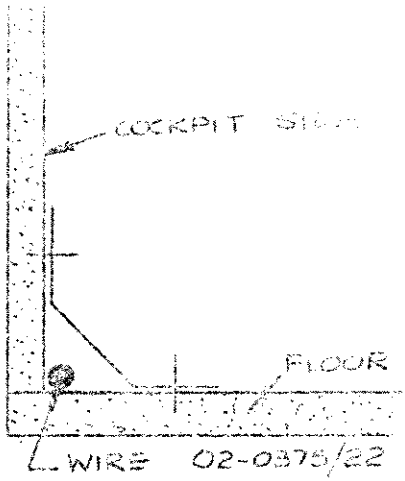
4 Protection for wire, Part No. 02-0375/22, against damage from shoes in the area where it runs along the cockpit floor may be provided by a guard as shown, Refer Fig. 2 & 3. Bend up from 22 or 24 SWG aluminium alloy, and rivet in place between the floor and cockpit side using [illegible] pop rivets at 3" pitch.

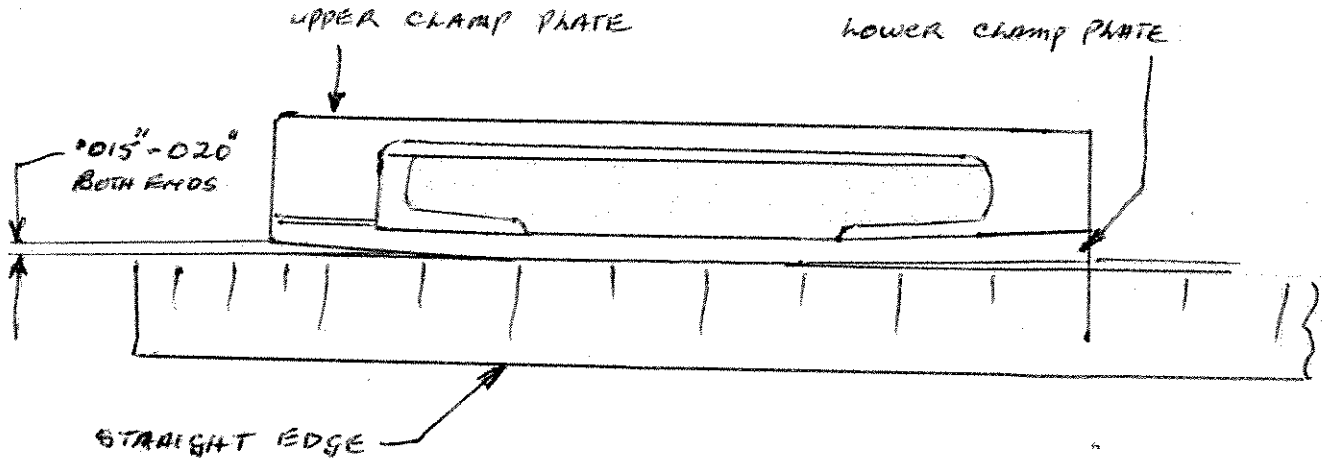
FIGURE 1

(b) Place a straight edge along the underside of the lower clamp plate and by means of feeler gauges at each end of the clamp plate measure the bow. (See Figure 1 - Sheet 3).

UPPER CLAMP PLATE
LOWER CLAMP PLATE
·015"-·020"
BOTH ENDS
STRAIGHT EDGE

(c) If the gap at either end of the clamp plate is less than the figure shown remove sufficient shim washers from between the plates to achieve this dimension when the bolts are torqued to 216 - 240 inch lbs.
