GLOS·AIR
LIMITED

GLOS AIR SERVICE BULLETIN No. I

VICTA IOO & II5 Spinners

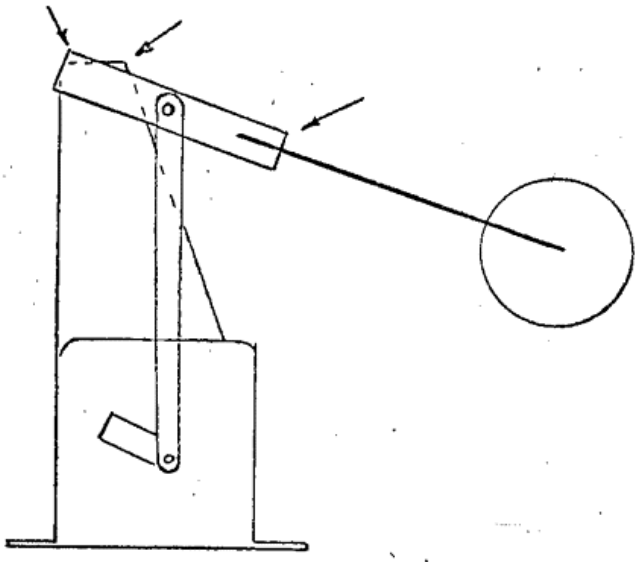
# CLOS-AIR SERVICE BULLETIN 14

Two cases of fuel leaks from the top of the rubber bag tank have recently occurred.

These have been caused by the top of the fuel contents transmitter chafing against the fuel tank (see attached drawing).

TRANSMITTER PT. No 48204/2

2. Inspect fuel tank for evidence of chafing immediately above the transmitter Pt No 48204/2. If any evidence of contact or wear is apparent remove the tank and repair in accordance with Victa Service Letter No 65/2.

REMOVE SHARP CORNERS AS INDICATED BY ARROWS

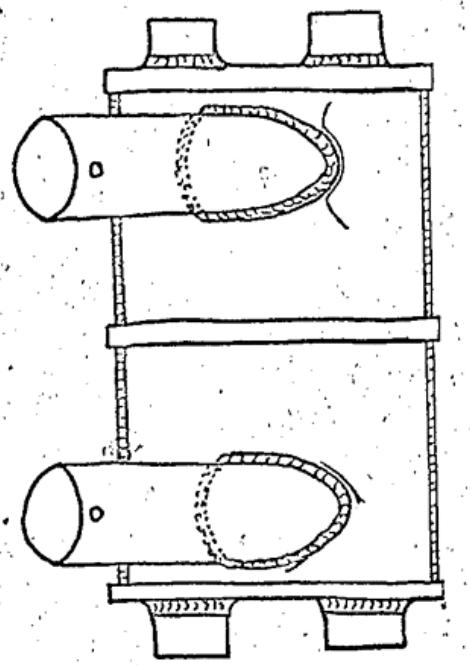
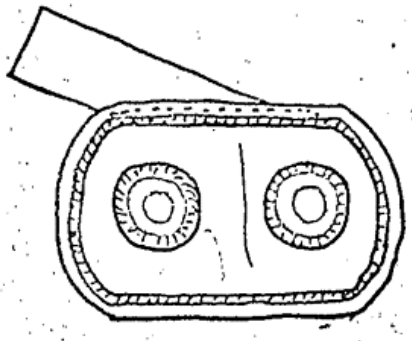
1. Recent routine inspections have revealed cracks in the exhaust heater muff assembly Pt No 42339/2 - See Page 2 for location of cracks. This could possibly introduce Carbon Monoxide into the cabin heating system.
2. Within 5 hours flying time remove the outer casing from the muff assembly and inspect for cracks paying particular attention to the welded joints.
   Cracked assemblies should be replaced.
3. This inspection must be repeated every 100 hours elapsed flying time.
4. At 12 month intervals the assembly must be pressure tested to 1½ p.s.i. to check for leaks.
5. The attention of owners and operators is drawn to ARB Notice No 40.
6. The inspections required by this Bulletin have been made Mandatory by the Air Registration Board.

= WELD

= CRACK

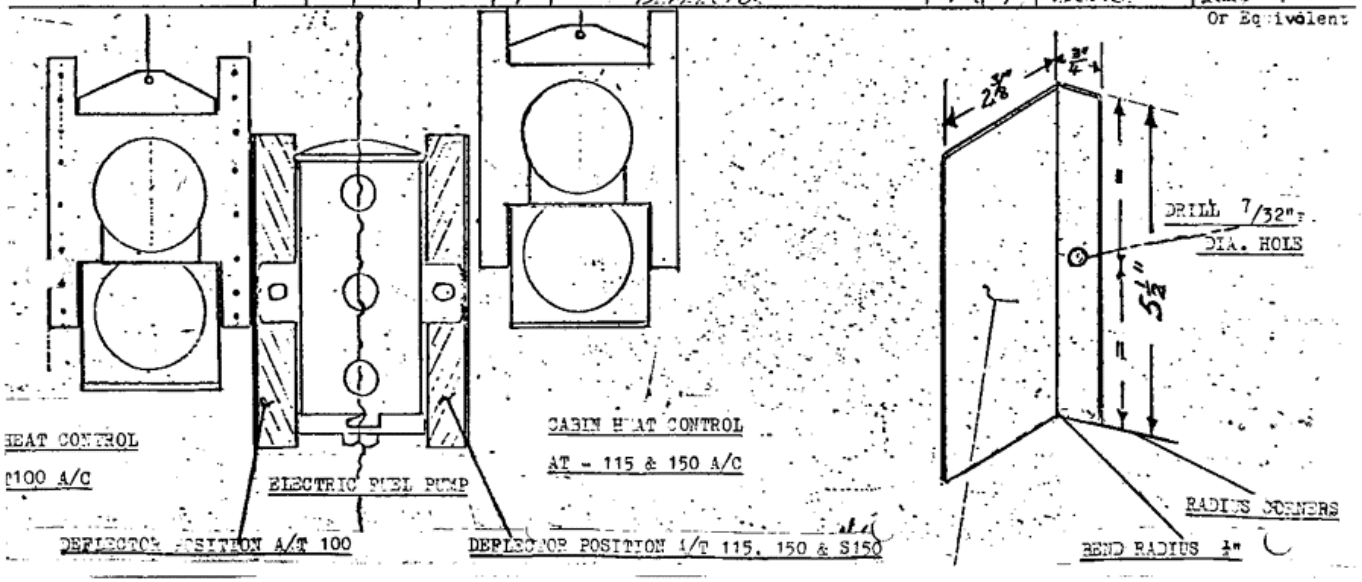
Details: It has been reported that suspected cases of fuel vapourisation has occurred in Australia caused by the electric fuel pump being overheated by the exhaust of hot air from the cabin heater distribution box assembly.

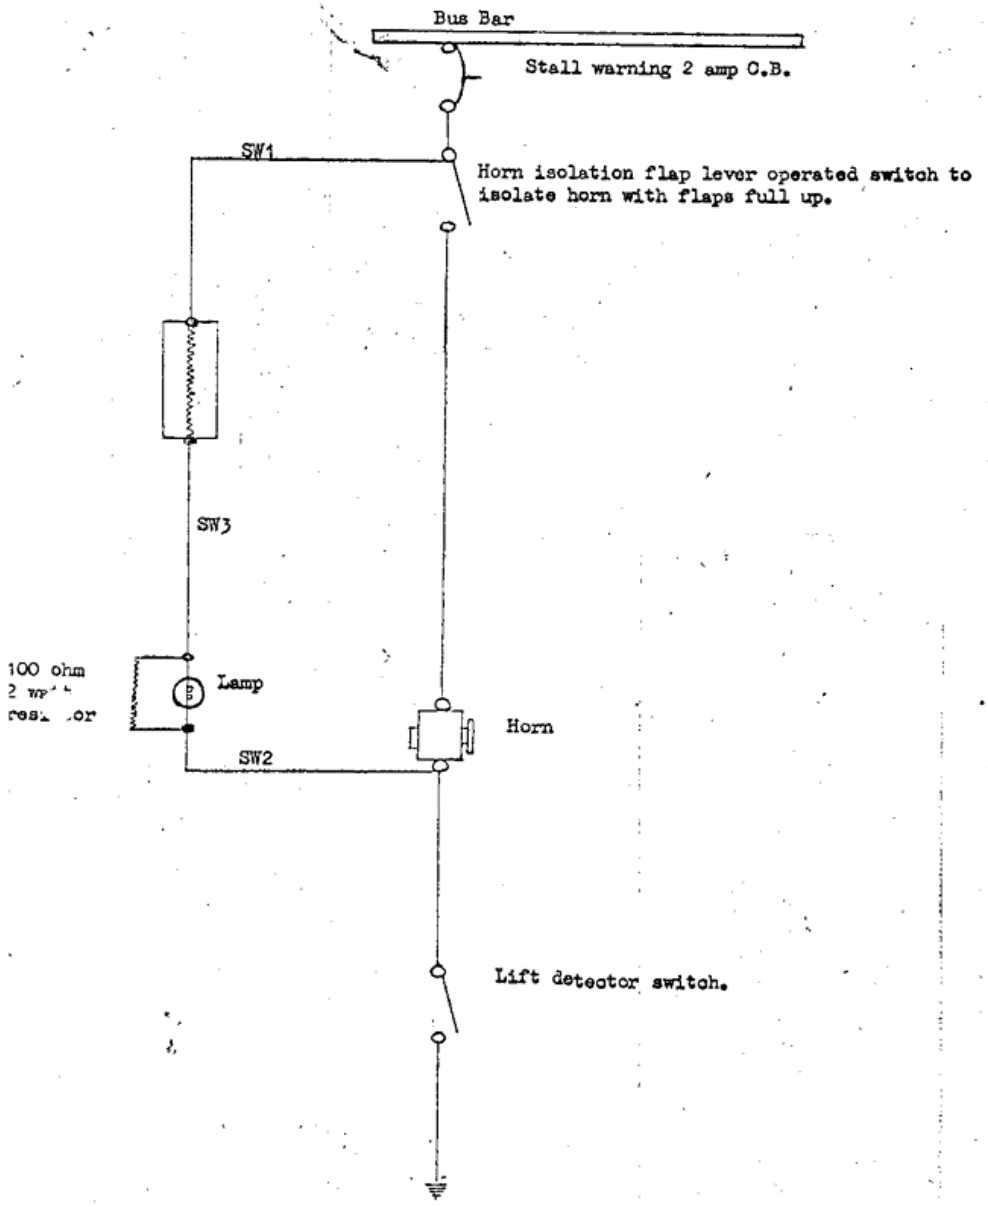
Modification No. GAL 95.

Wiring Diagram fo[illegible] [illegible]lation of Flasher Unit in all Airtourer Aircraft to Provide Stall Warning Light in the Flap Up Position When Horn is Isolated.
