POOL PLANT ROOM

AS-FOUND SURVEY

CURRENT
VERSION

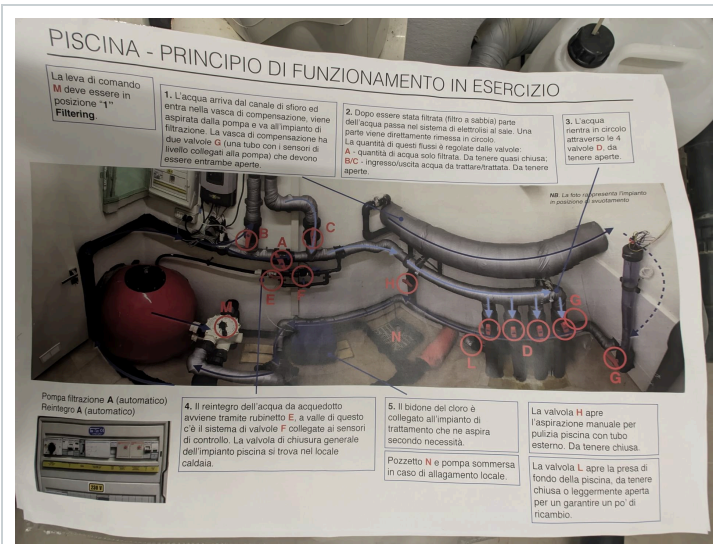
Note: everything above that needs the balance tank wants doing while it is empty and open. That will not stay true.

2. **Keep the chlorine out of this room, permanently.** Its own label carries EUH031: contact with acids liberates a toxic gas.
3. **Clip the overflow pipe's open end** in the balance tank. It lies loose on the floor and will move when the pool spills hard.

4. **Check the intercapedine is still ventilated.** That corridor is a cavity around the below-ground structure, so it is damp by design and the staining and blown plaster below the hatch are expected rather than alarming. It only stays harmless while the cavity can breathe.

5. **Buy an unstabilised chlorine** for shock dosing, calcium hypochlorite or similar. Both the Recupero and the Svernante labels call for one and there is none on the shelf. *This one is a purchase and not a job, so its detail and the words to search for live in the "What to buy" section. It stays listed here because this is where it was noticed.*
