POOL PLANT ROOM

AS-FOUND SURVEY

CURRENT
VERSION

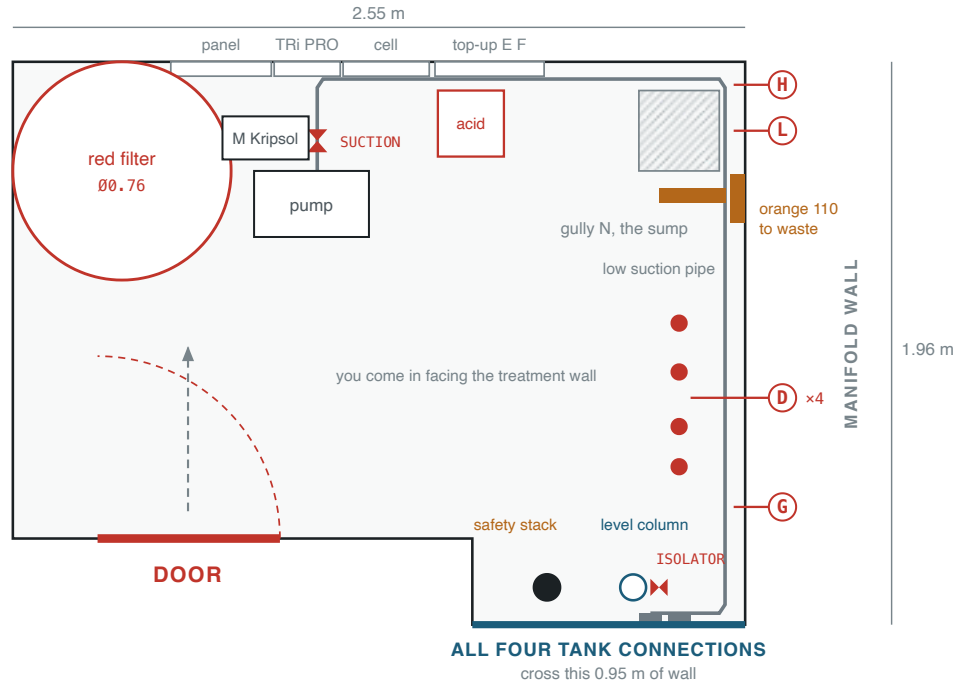
PLAN OF THE PLANT ROOM

to scale, 1 m = 200 units · 4.52 m² of floor · positions off the photosphere and the four reprojections, corrected on site

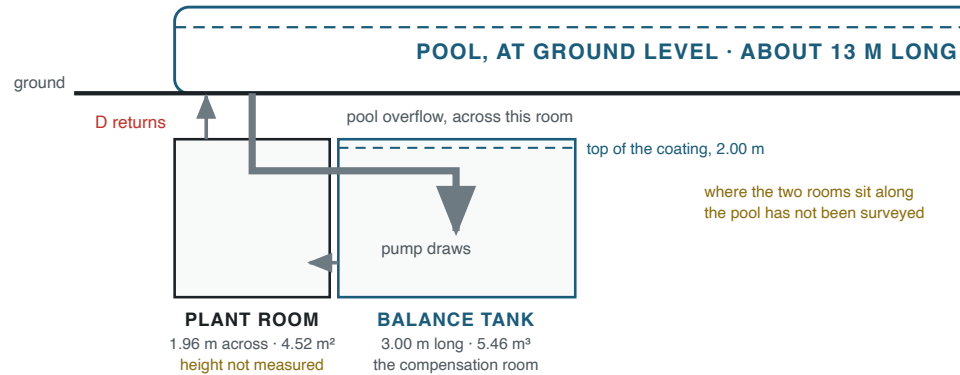
SECTION: HOW THE SPACES STACK UP

to scale sideways, 1 m = 55 units, the same as the site plan · heights are indicative
