Backgrounder on the Three Mile Island Accident

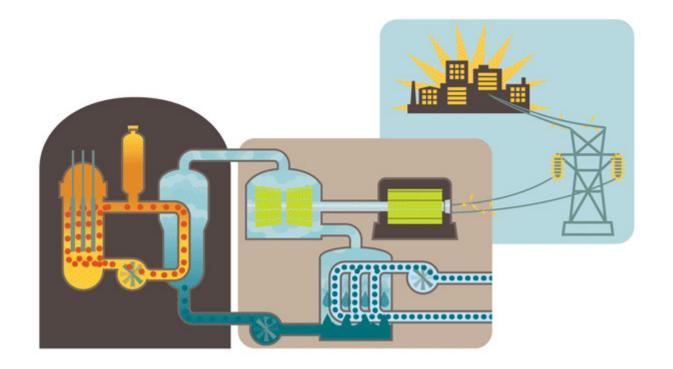
Animated Diagram of the Sequence of Events

The accident began about 4 a.m. on Wednesday, March 28, 1979, when the plant experienced a failure in the secondary, non-nuclear section of the plant (one of two reactors on the site). Either a mechanical or electrical failure prevented the main feedwater pumps—component (1) in the animated diagram)—from sending water to the steam generators (2) that remove heat from the reactor core (3). This caused the plant's turbinegenerator (4) and then the reactor itself to automatically shut down. Immediately, the pressure in the primary system (the nuclear piping portion of the plant shown in orange) began to increase. In order to control that

pressure, the pilot-operated relief valve (5) opened. It was located at the top of the pressurizer (6). The valve should have closed when the pressure fell to proper levels, but it became stuck open. Instruments in the control room, however, indicated to the plant staff that the valve was closed. As a result, the plant staff was unaware that cooling water in the form of steam was pouring out of the stuck-open valve. As alarms rang and warning lights flashed, the operators did not realize that the plant was experiencing a loss-of-coolant accident.

Other instruments available to plant staff provided inadequate or misleading information. During normal operations, the large pressure vessel (7) that held the reactor core was always filled to the top with water. So there was no need for a water-level instrument to show whether water in the vessel covered the core. As a result, plant staff assumed that as long instruments showed that the pressurizer water level was high enough, the core was properly covered with water too. That wasn't the case.

Unaware of the stuck-open relief valve and unable to tell if the core was covered with cooling water, the staff took a series of actions that uncovered the core. The stuck valve reduced primary system pressure so much that the reactor coolant pumps (8) started to vibrate and were turned off. The emergency cooling water being pumped into the primary system threatened to fill up the pressurizer completely—an undesirable condition—and they cut back on the flow of water. Without the reactor coolant pumps circulating water and with the primary system starved of emergency cooling water, the water level in the pressure vessel dropped and the core overheated.
