Wooden Tower Project Summary Report

Andy S. Chen · Massachusetts Science Olympiad, Tower 2024

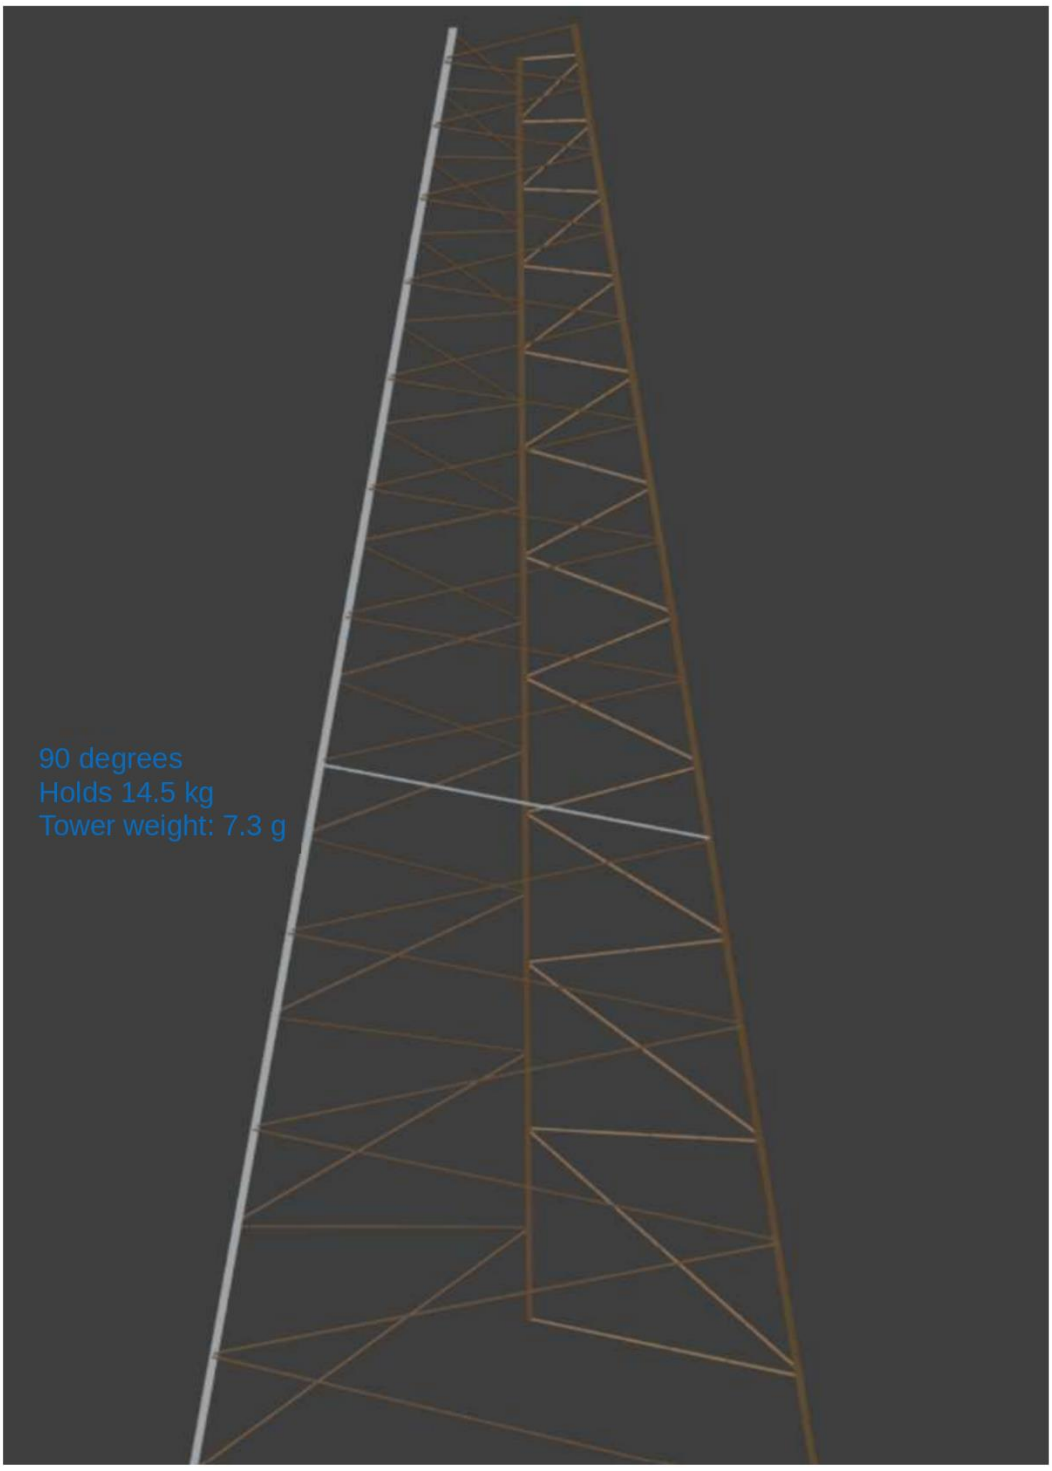
Figure 3. Side view of the 3D model, with the 90-degree brace-leg joints.

For the third tower, I made two changes. First, I rejoined every brace on all three legs, from top to bottom, so that each brace meets the leg at 90 degrees. Second, I added a few braces near the bottom to close the unbraced gap where my earlier towers had failed.
