Collision Telemetry Exhibit

Detected Collision — Farmington Ave SE at Co Rd 33, Buffalo, MN — September 30, 2026, 8:22 AM CDT

Data sources	MyGeotab GO device records (GPS log, accelerometer, engine status and fault data) via MyGeotab API; Geotab Collision Reconstruction (BETA)
Prepared	October 14, 2026 by GPS Fleet Management Solutions from unaltered system records

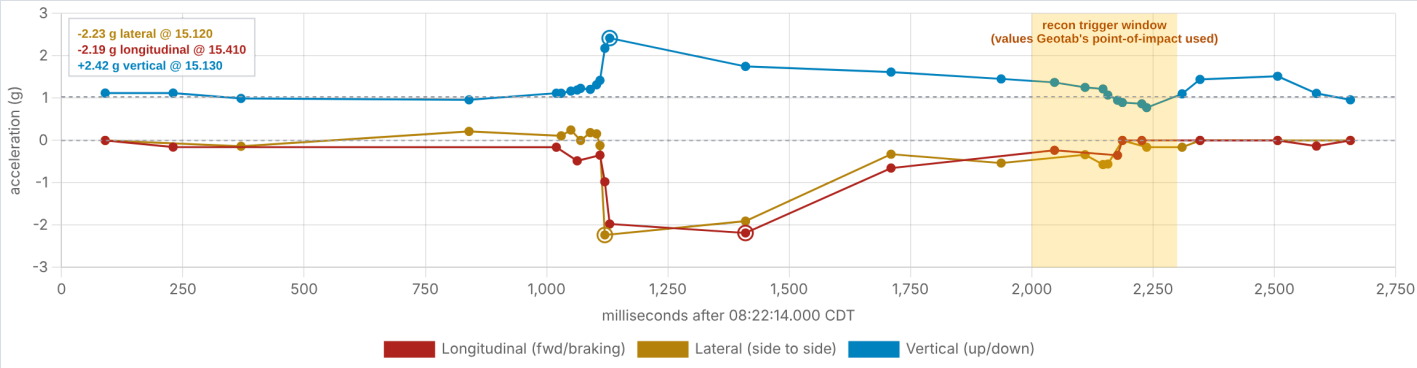
Point-of-Impact Discrepancy — Reconstruction vs. Physical Evidence

Geotab's Collision Reconstruction depicts the vehicle receiving a passenger-side impact. Scene evidence shows a different configuration: frontal. The reconstruction's estimate derives from accelerometer values present at its 08:22:16.000 trigger timestamp (-0.23 g longitudinal / -2.23 g lateral, the ft/s² figures printed in the report) — approximately 0.9 seconds after the recorded peak, when the longitudinal signal had already decayed; the residual sample reads to the algorithm as a broadside load. The full high-rate capture shows a single pulse at 08:22:15.120–08:22:15.410 with peaks of -2.19 g longitudinal / -2.23 g lateral / +2.42 g vertical. Near-equal longitudinal and lateral peaks with a pronounced vertical excursion — a tri-axial pulse. This pattern arises from terrain traversal or from a frontal strike into a crossing vehicle with front-end override of the struck vehicle's structure; scene evidence decides which. Geotab's own report notes the point of impact is an accelerometer-derived estimate that may vary; its impact graphic should not be relied upon for this event.
