Navajo Abandoned Uranium Mine

Site Screen Report

Mine Name: Bootjack

Mine ID: **252**

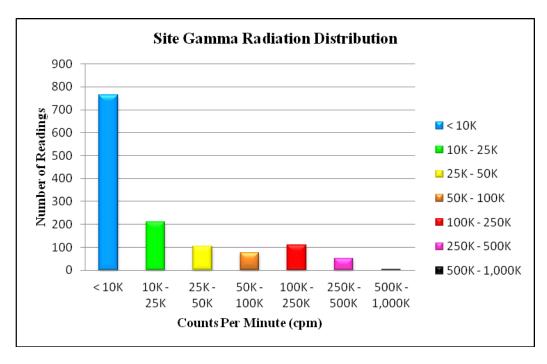
Highest gamma radiation measurement: 630,159 counts per minute (cpm)

A total of 1,333 gamma radiation measurements were collected from the mine site, ranging from 4,765 cpm to 630,159 cpm. Maximum levels of approximately 630,000 cpm were found in the center of the site. The measurements are represented in Figures 1 and 2.
