Roof Management Summary

Brecksville-Broadview Hts. City School District
Roof Management Program

ROOF EVALUATION REPORT

Brecksville-Broadview Heights Board of Education
6638 Mill Road
Brecksville, OH 44141

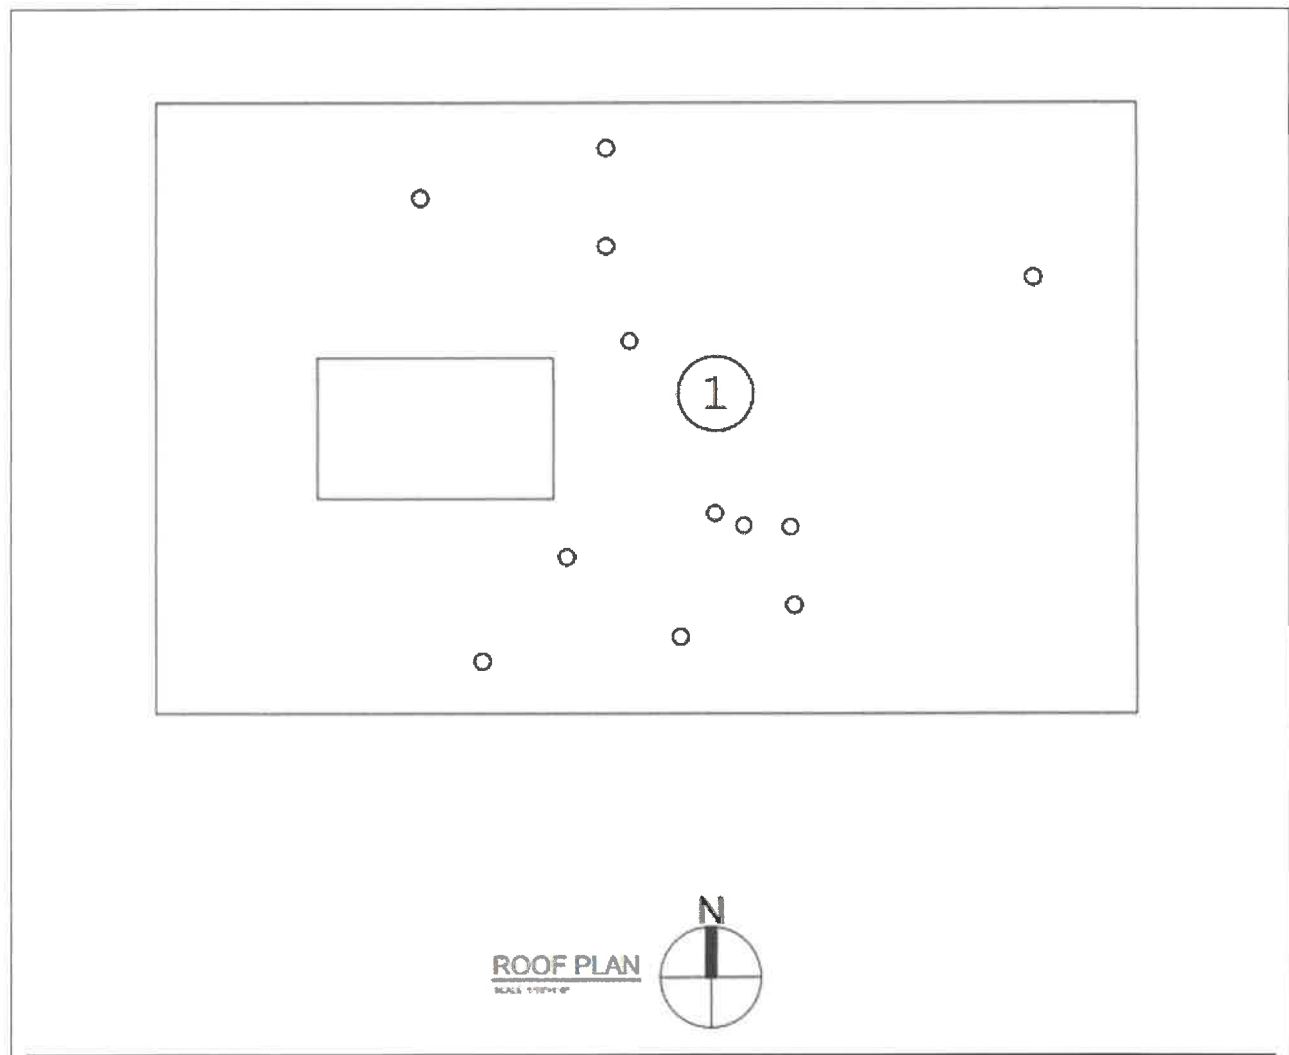
**BBHCSD
Board of Education Overview**

Brecksville – Broadview Heights Board of Education is comprised of one roof section. The roof system in place is a Duro-Last reinforced PVC roof system. The current roof is in fair condition, with areas of standing water and deterioration along the roof membrane seams. Additionally, the flashings are beginning to bridge as the roof shrinks due to normal aging. The roof, however, does not currently have any leaks to the interior of the building.

The Board Office and Bus Garage roof systems will require regular maintenance and an ongoing maintenance program to maintain a watertight condition.. Roof Section 1 has been classified outside the 10-Year Plan.

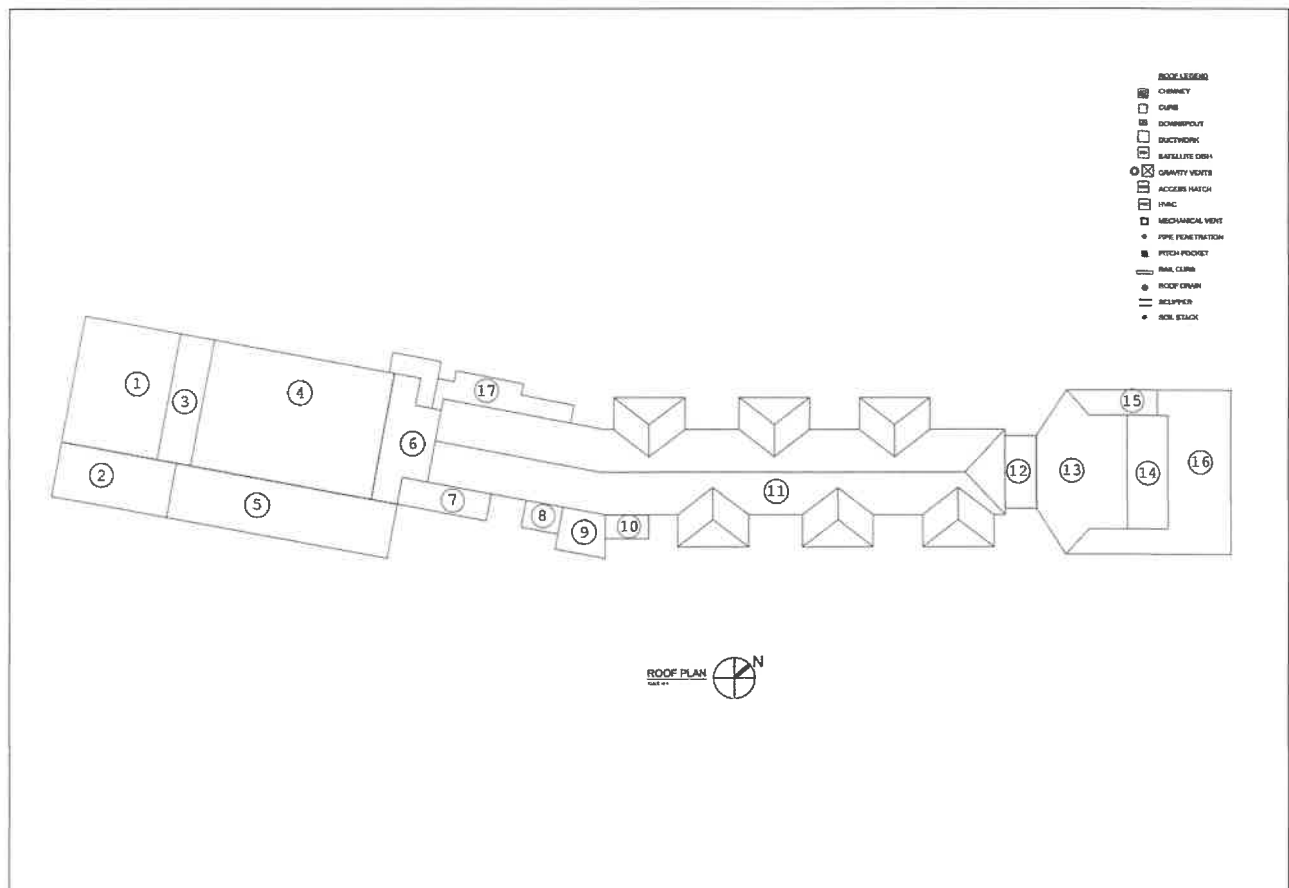
BBHCSD High School Roof Overview

Brecksville-Broadview Heights High School comprises 17 roof sections (labeled 1-17). The .060 fully adhered EPDM and modified bitumen roof sections are newer and in good condition. The older ballasted EPDM roof sections in in poor condition, with roof sections 2, masonry wall 2A, roof section 5, and masonry wall 5A having intermittent leaks into the cafeteria and kitchen areas. Roof construction during 2022 on roof sections 1, 3, 4, and 13 revealed that the existing ballasted EPDM roof sections have deteriorated EPDM roof membrane. The membrane is brittle and has shrunk significantly from exposure to the elements.

Due to the poor condition of several roof sections at BBHCSD High School TCG recommends replacement of The ballasted EPDM and shingle roof sections within the 10-year roof management timeframe. TCG recommends replacement of roof sections 2 and 5 in, with tuckpointing and waterproofing on walls 2A and 5A in 2023. Replacement of roof sections 11 and 11A in 2024. Replacement of roof sections 14, 15, and 16 in 2025. Roof sections 7, 8, 9, 10, and 17 should be considered for replacement in 2026.

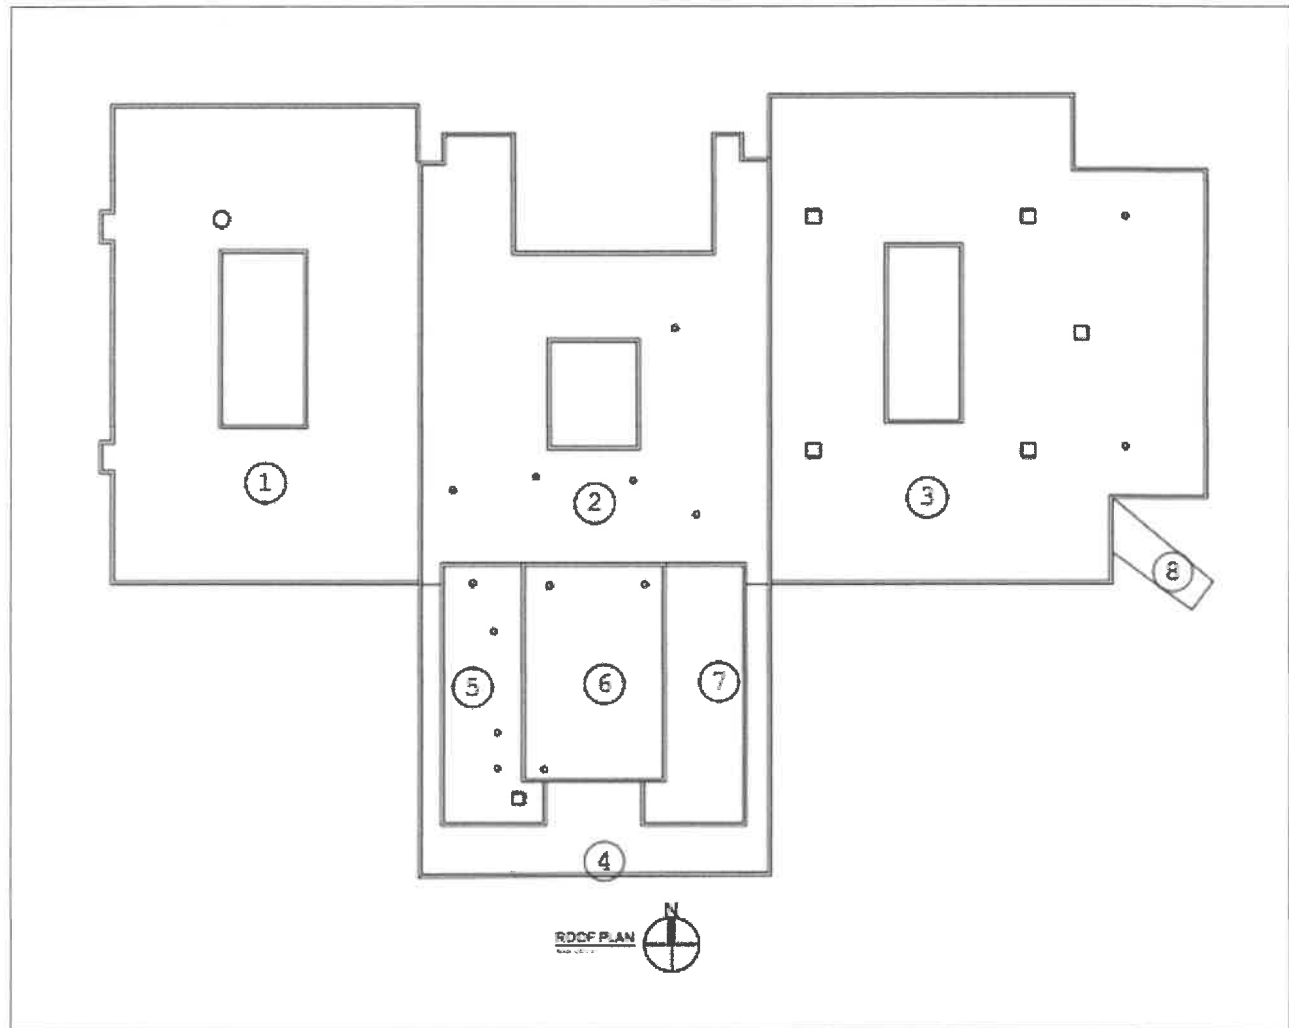
Hilton Elementary School Overview

Hilton Elementary comprises 8 roof sections (labeled 1-8). All roof sections are Duro-Last reinforced PVC and are in Poor condition. The roof sections hold water in several low spots, show deterioration along the field seams, and flashings have begun to pull away as the roof shrinks with time. Additionally, intermittent leaks have been reported by maintenance staff.

Hilton Elementary school roof systems will require replacement within the 10 year roof management timeframe. TCG recommends replacement of roof section 3 in 2029, roof sections 1, 4, and 5 in 2030, and roof sections 2, 6, 7, 8 in 2031.

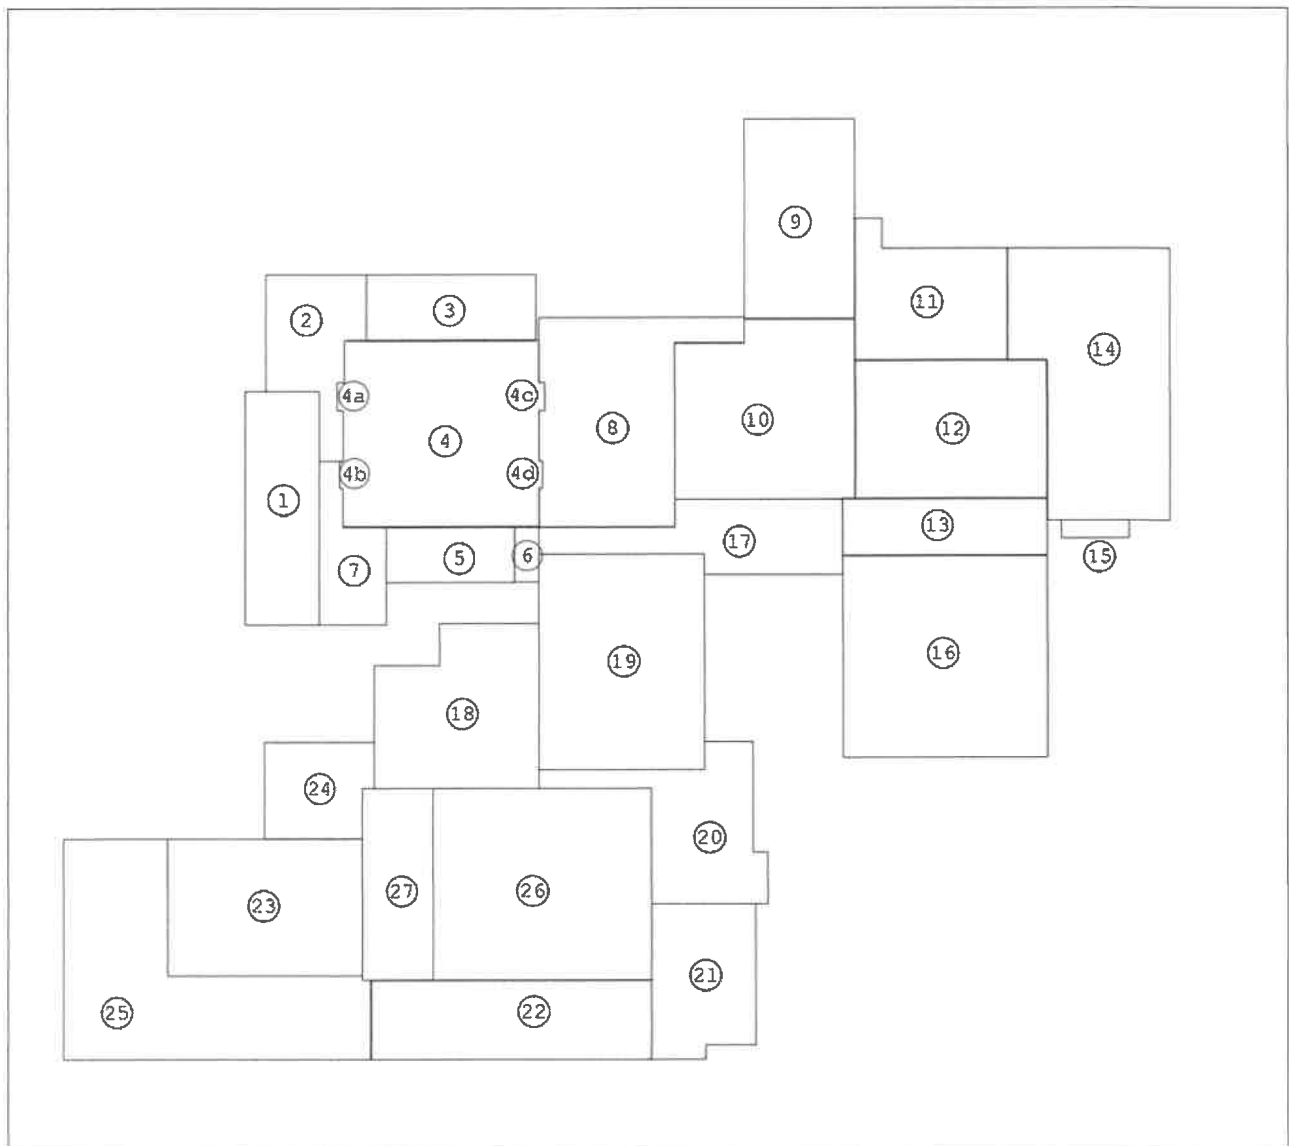
Brecksville–Broadview Heights Middle School Roof Overview

Brecksville – Broadview Heights Middle School comprises twenty-seven roof sections (labeled 1-27). Older EPDM roof sections are in poor condition, exhibiting signs of deterioration with ponding water, shrinking membrane around the perimeters, and debonding of adhesives along seams in the EPDM roof membranes. Reinforced PVC roof systems (Roof sections 4, 19, 26, and 27) are also in poor condition, with severe shrinking around the perimeters, causing bridging which leads to moisture accumulation between the membrane and insulation systems.

Due to the afore mentioned existing conditions on the older EPDM and Reinforced PVC roof systems, TCG recommends replacement of several roof sections within the 10-year roof management plan. Roof section 18 should be considered for replacement in 2026. Roof Sections 15, 20, and 25 (EPDM roof systems) require replacement by 2027. Roof sections 1, 5, and 19 will require replacement by 2028. Roof sections 4 and 6 should be considered for replacement by 2031. Lastly, Roof sections 8, 26, and 27 should be considered for roof replacement in 2032.

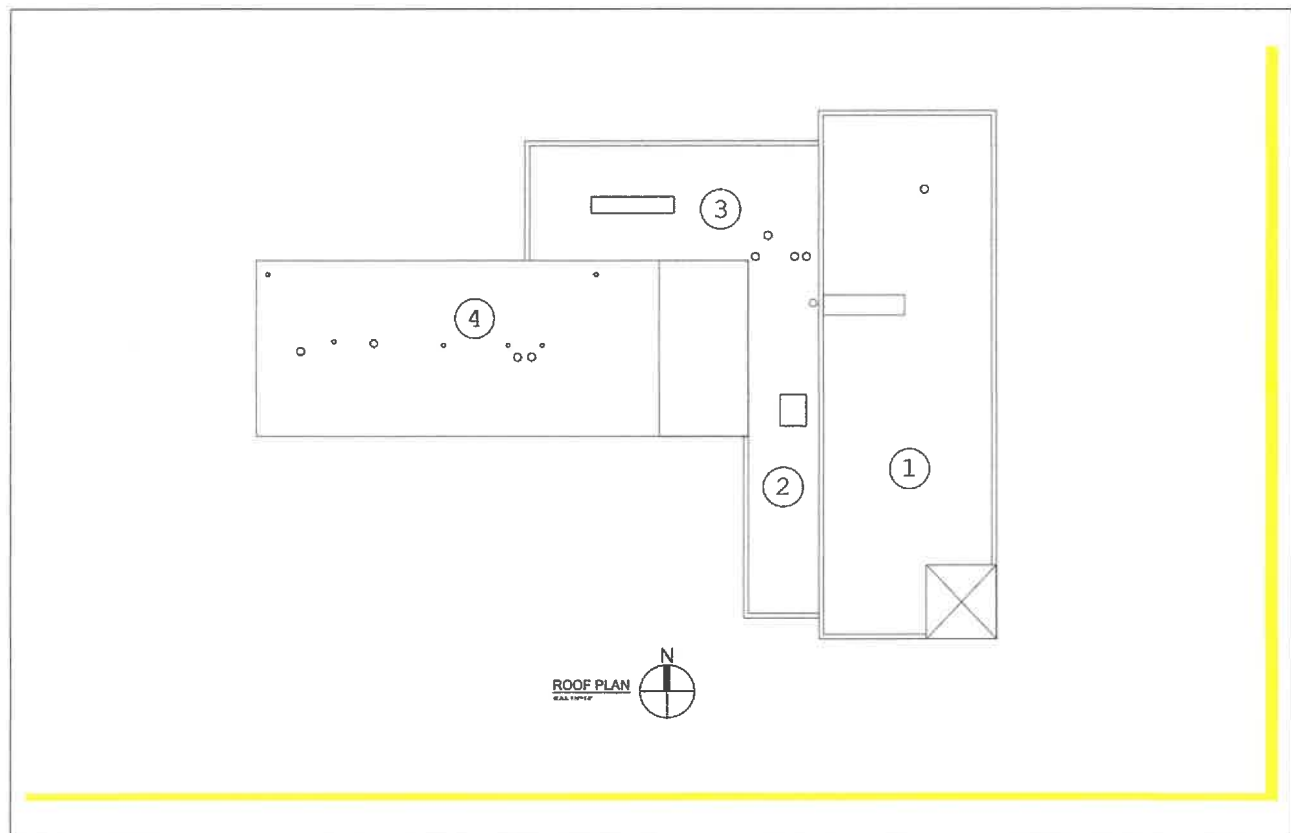
BBHCSD Stadium Roof Overview

BBHCSD stadium building comprises 4 roof sections labeled 1-4. Sections 1-3 are smooth surface built up roof systems in fair condition. Portions of these roof sections are beginning to show the fiberglass felt below the top layer of the BUR system, and are a viable option for a roof coating system. Roof section 4 is a Duro-Last reinforced PVC roof system in poor condition. The field seams are showing signs of deterioration, and the field of the roof has several low points holding water. Additionally, the edges of the roof are bridging as the membrane shrinks over time.

TCG considers the life expectancy of roof sections 1-3 to extend beyond the timeframe of the 10 year roof management plan. Roof section 4 however, is in poor condition and should be considered for replacement in 2032.
