Spark Plug Faces - Part 1

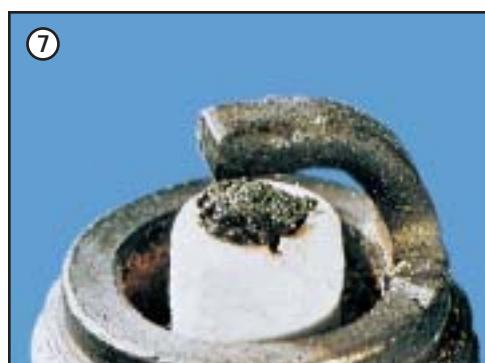
6. Formation of ash

Heavy ash deposits on the insulator nose resulting from oil and fuel additives, in the scavenging area and on the ground electrode. The structure of the ash is loose to cinder-like.

Cause: Alloying constituents, particularly from engine oil, can deposit this ash in the combustion chamber and on the spark-plug face.

Effects: Can lead to auto-ignition with loss of power and possible engine damage.

Remedy: Repair the engine. Fit new spark plugs. Possibly change engine-oil type.
