[2022] SGHC 32

Ten-League Corporations Pte Ltd v Debenho Pte Ltd

General Division of the High Court — District Court Appeal No 25 of 2021 Philip Jeyaretnam J 17, 19 January 2022

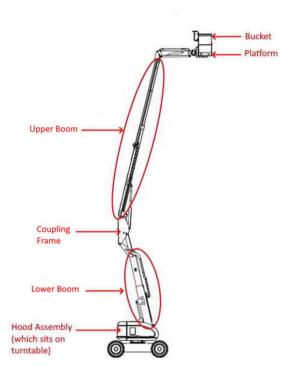
A boom lift is a mechanical device that enables workers to carry out tasks at height. It is a mobile elevating platform falling within the class of equipment for which Singapore Standard SS 616:2016¹ provides a code of practice for safe use. In this case, the boom lift had two booms, an upper and a lower one. I shall refer to it as the Boom Lift. Bearing model number GTZZ-25, it was manufactured by a company incorporated in the People's Republic of China, Changsha Skyboom Heavy Industry Co Ltd.² Their literature describes the Boom Lift as a self-propelled articulated boom lift.³ I reproduce here the seller's illustration of its main components:⁴
