QUALITY INSPECTION REPORT

Stainless steel kitchenware, incoming batch QC-2026-114

Supplier: Meridian Metalworks Pvt. Ltd. Inspector: R. Iyer Date: 14 October 2026

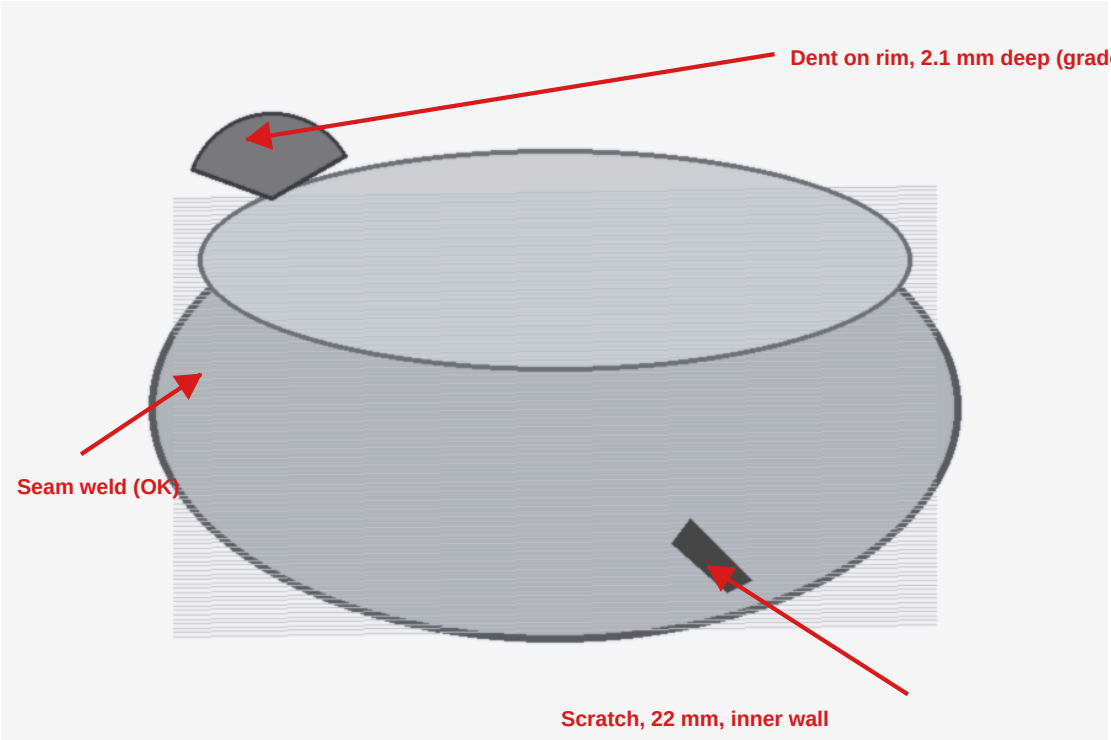
3.1 Rim deformation on SKU B-220. Seven of 240 bowls showed deformation of the rolled rim. The worst case is shown in Figure 1: the dent measured 2.1 mm at the deepest point and sits 35 mm from the seam weld. A 22 mm scratch on the inner wall of the same unit is also marked. The unit is graded B and sent for rework.

Figure 1. Mixing bowl SKU B-220, unit 117. Red arrows mark the rim dent (2.1 mm), a 22 mm scratch on the inner wall and the seam weld, which passed dye-penetrant inspection.

3.2 Surface finish. Brushed finish uniform on all units; no pitting observed. Nine units carried minor handling marks under 15 mm which are within specification. Compare the marked scratch in Figure 1, which exceeds the 15 mm limit.

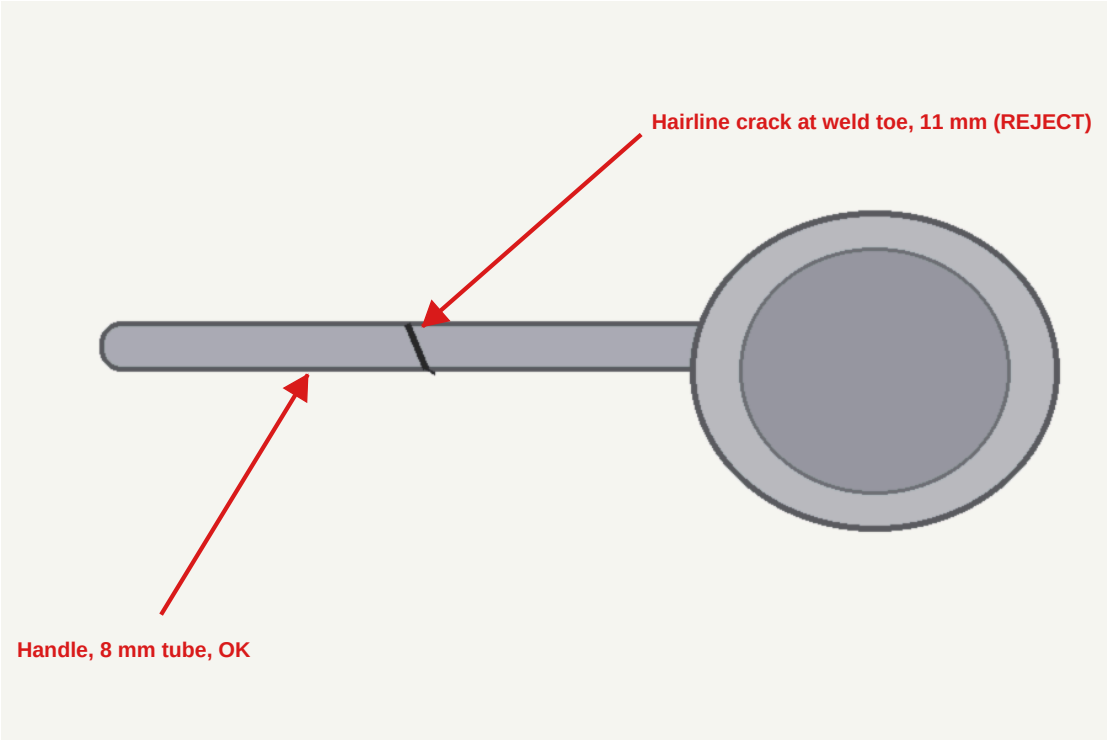
3.3 Weld integrity on SKU L-410. Dye-penetrant testing of 12 ladles revealed one hairline crack at the handle-to-bowl weld, shown in Figure 2. Crack length 11 mm, oriented across the weld toe. This is a reject under clause 2. The remaining 11 sampled welds were sound.

Figure 2. Serving ladle SKU L-410, unit 22, after dye-penetrant test. The arrow marks an 11 mm hairline crack at the handle-to-bowl weld toe. The unit is rejected.

Three units are rejected and scrapped (B-220 unit 203, L-410 units 022 and 067). Four units go to rework. The batch is accepted conditionally; the supplier is asked for a corrective action report on the handle weld within 15 days.
