Visual Evidence Record

Sample Business Park

Visual evidence record supporting the roof condition assessment.

Building Scanned
Sample Business Park

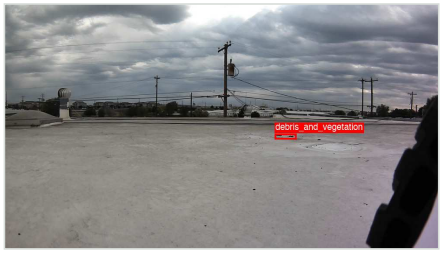
Figure 2.1. Section 1 — Debris And Vegetation capture locations

Debris And Vegetation

Total Defects	4
Quantity	4 EA
Repair Priority	Low

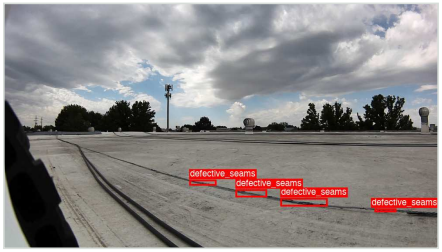
Figure 2.3. Section 1 — Defective Seams capture locations

Defective Seams

Total Defects	**5**
Quantity	**15 LF**
Repair Priority	**Medium**

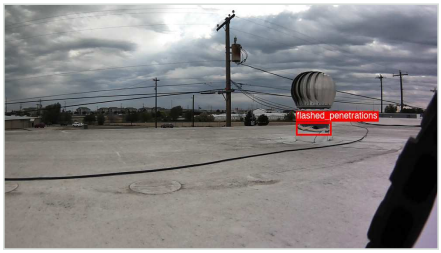
Figure 2.5. Section 1 — Flashed Penetrations capture locations

Flashed Penetrations

Total Defects	**4**
Quantity	**4 EA**
Repair Priority	**High**

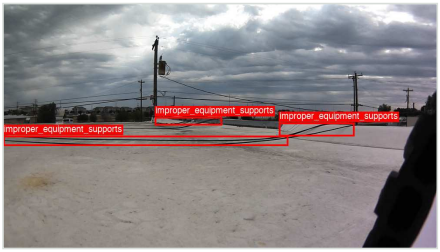
Figure 2.7. Section 1 — Improper Equipment Supports capture locations

Improper Equipment Supports

Total Defects	**29**
Quantity	**27 EA**
Repair Priority	**Low**

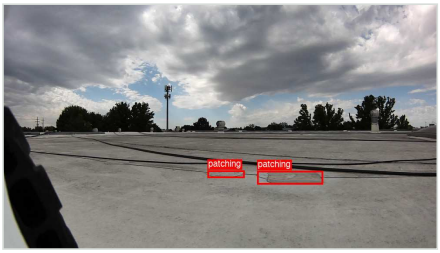
Figure 2.11. Section 1 — Patching capture locations

Patching

Total Defects	**5**
Quantity	**100 SF**
Repair Priority	**Low**

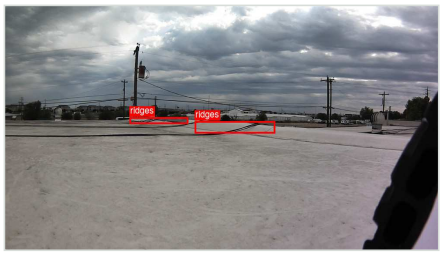
Figure 2.15. Section 1 — Ridges capture locations

Ridges

Total Defects	**2**
Quantity	**15 SF**
Repair Priority	**Low**

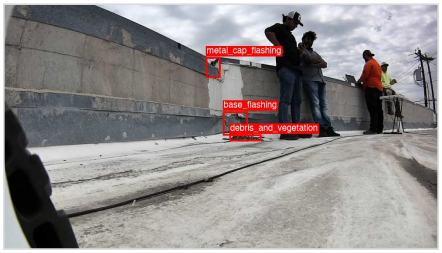
Figure 2.17. Section 2 — Debris And Vegetation capture locations

Debris And Vegetation

Total Defects	**33**
Quantity	**31 EA**
Repair Priority	**Low**

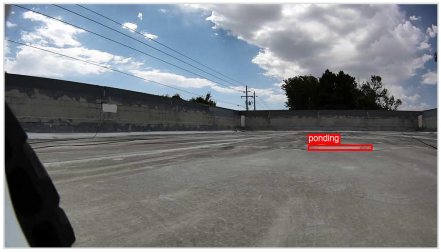
Figure 2.45. Section 2 — Ponding capture locations

Ponding

Total Defects	**3**
Quantity	**2 EA**
Repair Priority	**Low**

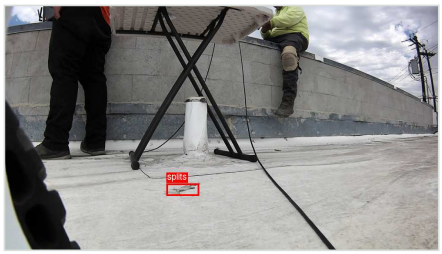
Figure 2.50. Section 2 — Splits capture locations

Splits

Total Defects	**1**
Quantity	**25 SF**
Repair Priority	**High**

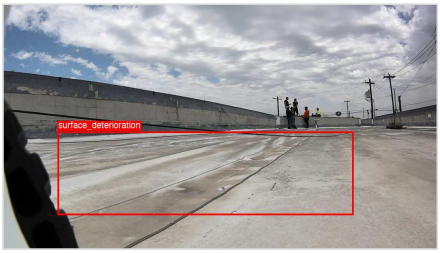
Figure 2.54. Section 2 — Surface Deterioration capture locations

Surface Deterioration

Total Defects	2
Quantity	Not priced
Repair Priority	Not priced

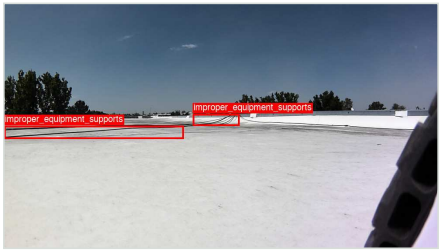
Figure 2.58. Section 3 — Improper Equipment Supports capture locations

Improper Equipment Supports

Total Defects	5
Quantity	5 EA
Repair Priority	Low
