NIST NCSTAR 1-4D

Federal Building and Fire Safety Investigation of the **World Trade Center Disaster**

Smoke Management Systems

September 2005

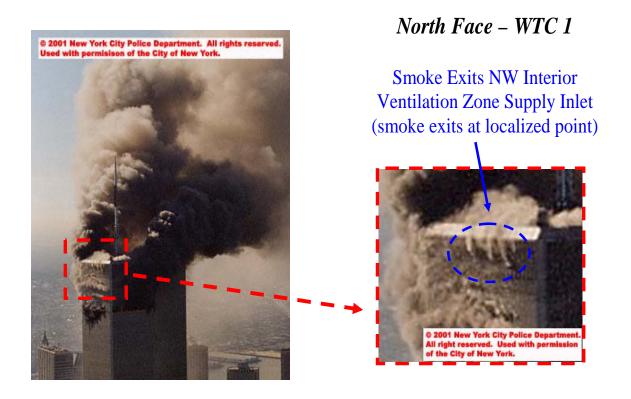
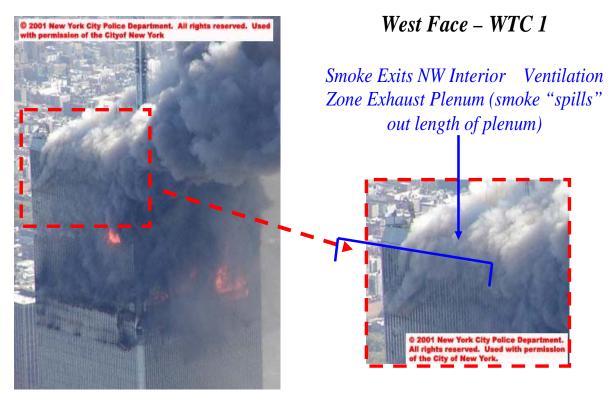
Figure 7-3. Impact damage to north and west faces of WTC 1.

In WTC 1, spread of large amounts of smoke via the ventilation shafts is evident in the examination of pictures of the exterior of WTC 1 after impact. Figure 7–3 depicts views of WTC 1 from the north and the west. A significant amount of smoke is observed coming out of the 108th floor MER from a localized spot on the north face of the building, and that smoke seems to exit from the MER along the length of the west face of the building. Figures 4–6 and 4–8 depict the supply and exhaust system layout in a typical MER (shown for WTC 2). At the 108th floor MER in WTC 1, the localized smoke emanating from the north face of the building corresponds to the location of the supply fan inlet for the northwest interior supply zone. The exhaust plenum for the northwest quadrant exhaust fans is located along the west face of the MER. The visual evidence depicted in Fig. 7–3, showing smoke exiting from the 108th floor MER, supports damage to the primary ventilation shaft serving the northwest quadrant of the impact zone, depicted in Fig. 7–1.

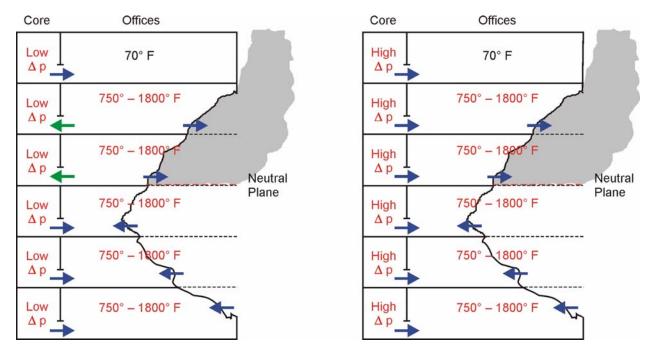
Figure 8-2. Effect of core pressure on airflows in impact zones.

In order to evaluate the results of the September 11, 2001, fire scenarios, it is important to note that the aircraft impact created a large, multi-floor zone with openings to the outside via damage to the building envelope and openings to the interior core spaces. The temperature throughout the impact zone is assumed to be uniform, at either 750 °F (400 °C) or 1,800 °F (1,000 °C). The temperature within the multi-floor zone creates a buoyant airflow due to localized stack effect within the zone caused by the high temperature. This phenomenon is shown in Fig. 8–2.

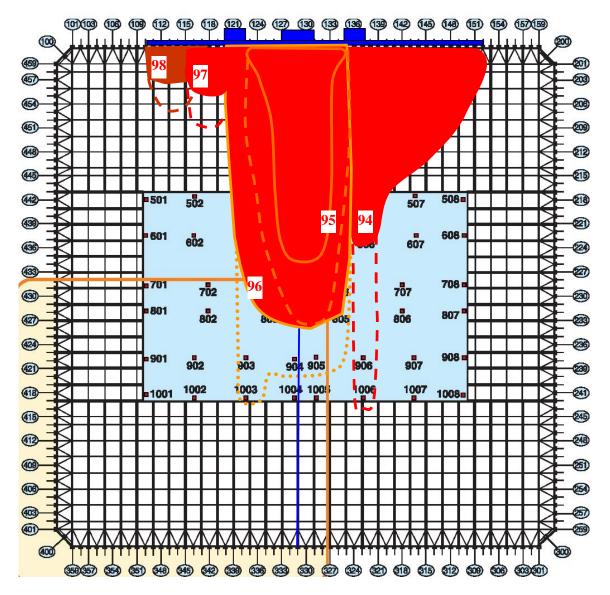
Figure A-1. Preliminary damage estimates, all floors, WTC 1.

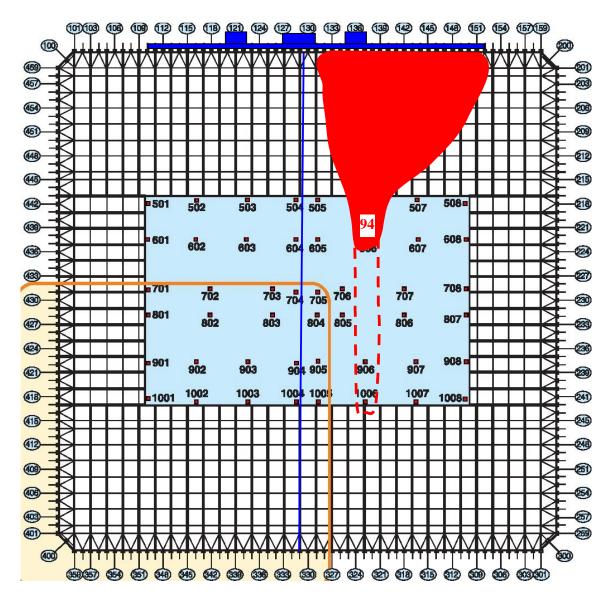
Figure A-2. Preliminary damage estimates, 94th floor, WTC 1.

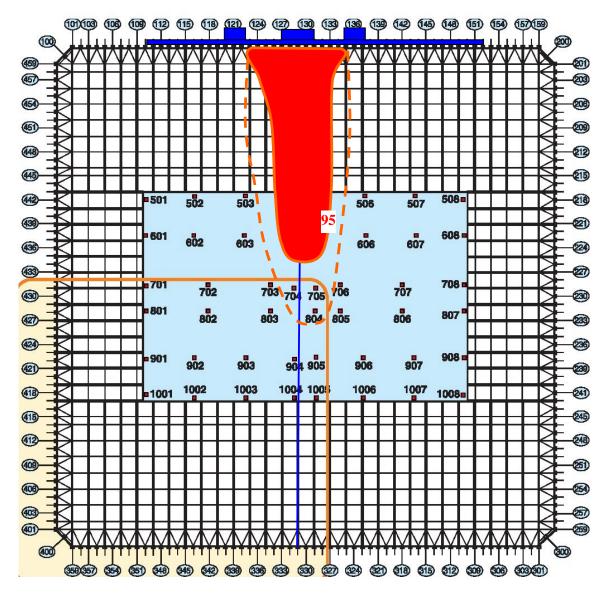
Figure A-3. Preliminary damage estimates, 95th floor, WTC 1.

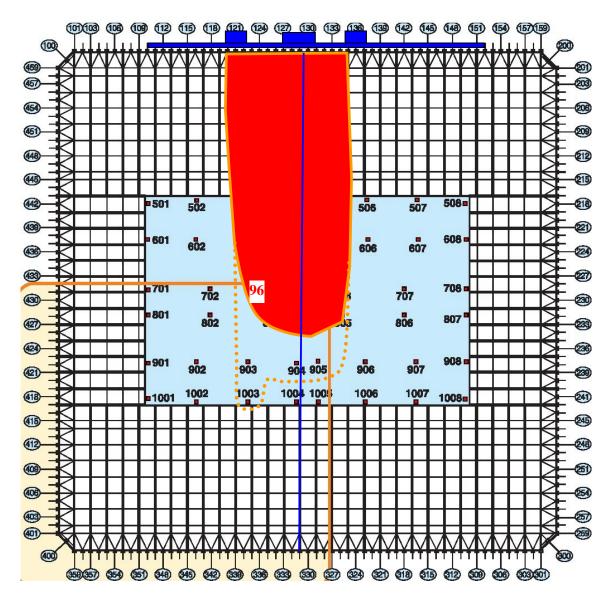
Figure A-4. Preliminary damage estimates, 96th floor, WTC 1.

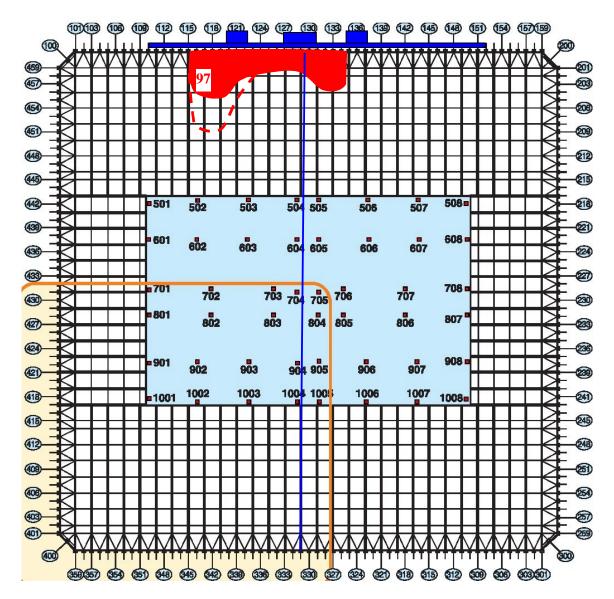
Figure A-5. Preliminary damage estimates, 97th floor, WTC 1.

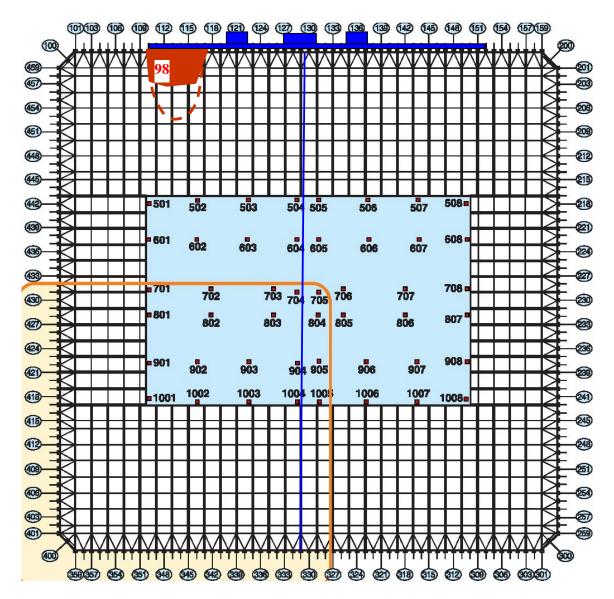
Figure A-6. Preliminary damage estimates, 98th floor, WTC 1.

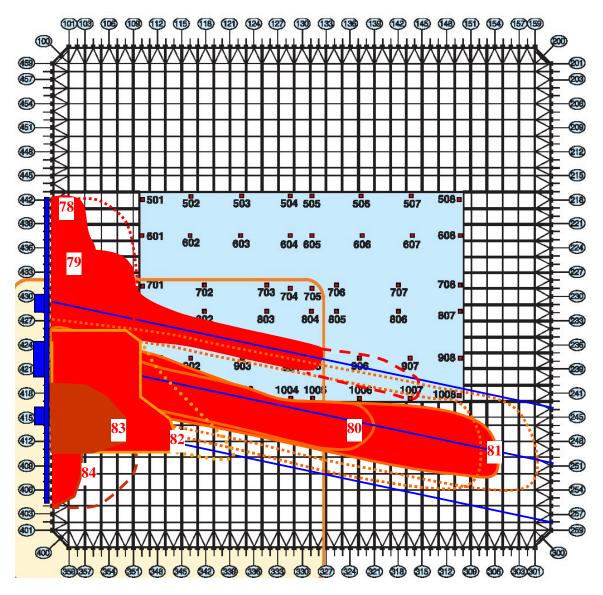
Figure A-7. Preliminary damage estimates, all floors, WTC 2.

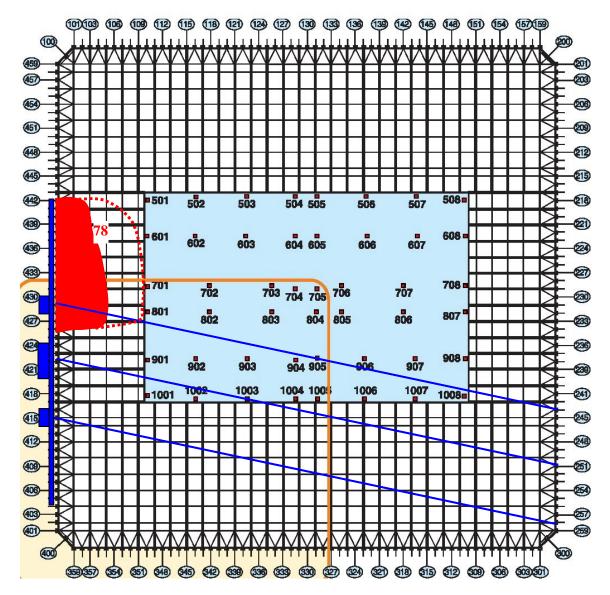
Figure A-8. Preliminary damage estimates, 78th floor, WTC 2.

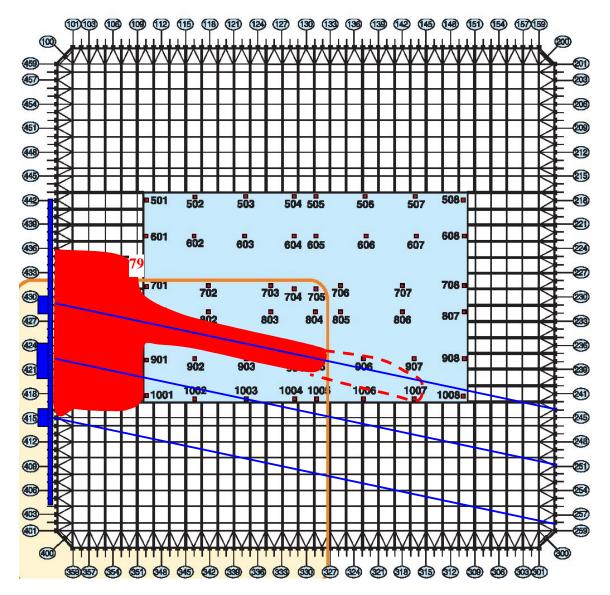
Figure A-9. Preliminary damage estimates, 79th floor, WTC 2.

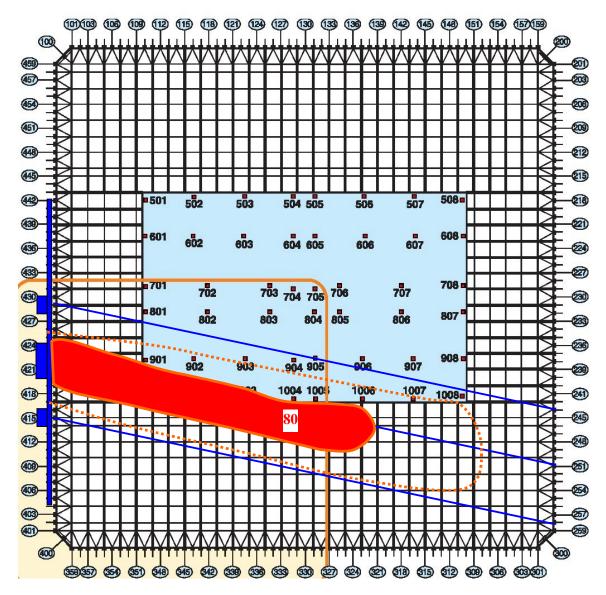
Figure A-10. Preliminary damage estimates, 80th floor, WTC 2.

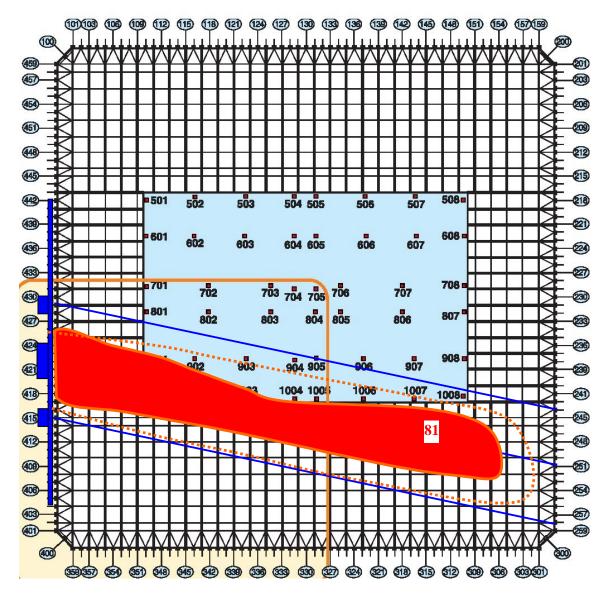
Figure A-11. Preliminary damage estimates, 81st floor, WTC 2.

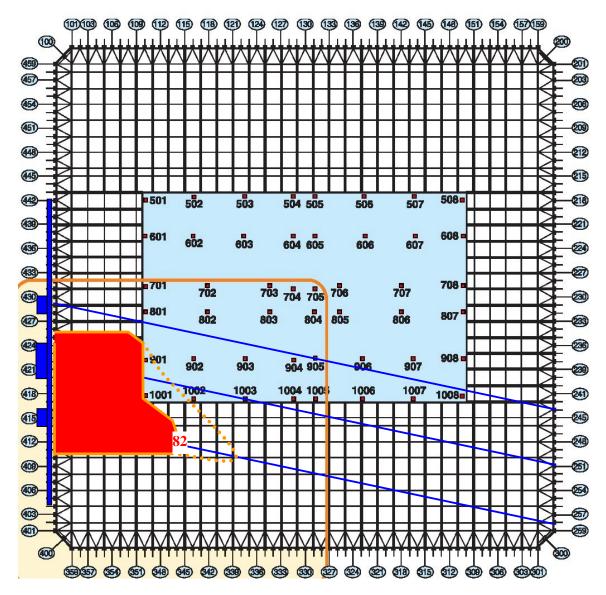
Figure A-12. Preliminary damage estimates, 82nd floor, WTC 2.

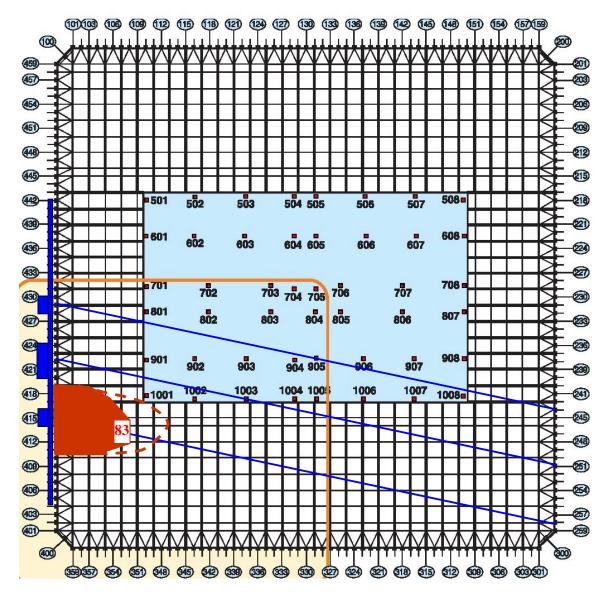
Figure A-13. Preliminary damage estimates, 83rd floor, WTC 2.

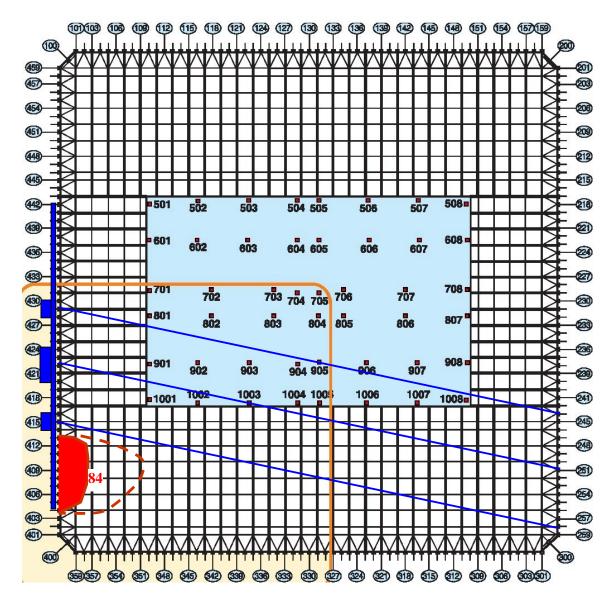
Figure A-14. Preliminary damage estimates, 84th floor, WTC 2.

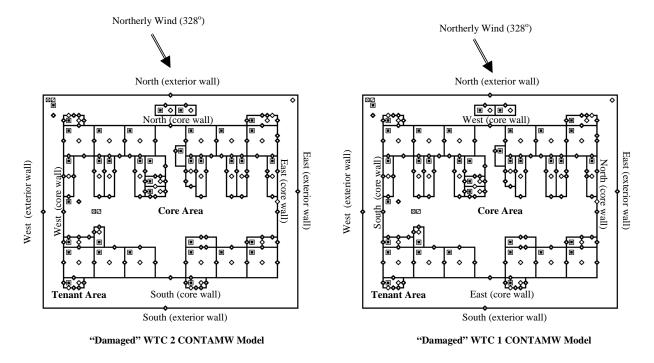
The impact damage to the core walls of WTC 2 were rotated by 90 degrees with respect to WTC 1 (see Fig. B–3). This was done to correctly account for the different core orientation in WTC 2 versus WTC 1 with respect to the point of aircraft impact. Since the CONTAM model considers the interior office space as one large open zone, the core can be effectively rotated by placing damage openings in the proper locations, rather than physically rotating the location of the core zones on the CONTAM SketchPad.

Figure B-3. CONTAM SketchPad, floor 15, exterior and core wall directional orientations for damaged CONTAM models.
