DTC P2251:00 [SKYACTIV-G 1.3, SKYACTIV-G 1.5]

Details On DTCs

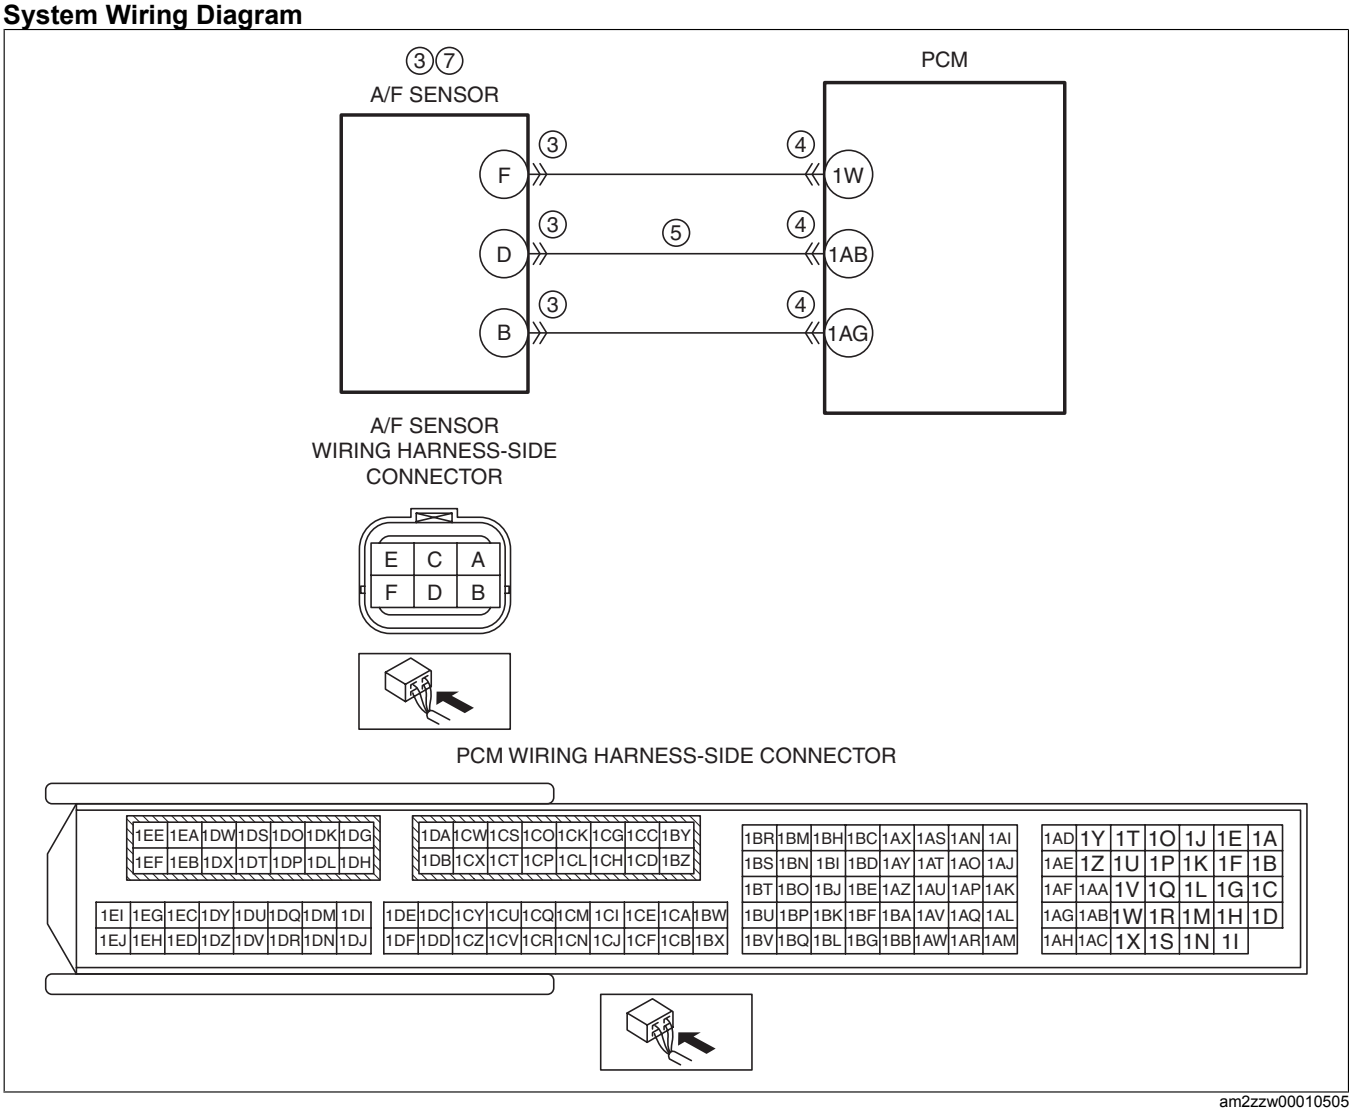
am2zzw00010505

DESCRIPTION	**Open circuit between A/F sensor terminal D and PCM terminal 1AB**	
DETECTION CONDITION	Determination conditions	• The following conditions are met: — A/F sensor element impedance is specified value or more — A/F sensor terminal F voltage (B+ terminal) is less than specified value or unstable.
	Preconditions	• Battery voltage: **11—18 V** *1 • A/F sensor is activated. • The following DTCs are not detected: — A/F sensor terminal F voltage (B+ terminal) is less than specified value: • A/F sensor heater: P0031:00, P0032:00 — A/F sensor terminal F voltage (B+ terminal) is unstable: • Internal PCM malfunction: P064D:00 *1: Value can be verified by displaying PIDs using M-MDS
	Drive cycle	• 2
	Self test type	• CMDTC self test, KOER self test
	Sensor used	• A/F sensor
FAIL-SAFE FUNCTION	• Not applicable	
VEHICLE STATUS WHEN DTCs ARE OUTPUT	• Illuminates check engine light.	
POSSIBLE CAUSE	• A/F sensor connector or terminals malfunction • PCM connector or terminals malfunction • Open circuit in wiring harness between A/F sensor terminal D and PCM terminal 1AB • A/F sensor malfunction • PCM malfunction

- If the PCM detects an open circuit in the wiring harness between A/F sensor terminal D and PCM terminal 1AB (COM wiring harness), it stores a DTC. In addition, when there is an open circuit in the wiring harness between A/F sensor terminal D and PCM terminal 1AB (COM wiring harness), the A/F sensor terminal F (B+ terminal) becomes unstable. At this time, the PCM determines an open circuit in the wiring harness (COM wiring harness) between A/F sensor terminal D and PCM terminal 1AB and stores a DTC.
- If the A/F sensor does not activate, monitoring cannot occur because the A/F sensor element has an insulation property which keeps it at a specific temperature range or less.
