DTC P2565:00 [SKYACTIV-D 1.5]

DTC P2565:00	Actuator position sensor circuit high input
DETECTION CONDITION	• If the input voltage at the PCM terminal 1BK is **more than 4.64 V** for **1 s**, the PCM determines that the actuator position sensor circuit has a malfunction. **MONITORING CONDITIONS** — Battery voltage: **8—20 V** — **0.5 s** have elapsed after the ignition was switched ON (engine off or on) **Diagnostic support note** • This is an intermittent monitor (turbo system). • The check engine light illuminates if the PCM detects the above malfunction condition during the first drive cycle. • FREEZE FRAME DATA/Snapshot data is available. • DTC is stored in the PCM memory.
FAIL-SAFE FUNCTION	• PCM restricts engine torque. • Inhibits the auto DPF regeneration control. • Inhibits the compulsory DPF regeneration control. • Inhibits the boost control. • Inhibits the EGR control. • PCM restricts engine-transaxle integration control. (ATX) • Inhibits engine-stop by operating the i-stop function.

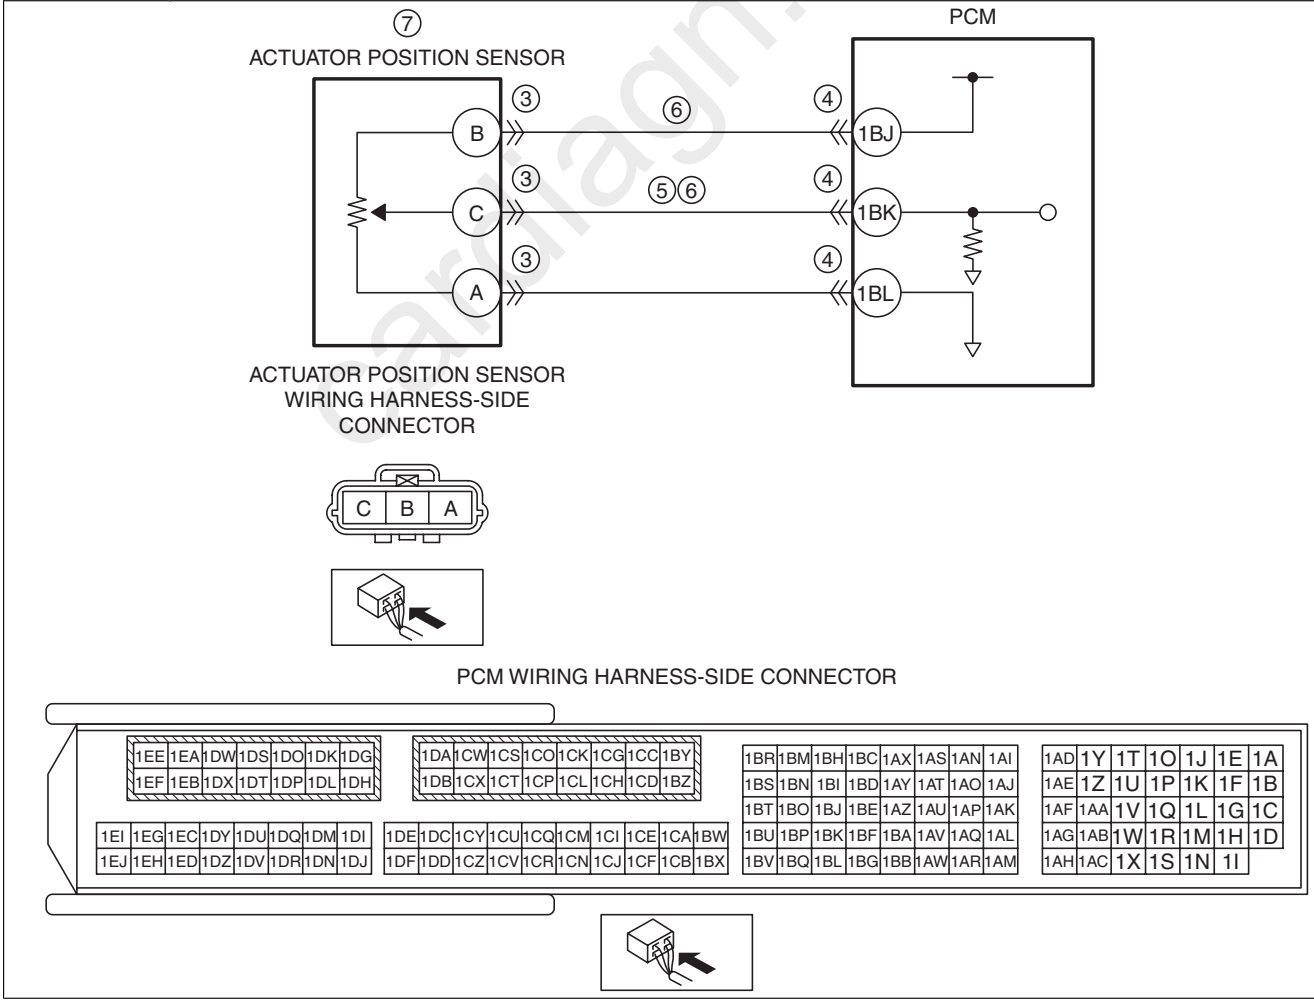
POSSIBLE CAUSE	• Actuator position sensor connector or terminals malfunction • PCM connector or terminals malfunction • Short to power supply in wiring harness between actuator position sensor terminal C and PCM terminal 1BK • Actuator position sensor power supply circuit and signal circuit are shorted to each other • Actuator position sensor malfunction • PCM malfunction
