DTC U200D:11 [FULL-AUTO AIR CONDITIONER]

id0702c1736600

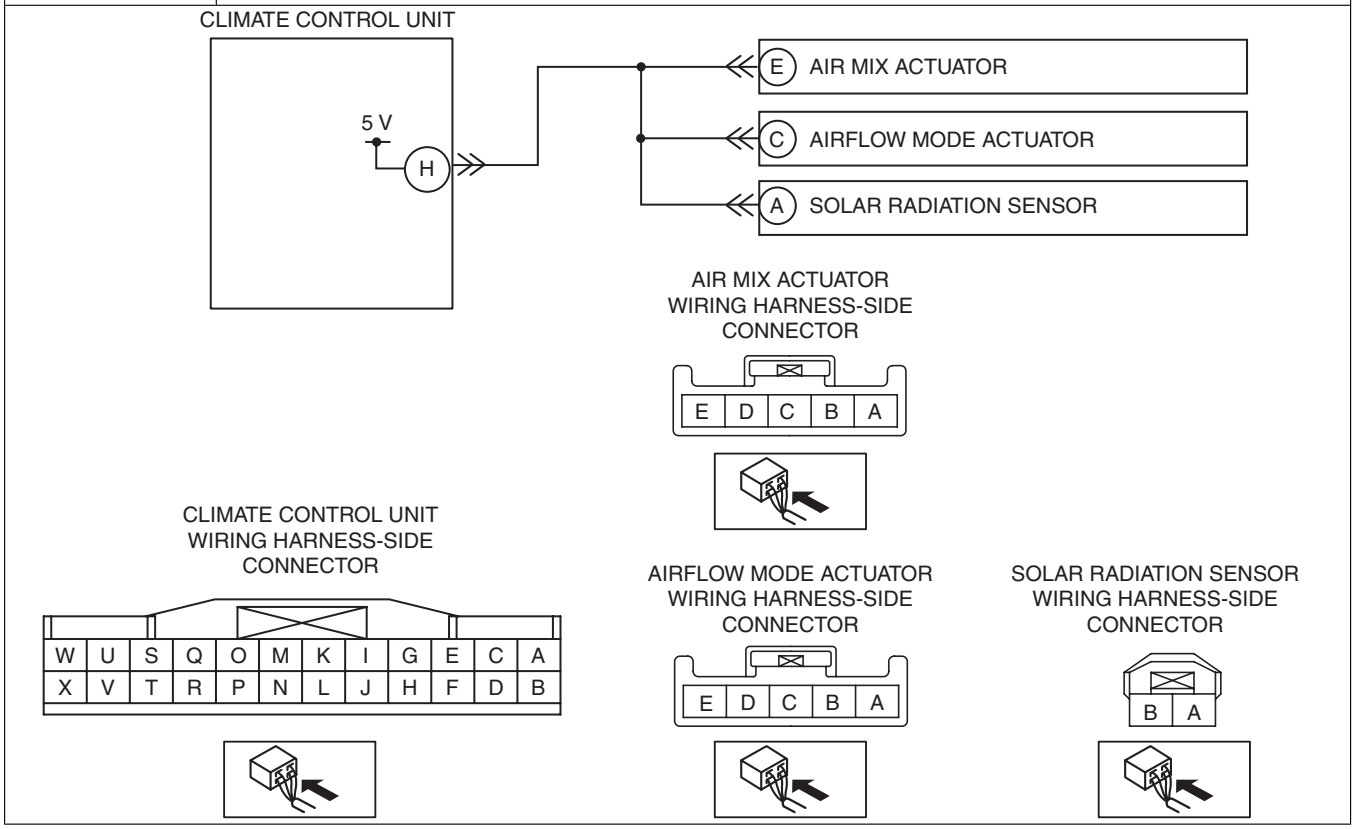
System malfunction location	• Climate control unit circuit voltage (+5V) circuit short to ground
Detection condition	• Malfunction in wiring harness between climate control unit circuit voltage (+5V) and each sensor/actuator
Fail-safe function	Not applicable
Possible cause	• Connector or terminal malfunction • Each sensor/actuator malfunction • Short to ground in wiring harness between climate control unit and air mix actuator • Short to ground in wiring harness between climate control unit and airflow mode actuator • Short to ground in wiring harness between climate control unit and solar radiation sensor • Climate control unit malfunction
