PC PRO INSPECTIONS

PC PRO RESIDENTIAL INSPECTION

1234 Main Street
Fairfield , IL 62837

06/13/2026 9:00AM

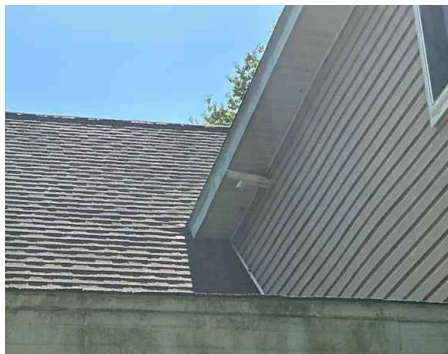
Flashing: Eaves, Gables and Wall Intersections

I looked for flashing installed at the eaves (near the gutter edge) and at the gables (the diagonal edge of the roof). There should be metal drip flashing material installed in these locations. The flashing helps the surface water on the roof to discharge into the gutter. Flashing also helps to prevent water intrusion under the roof-covering.

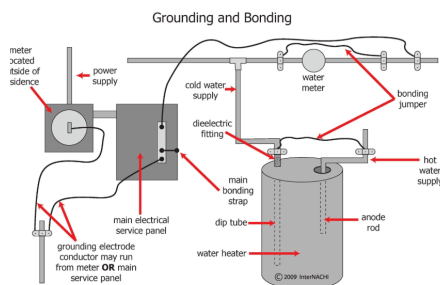
Panelboards & Breakers: Inspected Main Panelboard & Breakers

I inspected the electrical panelboards and over-current protection devices (circuit breakers and fuses).

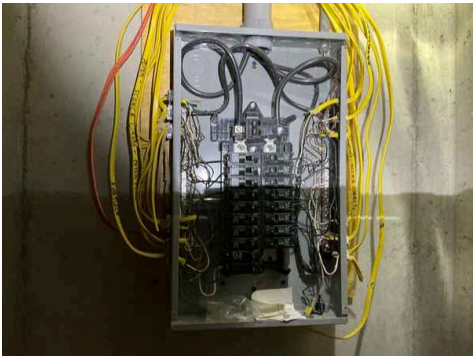
6.6.1 Panelboards & Breakers

PANEL NEEDS COVER PUT ON

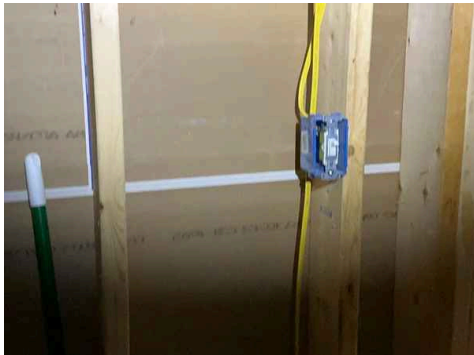
6.6.2 Panelboards & Breakers

SWITCHES AND JUNCTION BOXES NEED COVERS

Contact a qualified professional.

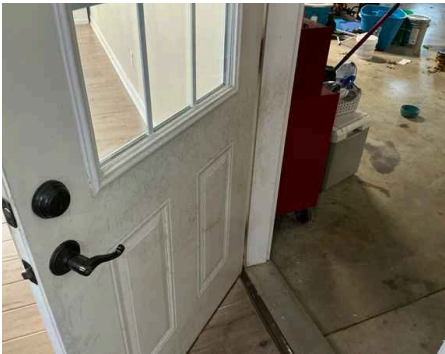
Ceiling, Walls & Firewalls in Garage: Garage Ceiling & Walls Were Inspected

I inspected the ceiling and walls of the garage according to the Home Inspection Standards of Practice.

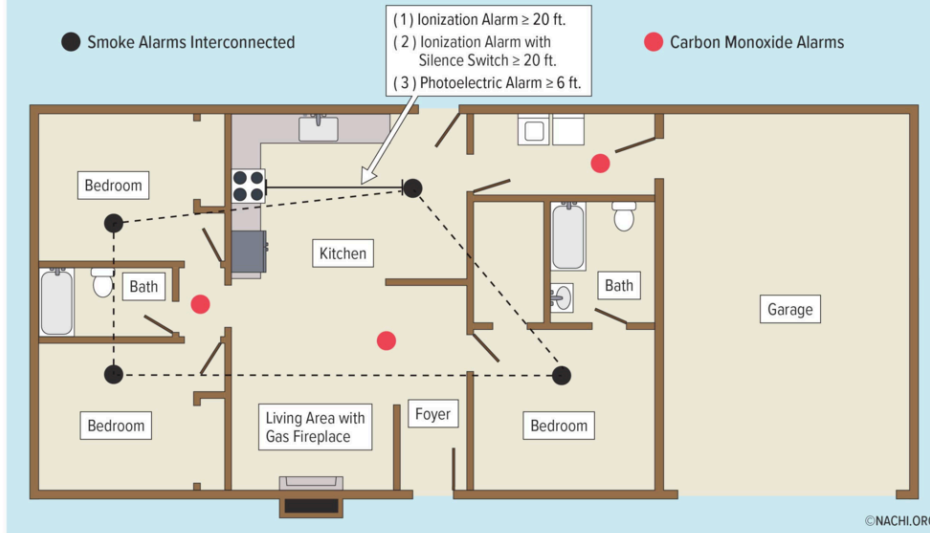
Presence of Smoke and CO Detectors: Inspected for Presence of Smoke and CO Detectors

I inspected for the presence of smoke and carbon-monoxide detectors.

There should be a smoke detector in every sleeping room, outside of every sleeping room, and one every level of a house.

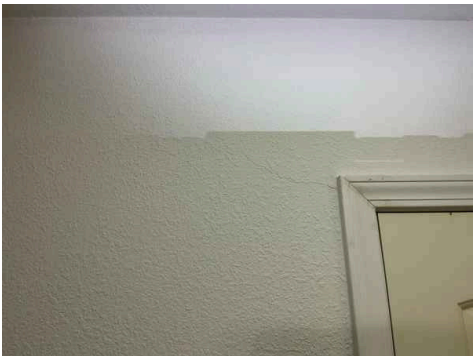
MINOR CORNER CRACKS

Minor cracks at the corners of doors and windows in walls. Appeared to be the result of long-term settling. Some settling is not unusual in a home of this age and these cracks are not a structural concern.

Recommendation
Contact a qualified professional.
