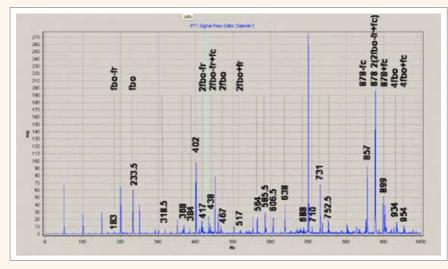
A good example of how the bearing speed ratio can be used to identify a potential problem is shown in Figure 6, which shows a vibration acceleration spectrum measured axially on the end cap of a 250 kW electric motor.

In this case the Type 6217 radial ball bearings were experiencing a high axial load as a result of the non-locating bearing failing to slide in the housing (thermal

Figure 6 Axial vibration acceleration spectrum on end cap of a 250 kW electric motor

Eventually this motor failed catastrophically and thermal loading (cross location) of the bearings was confirmed. A number of harmonics and sum and difference frequencies are also evident in the spectrum.

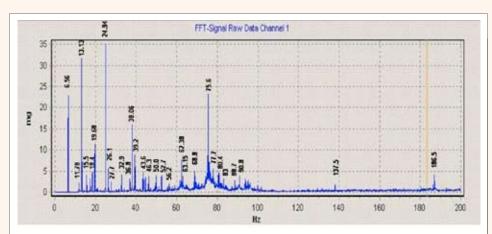
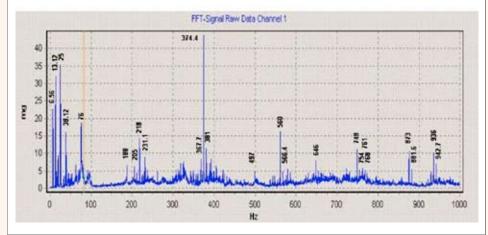
Figure 9 Spectra obtained from the housing of a taper roller bearing

This would suggest some deterioration in the condition of the roller(s), which was confirmed upon examination of the bearing. The spectrum also shows discrete

peaks spaced at cage speed, 2.93 Hz, which again is consistent with deterioration in the condition of the rollers. The 374.4 Hz component is related to the gear mesh frequency, with sidebands at rotational speed, 6.56 Hz.

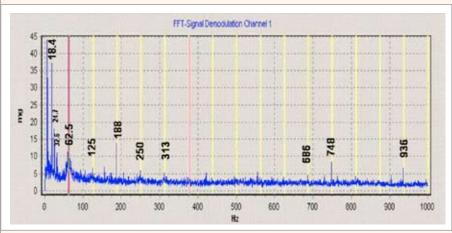
As previously mentioned, bearing defects normally produce a signal which is amplitude modulated, so by demodulating the signal and analysing the envelope provides a useful technique for early fault detection. *Figure 10* shows the envelope spectrum, where discrete peaks are present at 62.5 Hz, and its harmonics which correspond with the roller defect frequency, clearly showing how demodulation can be used, in some circumstances, to provide a convenient and early detection of deterioration in rolling bearings.

Figure 10 Envelope spectrum from the housing of a taper roller bearing

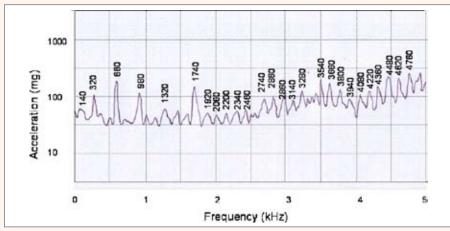
The vibration spectrum shown in *Figure 11* was measured on the spindle housing of an internal grinding machine which was grinding the raceways of bearing outer rings. Although the machine was producing work to the required quality the routine vibration measurement immediately raised some concerns regarding the condition of the spindle.

The spindle was rotating at 19,200 rev/min (320 Hz) and the most unusual aspect of the spectrum is the presence of a large number of discrete peaks spaced at 140 Hz, which related to the fundamental train frequency of the angular contact ball bearings which had a plastic cage and were lubricated with oil mist.

Upon examination of the bearing the

Figure 11 Vibration acceleration measured on the spindle housing of an internal grinding machine.

cage outer diameter showed clear signs of damage with some fragments of plastic material which had broken away, but was still attached to the outer diameter. As a result, the spectrum had sum and difference frequencies related to the shaft (fr) and cage (fc), e.g. 1740 Hz (5fr+fc).

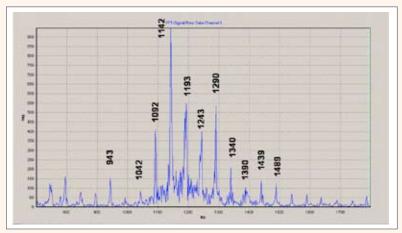
Figure 12 Vibration acceleration measured axially on the DE of a 250 kW electric motor.

When the bearings were removed from the motor and examined the ball running path was offset from the centre of the raceways towards the shoulders of the both the inner and outer rings, indicative of high axial loads. The cause of the failure was thermal pre-loading as a result of the non-locating bearing not sliding in the housing to compensate for axial thermal expansion of the shaft; this is often referred to as 'cross location'. The non-drive end bearing had severe damage to the raceways and the rolling elements which was

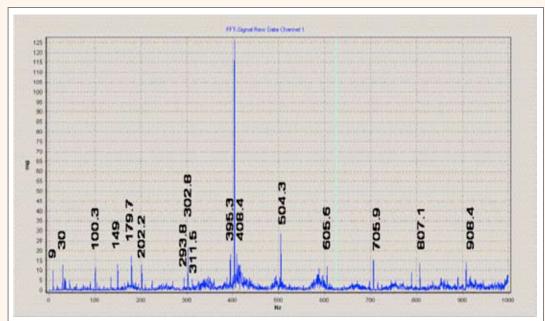
Figure 13 Vibration acceleration measured radially on the housing of a Type 23036 spherical roller bearing

consistent with the highly modulated signal and high amplitude of vibration at $5f_{b/o}$. The overall RMS vibration level of the motor increased from typically 0.22g to 1.64g.

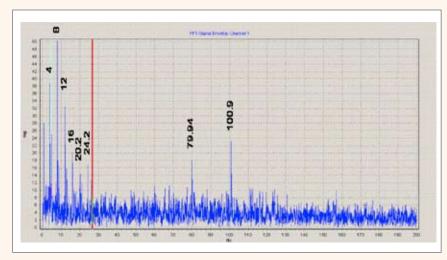
Also a number of the rollers had black corrosion stains, which was consistent with the vibration at cage rotational frequency, fc=4 Hz, in the envelope spectrum (*see Figure 15*).

Figure 15 Envelope spectrum of the Type 23036 spherical roller bearing

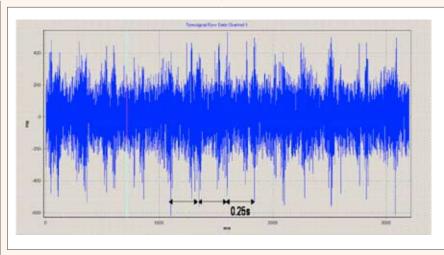
Figure 16 Acceleration time signal of the Type 23036 spherical roller bearing

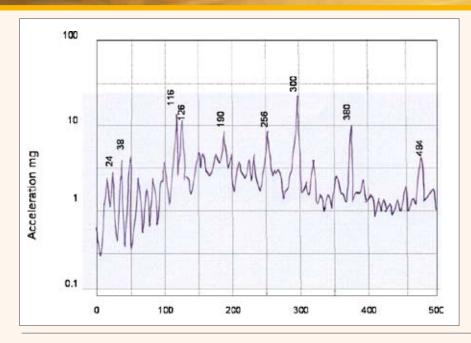
Figure 17, which shows the vibration acceleration spectrum, 0-500 Hz, measured on the spindle housing of an external shoe centreless grinding machine during the grinding of an inner ring raceway, where the typical values for out-of-roundness and surface roughness were $>4 \mu m$ and 0.3 μ mRa respectively. The most distinctive feature on the finished raceway was the presence of 21 lobes which, when multiplied by the workpiece rotational speed (370 rev/ min or 6.2 Hz), corresponded to a frequency of 129.5 Hz. This was very close to the 126 Hz component in the spectrum which was associated with the ball pass frequency relative to outer raceway of a ball bearing in the drive head motor. Also present are harmonics at 256 and 380 Hz. The discrete peaks at 38, 116 and 190 Hz correspond to the spindle rotational speed and its harmonics.

Figure 17 Vibration spectrum and roundness before replacing wheel head drive motor bearings (a) Vibration spectrum on spindle housing (b) Roundness of raceway

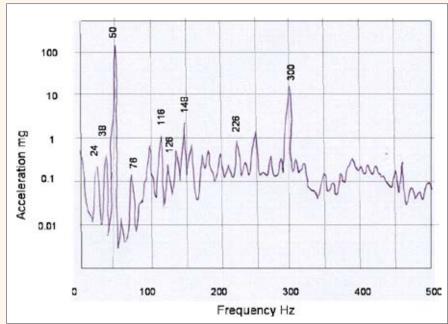
Figure 18 Vibration spectrum and roundness after replacing wheel head drive motor bearings (a) Vibration spectrum measured on spindle housing (b) Roundness of raceway

Figure 18 shows that after replacing the motor bearings the vibration at 126 Hz reduced from 0.012g to 0.00032g and the associated harmonics were no longer dominant. This resulted in a dramatic improvement in workpiece out-of-roundness of <0.4 μ m and the surface finish improved to 0.19 μ mRa. This demonstrates that with some critical equipment such as machine tools it is possible to assess directly the condition of the machine by measuring the resultant workpiece quality [2, 3].
