Address	8252 Agarito Way	Community	University Place
Assigned To	Edgar Mejia	Builder	Beazer

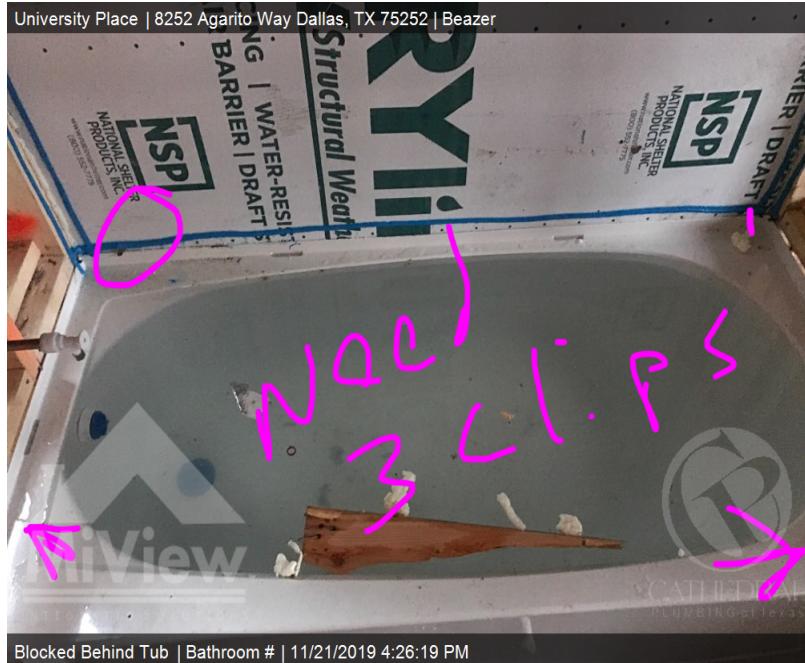
Section	Punch Item	Created By	Due Date
Bathroom #	Need 3 additional clips on down tub, only 1 installed.	Shane Miles	Fri. Nov 22, 2019

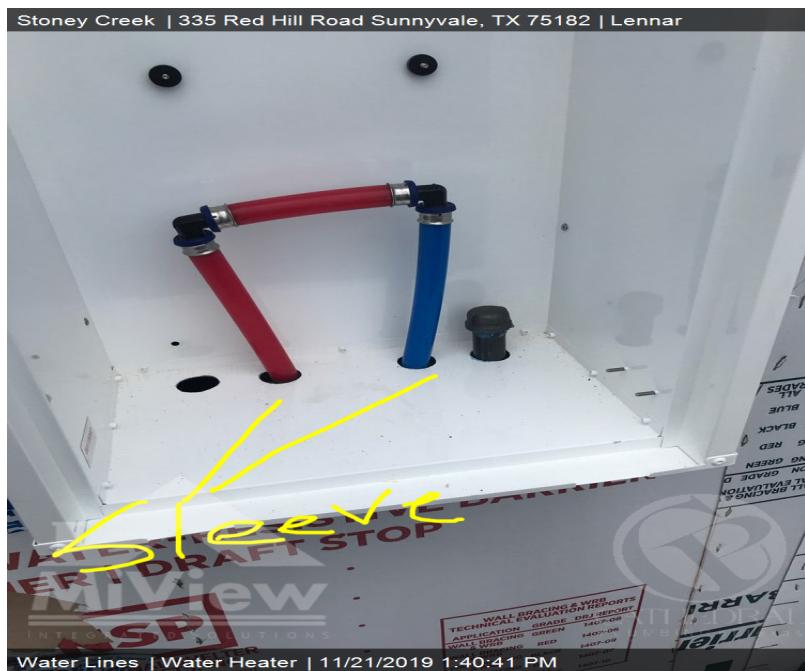
Section	Punch Item	Created By	Due Date
Outside	Properly tape and seal all exterior penetrations ^(OB)	Robert Maner	Fri. Nov 22, 2019

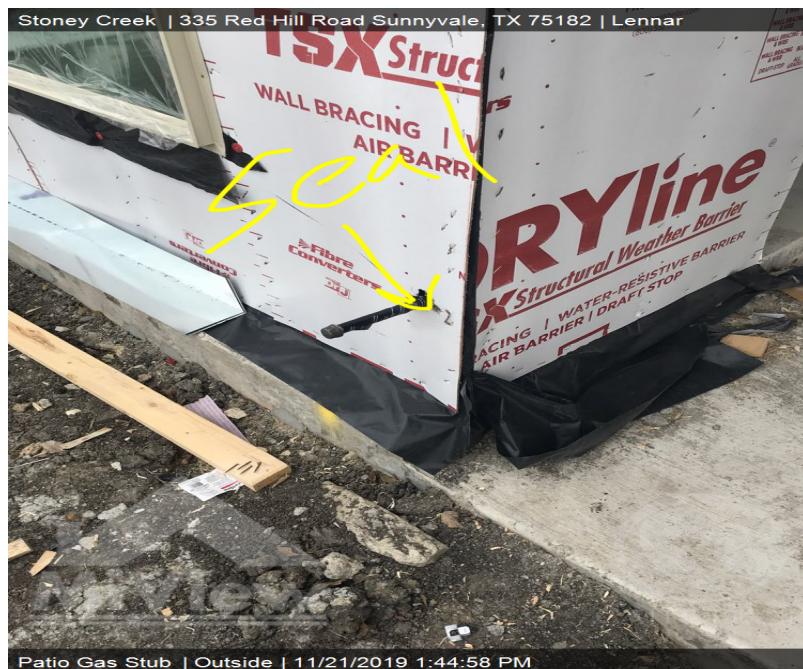
Section	Punch Item	Created By	Due Date
Outside	WRap hose bib and tape and seal penetrations ^{OBJ}	Robert Maner	Fri. Nov 22, 2019

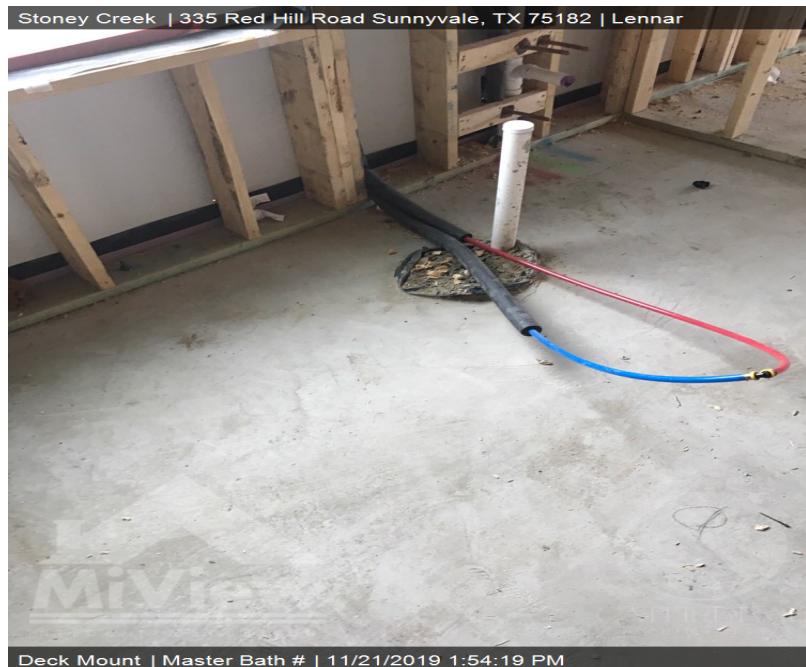
Section	Punch Item	Created By	Due Date
Master Bath #	Install concrete under master tub [08]	Robert Maner	Fri. Nov 22, 2019

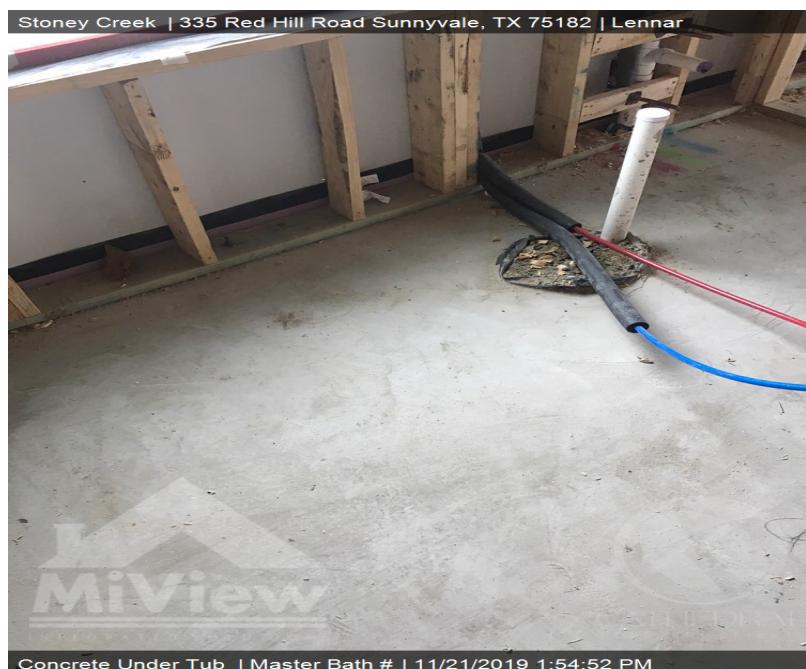
Section	Punch Item	Created By	Due Date
Master Bath #	Install tubs ^{OBJ}	Robert Maner	Fri. Nov 22, 2019

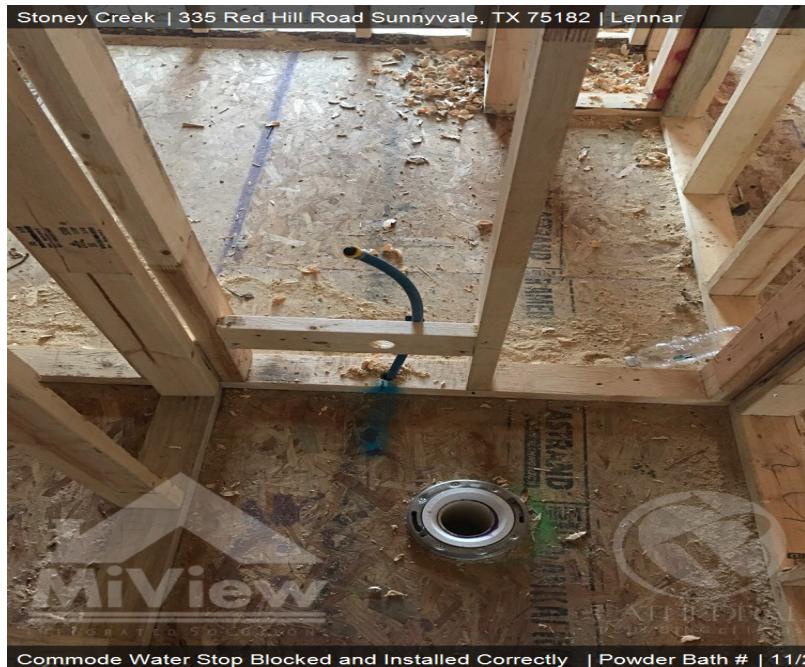
Section	Punch Item	Created By	Due Date
Powder Bath #	Nail guard powder toilet supply	Robert Maner	Fri. Nov 22, 2019
