Structural Damage Claim Policy

Insured:	MCKEE, CHARLES	Estimate:	51-80B9-27C
Property:	2355 ROUND TOP DR HONOLULU, HI 96822-2067	Claim Number:	5180B927C
		Policy Number:	51BEN0770
Home:	808-685-1153	Price List:	HIHO28_JAN25 Restoration/Service/Remodel
Cellular:	808-741-6602		
Type of Loss:	Wind Damage		
Deductible:	$500.00		
Date of Loss:	1/30/2025		
Date Inspected:	2/17/2025

Summary for Coverage A - Dwelling - 35 Windstorm and Hail

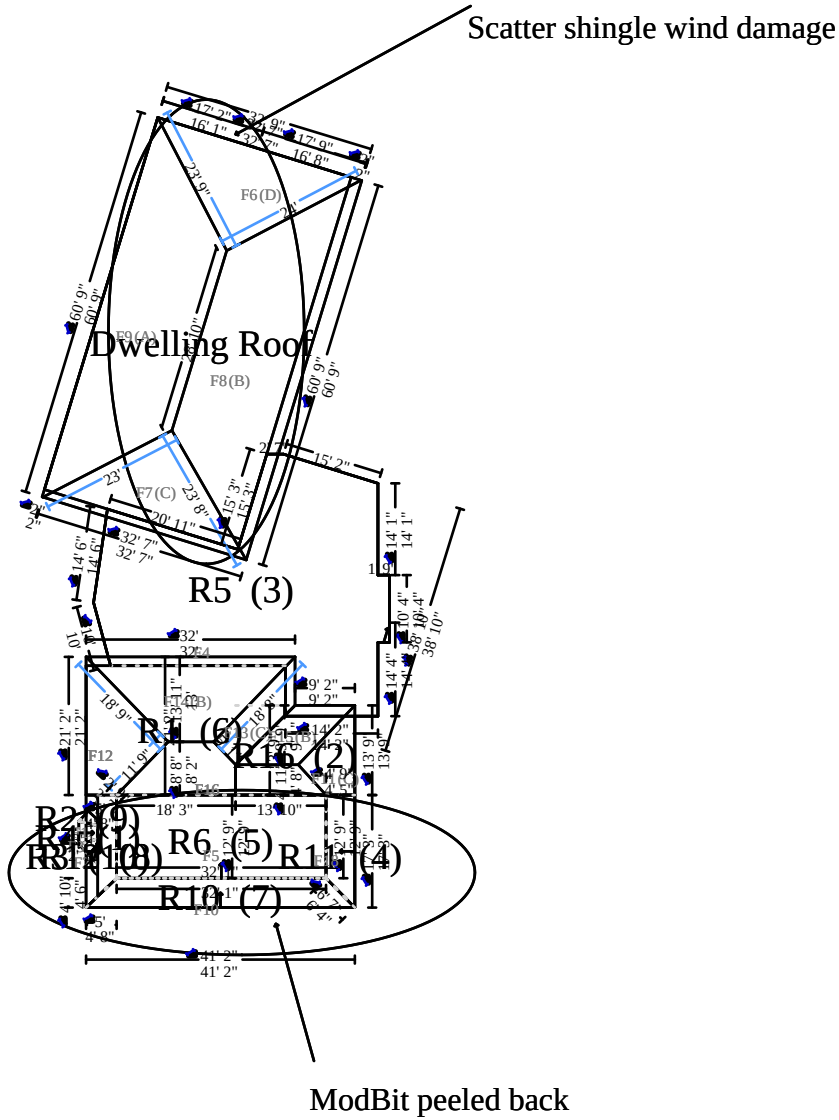
Scatter shingle wind damage
Dwelling Roof
R5 (3)
R4 (6)
R10 (2)
R6 (5)
R11 (4)
R10 (7)
ModBit peeled back
