Hawaii General LLC/RSC Roofing LLC

Client:	Charles McKee	Home:	(808) 685-1153
Property:	2355 Round Top Drive Honolulu, HI 96822		
Operator:	JIENYA		
Estimator:	Alex Adair	Business:	(808) 265-2823
Position:	Project Manager/Estimator	E-mail:	alex@hawaiigeneral.com
Company:	Hawaii General		
Business:	1314 S King St. Suite 522 Honolulu, HI 96818

Type of Estimate:	Wind Damage		
Date Entered:	3/5/2025	Date Assigned:

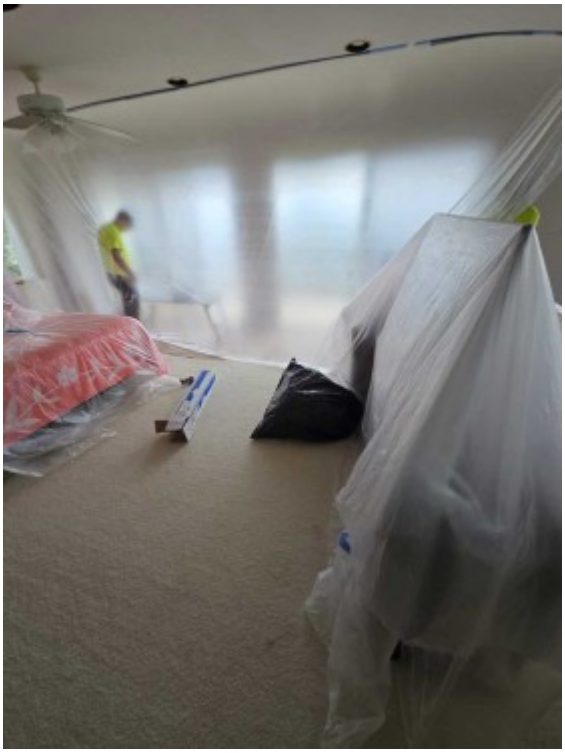
4 4-Dust barrier

Furniture that couldnt be removed from the upstairs were covered in protective plastic

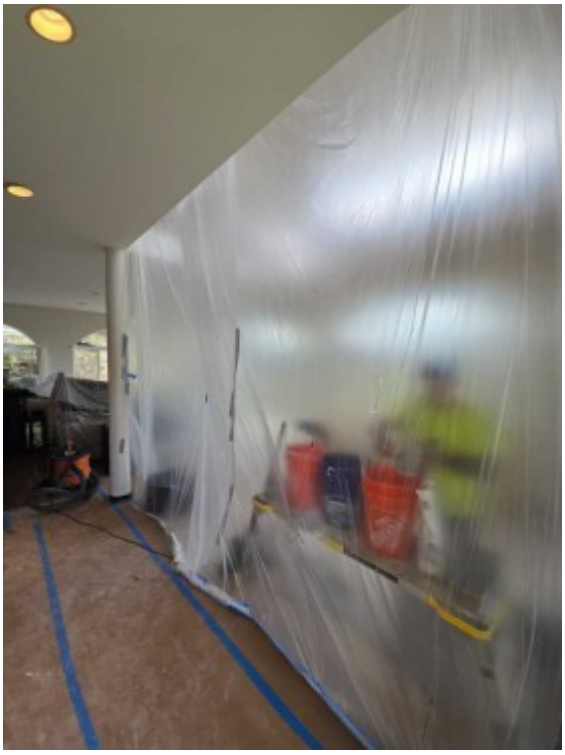
7 7-plastic barrier downstairs

floor protection for tile and hardwood downstairs and plastic dust barrier

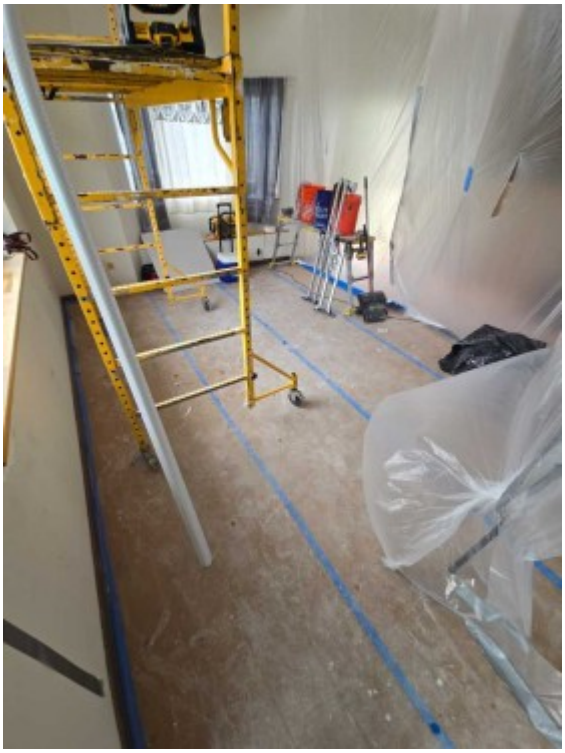
17 17-insulation installed

28. Batt insulation - 10" - R30 - paper / foil faced	**160.00**	**SF**		**0.00**	**2.59**	**36.69**	**89.62**	**540.71**
Insulation was removed during initial mitigation. R30 insulation was installed before hanging drywall on the ceiling See photo 17

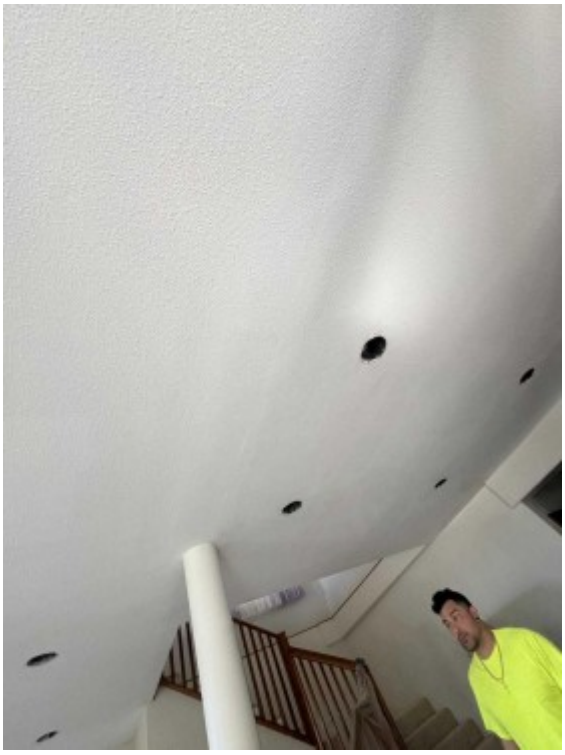
19 19-Can light detachment
Date Taken: 3/31/2025

Can lights were detached and reset to paint the ceiling according to the scope

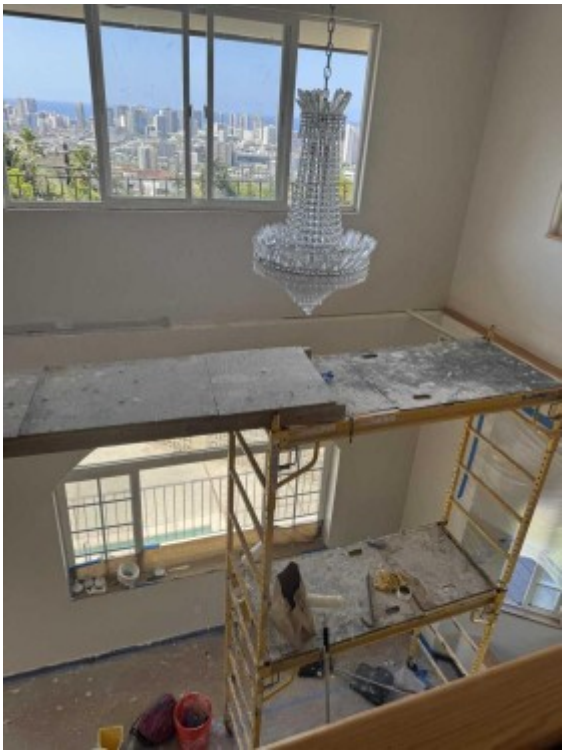
23 23-second level scaffolding
Date Taken: 3/31/2025

25. Scaffold - per section (per week)	**4.00**	**WK**		**0.00**	**65.36**	**14.91**	**54.90**	**331.25**
This job required two sections of scaffolding stacking 11 feet high. Scaffolding was being used 3/18/2025 through 3/31/2025

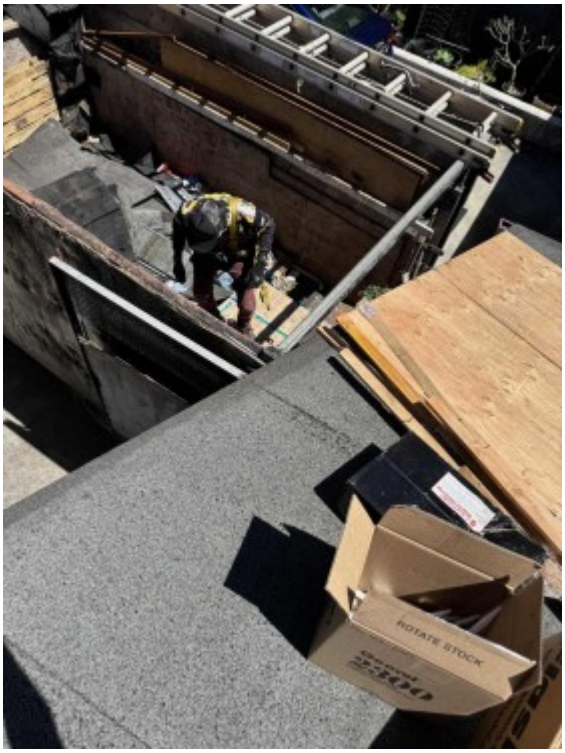
52 52-Hand carrying material from our truck
Date Taken: 3/10/2025

15. Flashing - pipe jack	6.00 EA		0.00	69.49	28.73	88.54	534.21
16. Roofing - General Laborer - per hour	**15.00 HR**		**0.00**	**66.36**	**56.75**	**209.03**	**1,261.18**
For hand carrying material and debris to rear roof. 3 workers working 5 hours **See photos 52, 53, 54**

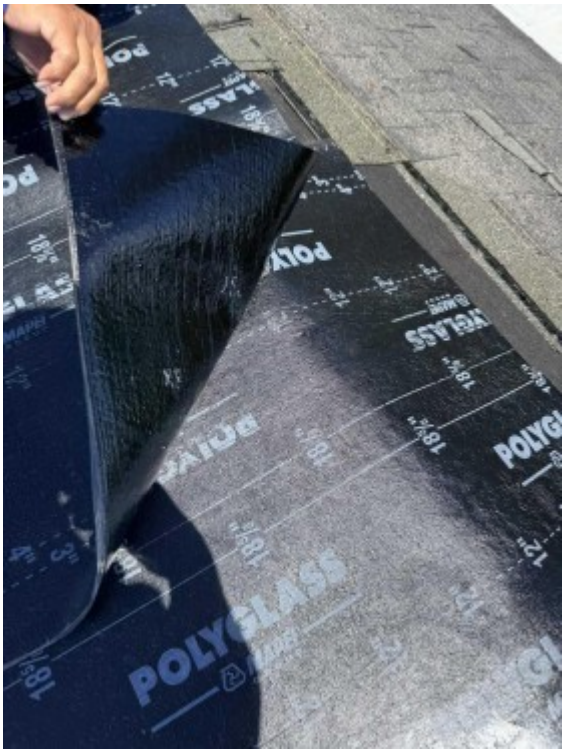
58 58-lapped at 18 5/8"
Date Taken: 3/10/2025

DESCRIPTION	QTY	RESET	REMOVE	REPLACE	TAX	O&P	TOTAL
1. R&R Modified bitumen roof	**10.00 SQ**		**83.68**	**620.87**	**499.91**	**1,499.07**	**9,044.48**
The flat roof area has no slope and must be lapped 18 *5/8" over. This requires 5 rolls of double base sheet and 5 rolls of cap sheet. Each roll is 2 SQ of material*							
See photos 56, 57, 58, 59

Because there is no slope on the mod bit roof, the material must be overlapped at 18 5/8". This results in 5 rolls being used
