INSTITUTION OF CIVIL ENGINEERS

Forensic engineering

a professional approach to investigation

Proceedings of the international conference organized by the Institution of Civil Engineers and held in London, UK, on 28–29 September 1998

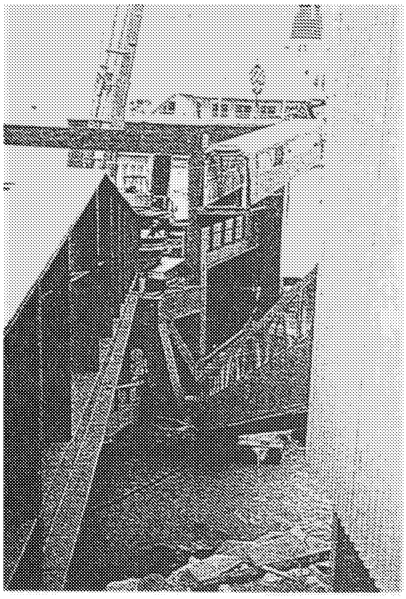
After four months in service, at 00.45 a.m., the seaward end of the shore span of the walkway fell without warning about 10 metres to the deck of the pontoon (**Figure 4**). The violent deceleration caused the death of six passengers and seriously injured seven others.

Fig 3. The collapsed walkway

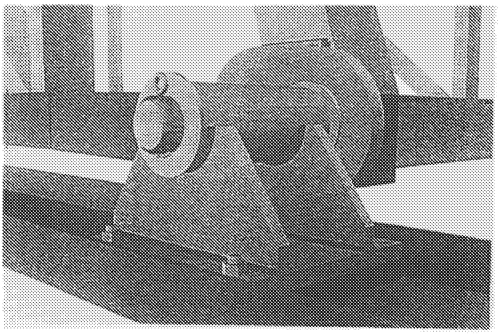
Fig 5. Sliding bearing, shore end

welded within a hole in a disc, which was site welded to the walkway structure. The shore bearings could slide in channels (**Figure 5**). A pad of low friction material was attached to the under-side of the bearing, and was believed by FKAB/FEAB to require no lubrication. The right hand (seen from the shore) seaward bearing was retained in position by a pintle passing through the plating of the bracket (**Figure 6**). The left hand seaward bearing had no pintle. It can be seen that of the six degrees of freedom of the pontoon, surge, sway, heave, pitch, and yaw were accommodated, but roll was not.

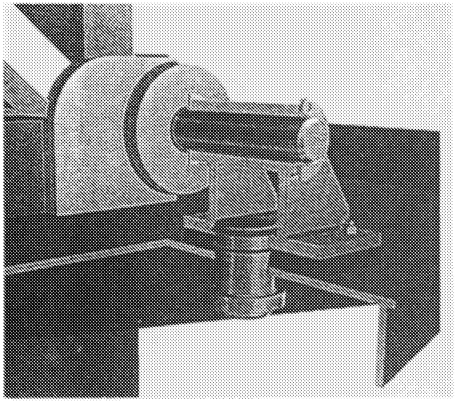
Fig 6. Right-hand seaward bearing with pintle

The bearings had been assembled at works, with the axles fixed within the bore of the discs by two circumferential welds (**Figure 7**). The disc was site welded to the D plates around half the circumference and on the vertical diameter (**Figure 6**).

The metallurgical examinations established that all axles had extensive fatigue cracking. The cracking had completely severed the right hand seaward connection (**Figure 9**). This bearing could only tilt to the extent permitted by the pintle retaining ring, and it seems possible that the end of the axle remained within the disc for a short period before being dislodged. The left hand seaward axle was largely cracked, but final failure occurred when the bearing struck the pontoon deck. Both shore bearings had advanced fatigue cracking. There were a number of weld defects, some of which reached the surface of the weld.

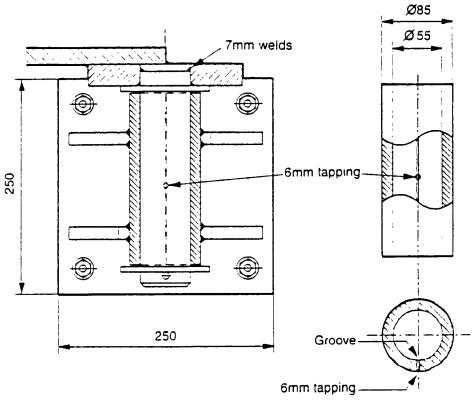
A 6mm tapping was provided on the underside of each sleeve (**Figure 7**), to receive the supply tube from a Greasomatic, which had not been fitted.

Fig 7. Bearing details, with hole for Greasomatics

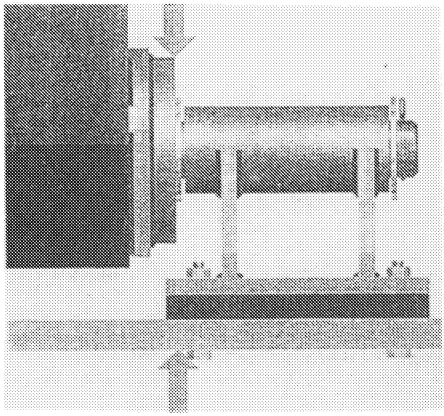
Fig 8. Designer's assumption for position of bearing reaction (the bolts are fictitious)

The dominant cause of the collapse quickly emerged from the design calculations supplied to HSE by FKAB. Nominally the resultant reactions to the vertical and horizontal forces applied to the bearing were at the centre of the bearing pads. Prudently it would have been assumed that the reactions were at the outer edges of the pads, and the bending moment on the axle at its connection to the disc, and the axle and weld stresses, would have been calculated accordingly. The section modulus of the axle was calculated, but it was evidently then decided that the axle bending moment was zero. This was frankly confirmed in response to HSE's questions after the accident; the response included the assumed bending moment diagram. It was decided that the axle and welded connection need only be designed against shear. The axle and connection were therefore grossly overstressed

Bending was not absent from their consideration. Because the axle was contained by a sleeve, which was stiffer and stronger than the axle, they checked the sleeve alone for bending. The moment was taken as the force applied at the disc multiplied by the distance from the disc to the first vertical support plate (**Figure 8**). It appears that the designers visualised that the forces were applied without moment at the disc and that the moment was resisted by the bearing, which was prevented from rotating, whereas the reverse was true. A smaller, but still major, error was to assume that all reactions were equal. The explanation given to HSE was that they had thought that the torsional stiffness of the structure would be small enough to justify that assumption. Also the design concept was inappropriate.

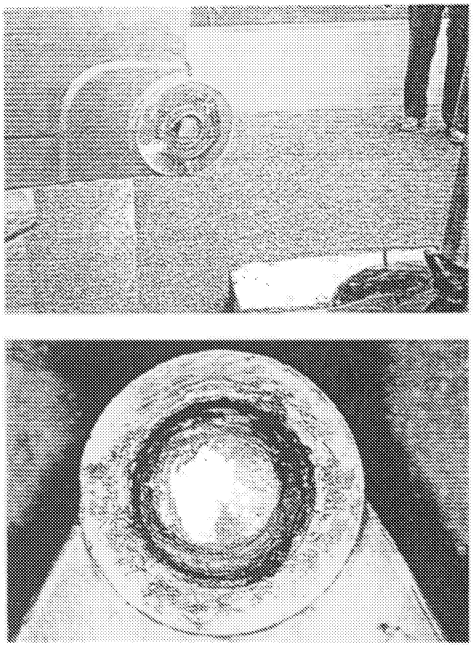
Fig 9. Fracture surface of right-hand seaward axl

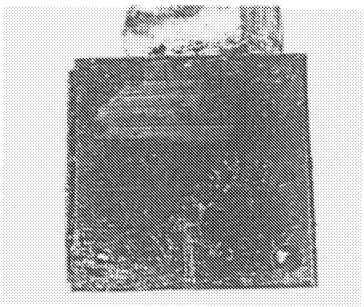
Fig 10. Sliding marks

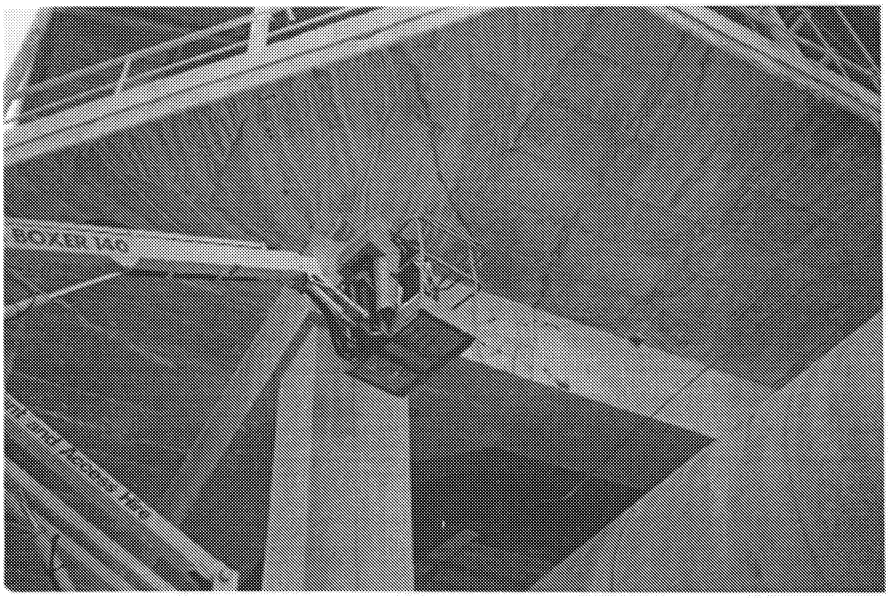
spalling of the surfaces on the compression faces. A typical pattern of cracks at one corner of the structure is illustrated in Figure 1.

Figure 1. Cracking to soffit of main beams and slab.

A review of the design loading and reinforcement details indicated that the original design appeared to make no specific provision for thermal gradients and associated movements in the concrete structure. A detailed analysis of the loading regime demonstrated that the main source of distress in the structure arose from excessive compressive stresses immediately around the perimeter of the furnace. A balancing system of tensile forces was required to maintain internal equilibrium and this system of forces was primarily responsible for the initial cracking around the supporting beams and outer sections of the slab. Subsequent stress reversals merely served to aggravate the distress as localised yielding and debonding of the steel occurred at critical sections. The risk of concrete fragments falling onto personnel was high and a strategy for strengthening the structure was required as a matter of urgency.

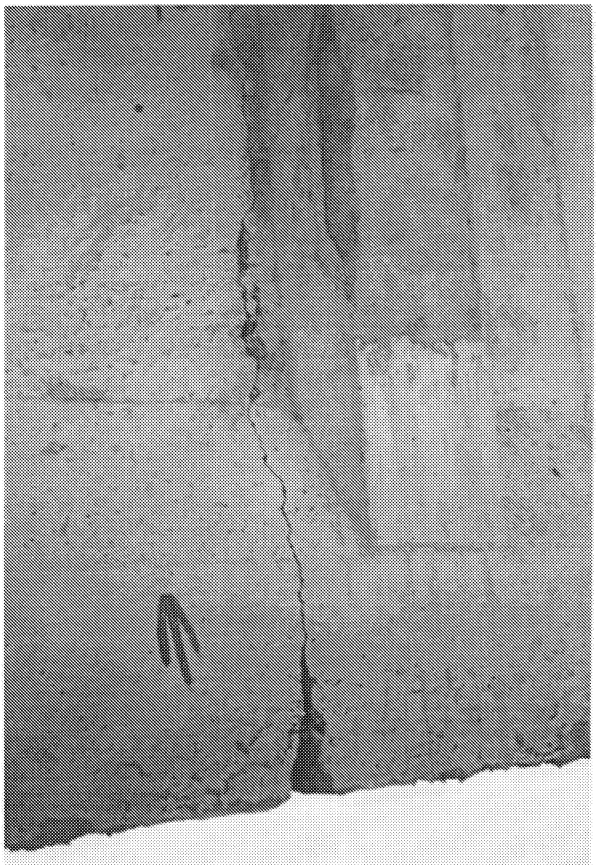
transverse diaphragms. A major crack adjacent to a diaphragm is illustrated in Figure 2. A review of the original design calculations, drawings and construction records highlighted a series of important factors which could have contributed to a significant loss of pre-compression in the bottom flanges. The design was based upon the first UK Code of Practice for prestressed concrete, CP115[1], which has now been superseded by BS 5400[2].

Figure 2. Flexural shear crack in bottom flange and web.

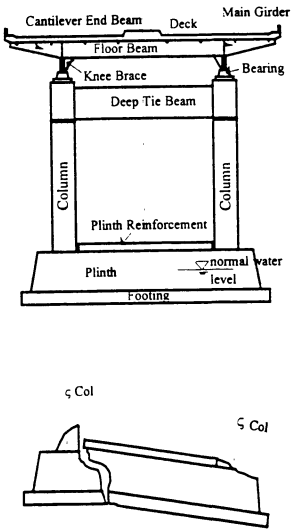
Figure 4 (left) Schoharie Creek bridge pier, showing the fractured plinth.
Figure 5 (right) Cross-section of one of the cracked monoliths of Fontana dam, showing approximate crack trajectory.

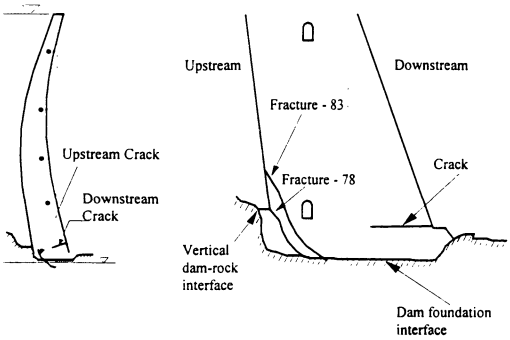
Figure 6 (left) Kölnbrein dam cross-section and details of upstream cracking revealed in 1978 and 1983 and of the toe crack.
Figure 7 (right) Cross-section of the cracked diamond-head buttress of Zhexi dam, showing the approximate locations of crack when construction was completed and after 8 years.

The Kölnbrein (Austria) doubly curved arch dam with an overall height of 200 m (Linsbauer 1991) was constructed between 1973 and 1979 but the reservoir was progressively filled during the construction to meet electricity demand. When the reservoir was filled to a level of 40 m below the crest, increasing uplift pressure and water loss were noticed. Investigations revealed well-developed crack systems both at the toe and the heel of the dam (Figure 6) and established the cause of the cracking at the toe; it was caused by a combination of dead load with high grouting pressure used to fill the vertical construction joints and of inelastic deformations in the foundation region.

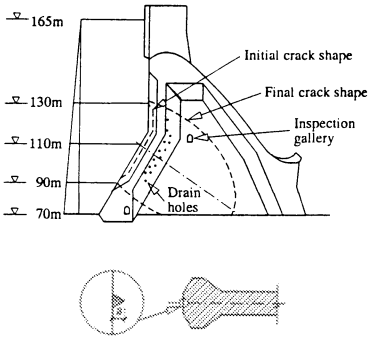
Zhexi diamond-head buttress dam is one of the largest concrete dams in the Hunan Province of China. There are eight buttresses in all. Concreting began in 1959 and was completed at the end of 1960. Between elevations 92 and 126 m (Figure 7) concrete was placed during the period March–August 1960. Surface cracks were observed in all concrete sections between these elevations, presumably caused by thermal shrinkage. There were nearly 120 cracks in the upstream face which were almost symmetrical with respect to the centrelines of the buttresses. There were also some horizontal cracks. The longest vertical crack was about 20–30 m with a width of 0.1–0.2 mm (Figure 7). The depth of the cracks was estimated to be in the range 20–100 mm. Before the reservoir was impounded, the cracks were repaired by cutting grooves along them which were then grouted. In some instances, wire mesh was placed in the grooves before grouting.

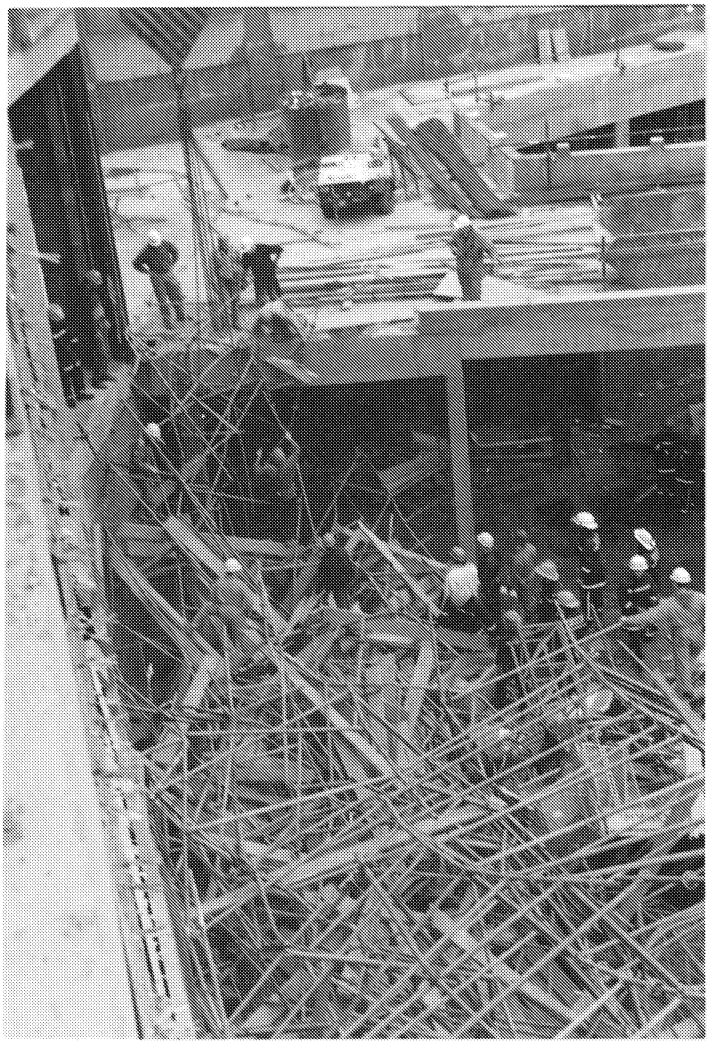
figure 2 - *A tangled pile of tubes lay where the scaffold had been*

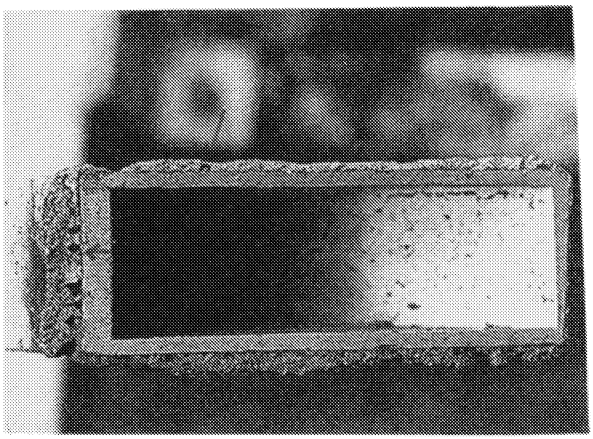
- all the welds exhibited porosity. Generally, the degree of porosity was 30%, but in some welds it was as much as 50% - see figure 3;
- there was a general lack of penetration in all of the welds; and
- there were cracks in the weld that failed.

figure 3 - *porosity in the welds*

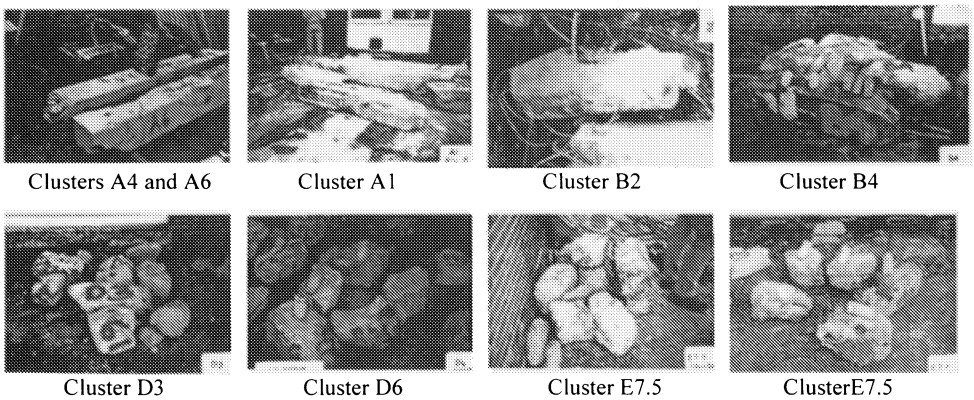
Figure 2. Excavated piles

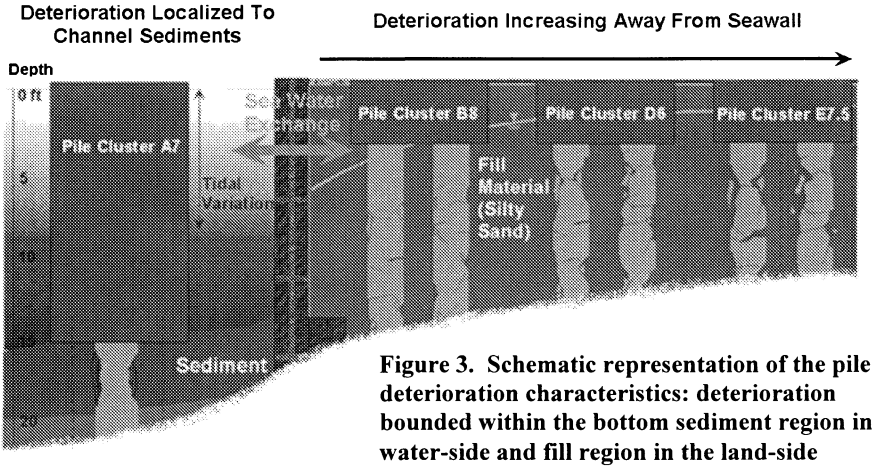
Figure 3. Schematic representation of the pile deterioration characteristics: deterioration bounded within the bottom sediment region in the water-side and fill region in the land-side

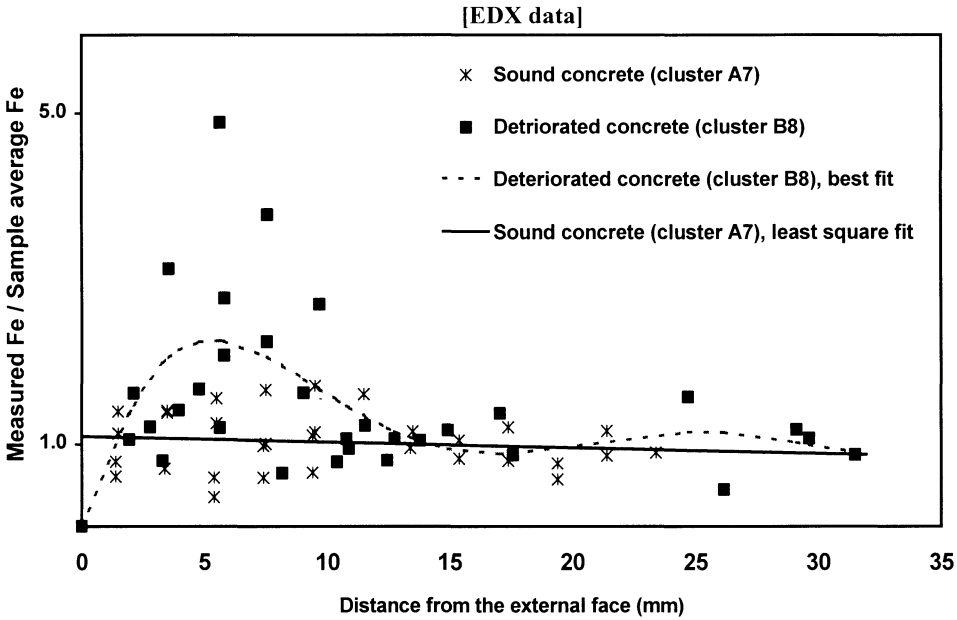
Bio-corrosion of concrete results in a series of changes in the microstructure of concrete, which can be identified by microscopic studies. In hardened concrete, a reduction of pH at the surface and possibly the successive layers by neutralizing effects such as carbonation, creates migration of iron ions (cations, i.e. positive ion charge) from an inside to outward direction. During microbial corrosion, migrating iron ions gradually accumulate and concentrate locally between the corroded and sound concrete. These ions eventually form a very thin iron layer dividing concrete between corroded and sound.[16] Thus, the iron layer can be an indicator of the rate of microbial corrosion of concrete. The SEM-EDX data of the samples from the concrete cores taken from the deteriorated piles showed a high concentration of iron at about 6-7mm away from the surface of the pile, Figure 5. On the other hand, the iron-rich layer could not be identified in the concrete samples taken from the pile within the skirt and below the mudline, Figure 5. The segments of piles within the skirt and below the mudline did not exhibit signs of deterioration.

Figure 5. Variation of iron content in samples taken from deteriorated piles (cluster B8) and sound pile segments (cluster A7, within the skirt and below the mudline)

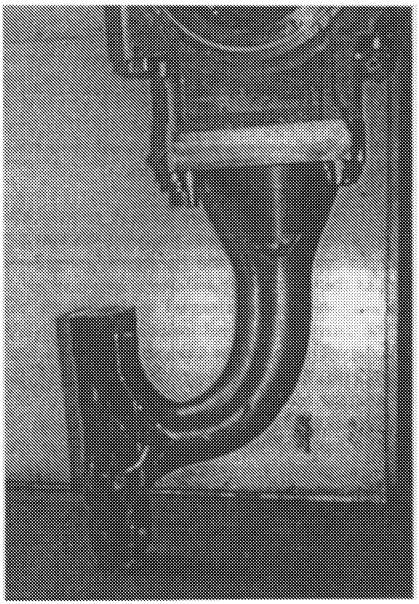
The engine which suffered damage was an eight cylinder two stroke diesel engine arranged to drive a large alternator. The first indications that it had a problem were loud knocking sounds during normal operation. Unfortunately, before the engine could be brought to a stop, one of its connecting rods had abandoned its relationship with the crank pin and emerged from the crankcase, causing substantial internal and external damage. The final state of the connecting rod can be judged from **Figure 3.**

As the various damaged parts became accessible from the wreckage, possible alternative causes were continually tested for credibility. By this process, attention was increasingly drawn to the need to find the crank bearing bolts, which were not initially accessible. When they were retrieved, one of them was found to be virtually intact, but without its nut. This nut, its locking device and locking screw were all found separately. The nut threads for about one and a half turns nearest to the lower face were seen to have been damaged by axial shear. About one quarter of the first turn, although present, had been separated from the nut around its circumference. The other bolt had broken under severe combined tensile and bending load and its nut with locking device and screw were still present on the broken end. Furthermore, a bolt in a different connecting rod was found to be 1 mm slack with its nut locking device and locking screws correctly fitted.

Figure 3 - Damaged Connecting Rod

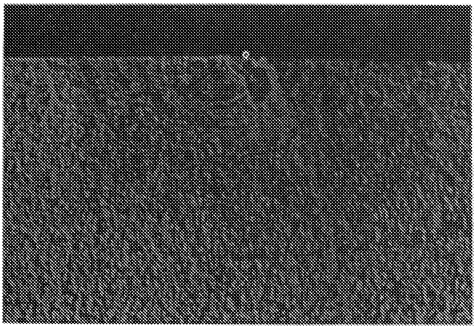
(a) Typical Propeller Blade Failure

Figure 5 Typical Fatigue Failure

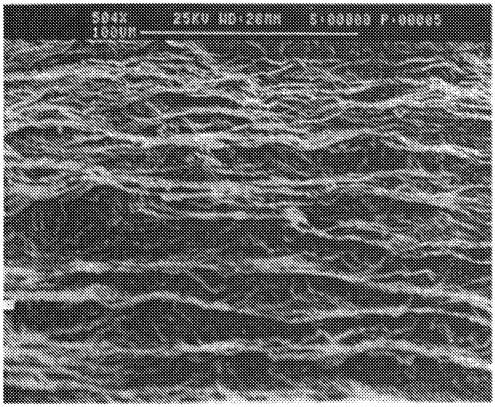
Figure 6 - Fatigue Crack Striations on a Gear Tooth Failure (x500)

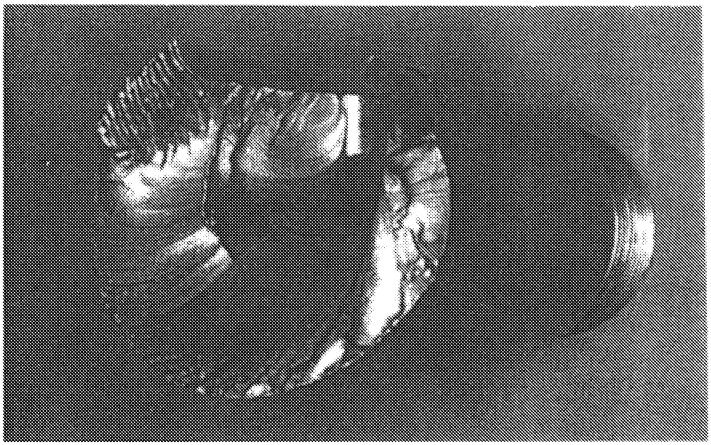
Figure 8 shows an example of a failure caused by fretting initiated torsional fatigue. This failure was induced by fretting which occurred at the interface between a drive shaft and fluid coupling due to an inadequate compression fit on a 1:10 taper. This fretting action induced over one hundred separate fatigue crack initiation sites on the shaft. In this case the function of the key was to provide a reserve safety factor to the design. The lack of compression fit was induced partly because of the high taper and in part due to the original design not taking due account of the restricted conditions under which the required compression fit had to be achieved during construction or maintenance in the ship.

Figure 8 - Fretting Fatigue of a Tapered Shaft

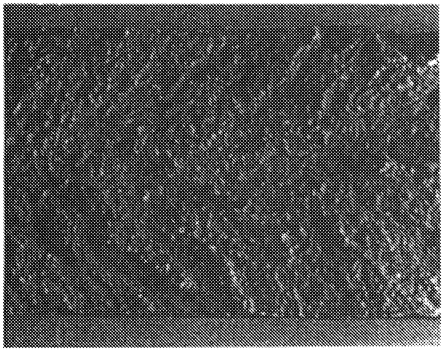
Figure 9 - Chevron Markings on a Brittle Fracture of a Plate

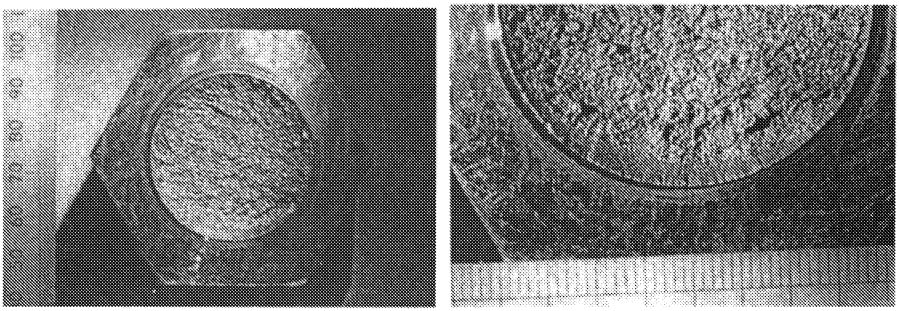
Brittle Failure:
True brittle fracture occurs without significant gross deformation. This fracture mechanism manifests itself in a plane normal to the applied stress and is essentially a fracture mechanism which occurs through the grains of the material. When viewed under the microscope the fracture face is seen to contain a large number of facets together with a branching pattern of cracks. In plate sections a pattern of *chevron* markings is normally seen, the direction of which points to the origin of the failure, **Figure 9**. While brittle fracture is not a commonly encountered type of failure today, a recent example of its appearance is the failure of some 38 mm bolts shown in **Figure 10**, from a steering gear hydraulic ram stopper pedestal. These bolts were manufactured from a 0.35% C, 1.48% Mn steel. Material tests showed them to have a ratio of the 0.2% proof to ultimate strength of 98% and an elongation of only 9%. The bolts had failed at the underhead position in way of a 0.45 mm radius by brittle fracture. Also around the circumference of the failed section is a small, 5 mm deep region of fatigue propagation from multiple origins.

Figure 10 - Brittle Fracture of a Bolt

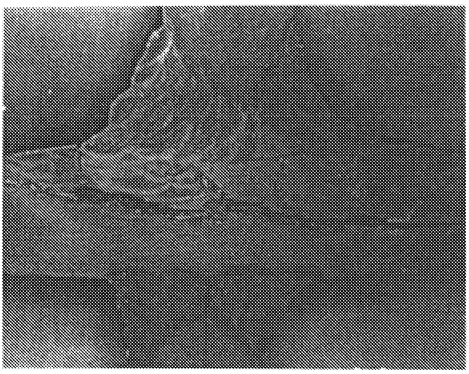
Ductile Failures Types:
Pure ductile failures are rarely encountered today in the marine industry, however, a variant of this mechanism is occasionally seen. This is the lamellar tearing mechanism which is known to sometimes occur in the parent plate beneath welds in the through thickness direction. **Figure 11** shows a classical example in a cruciform joint. In this type of tearing mechanism the presence of non-metallic inclusions has a significant affect on its development. Another example has recently been found in a fractured fuel injector. The injector was made from a medium carbon sulphur bearing steel with a significant quantity of manganese sulphide inclusions elongated in the axial direction. The holder had cracked longitudinally due to the action of lamellar tearing caused by high hoop stresses and an unfavourable microstructure of the material; **Figure 12**.

Figure 11 - Lamellar Tear on a Cruciform Joint

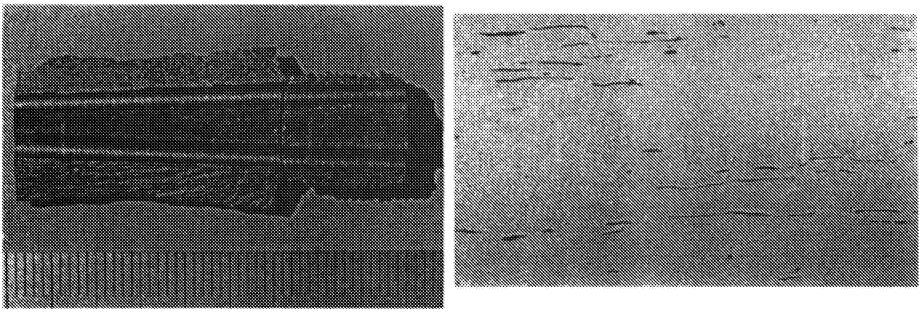
(a) Axial Fracture Face

(b) Manganese Sulphide inclusions in the Material

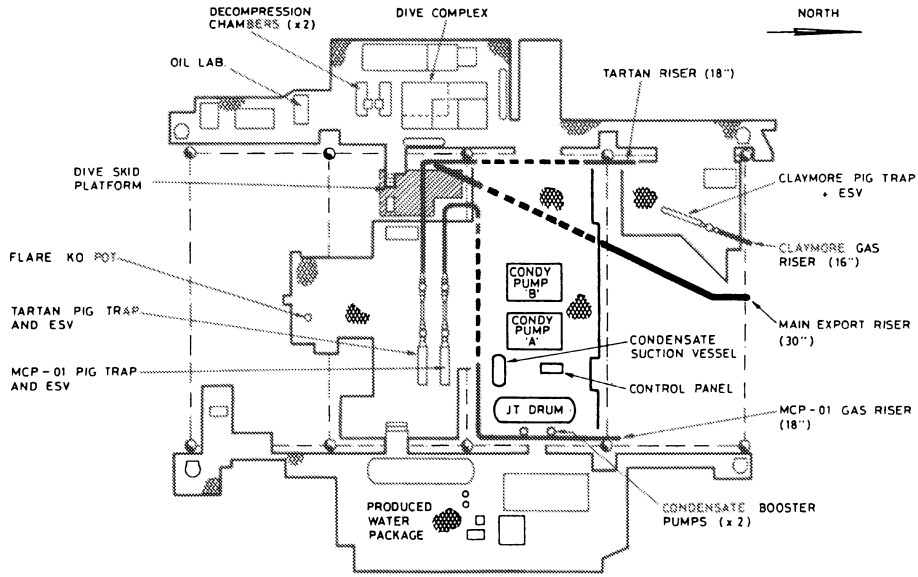
FIGURE 5

PIPER ALPHA – DECK SUPPORT FRAME (68 ft LEVEL)

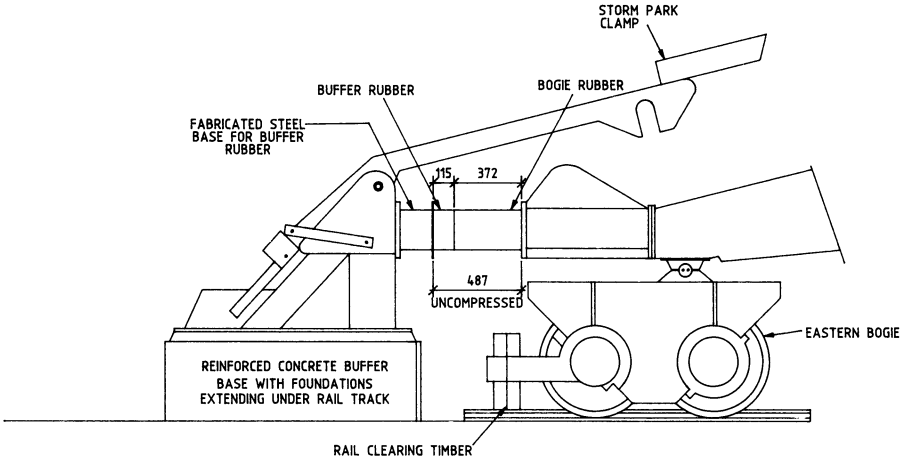
At the eastern end of the rail track, a storm park was installed and at this location the bucketwheel boom could be lowered onto a structural rest and the unit tied down during high winds and storm conditions. This was also the area where maintenance could be undertaken. The end of the track incorporated concrete based buffers onto which were mounted compressible cellular plastic buffer rubbers some 250mm diameter and 750mm in length.

SKETCH 'A': BUFFER & EASTERN BOGIE IN REST POSITION (STORM PARK)

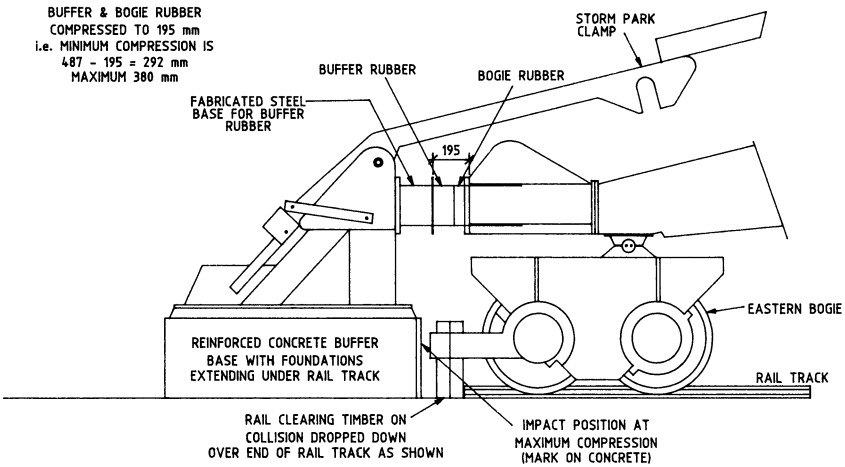
SKETCH 'B': BUFFER & EASTERN BOGIE AFTER COLLISION 19 JULY 1986

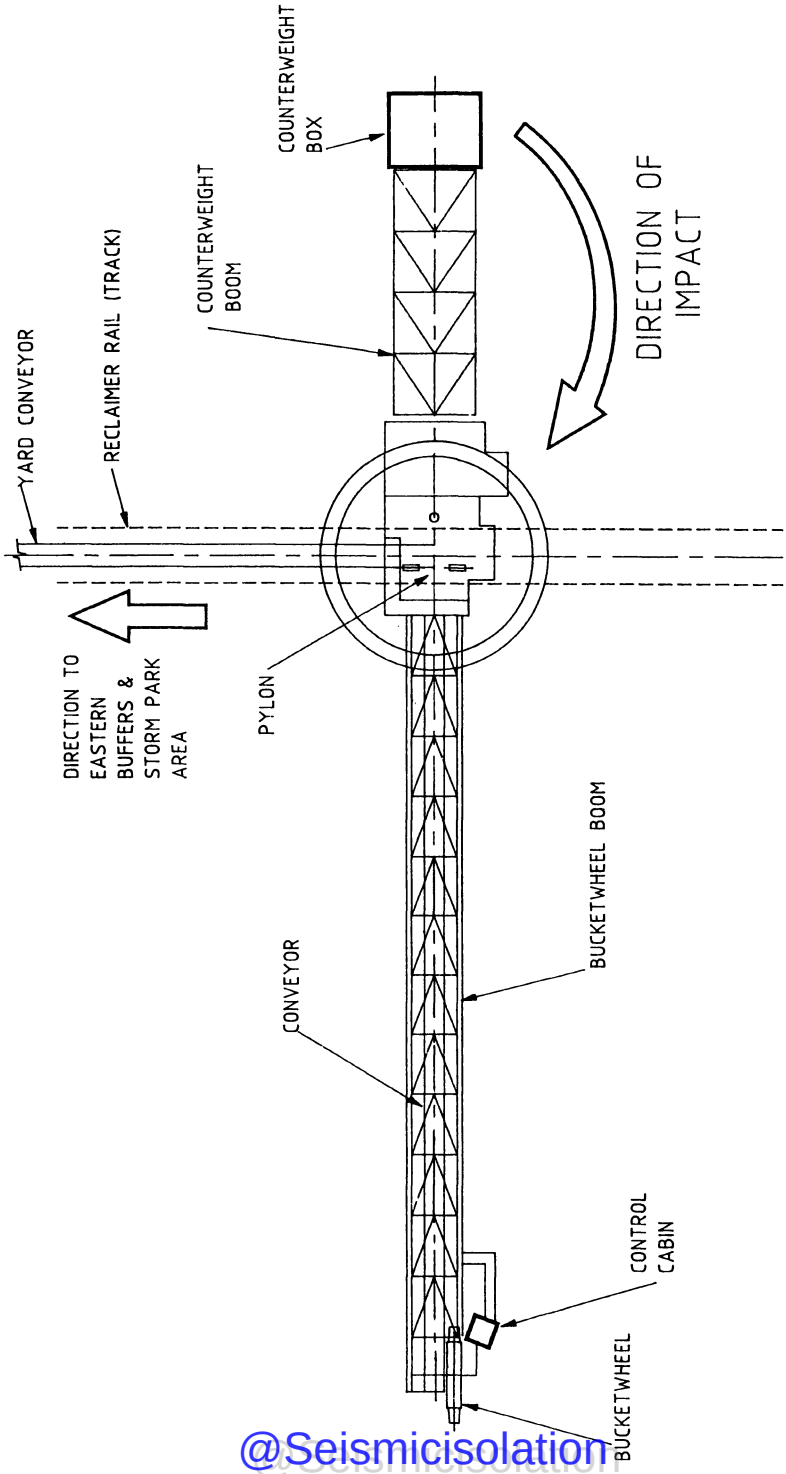
On arriving at the scene of the collapsed unit by aircraft, careful observations were made immediately above the collapsed unit and it was noted that the 225 tonne counterweight box had not collapsed down directly behind the unit, but had rather swung, as it fell, to the side. This is shown on sketch 'C' attached.

BUCKETWHEEL RECLAIMER - SKETCH PLAN SKETCH 'C'

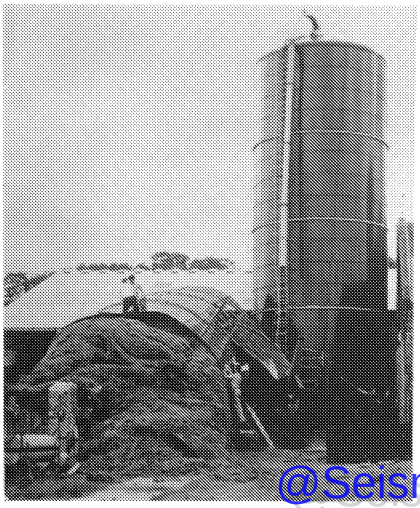
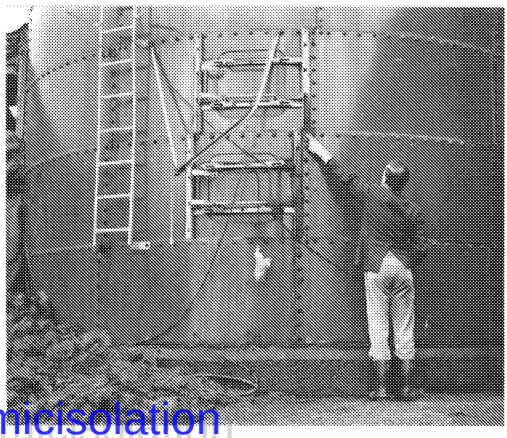
Assessment: The silo was designed for fibrous maize and alfalfa crops which can be wilted to part dry in US conditions. The young compressible grass and more difficult weather conditions in UK gave much higher pressures. The bolted joint strength, designed assuming uniform load per bolt, was reduced by the drilling of holes for a cylindrical geometry but assembly as conical, the manhole adjacent to joint, the use of fully threaded bolts which sheared on the weaker threaded section, some corrosion from acid effluent. Report by W F Cassie and J G M Wood 12.1.66, details from SS&D, Northbridge Ho. Chiddingfold GU8 4UU.

Actions: Report on failure to manufacture used to improve designs and instructions for use. Data from collapse was used in research (PhD Thesis, J G M Wood, Univ. of Newcastle on Tyne 1970) and in developing BS5061:1974 for forage tower silos. See 'Greater Safety on the Farm- a standard for tower silos', BSI News May 1974.
