DIAX8-01

DTC□	B1279□	Rain[sensor@communication[stop
------	--------	--------------------------------

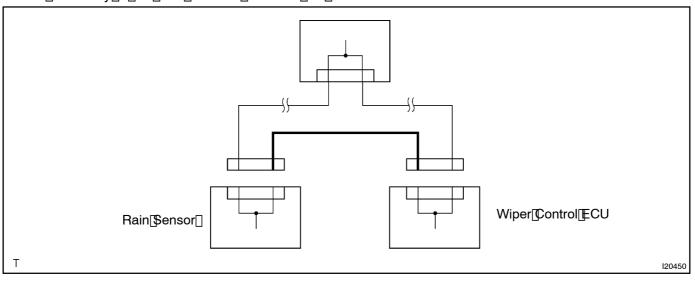
Check[wire[harness.[See[page]N-38]

Wire[harness[side[connector[of[ECU	Terminal
Rain[sensor -[Wiper[control[ECU	MPX[[R58-3) -[MPX1[[A65-1]]

$Check \verb|[]continuity| \verb|[of]] the \verb|[]wire| \verb|[]harness| \verb|[between]] the \verb|[]connectors|.$

There[]sacontinuity[between[]theconnectors.

If[]there[]s[OPEN[]n[any[]wire[]harness,[]please[]repair[]t.

Replace rain sensor See page N-38).
