Narrated Accessibility Walk

North Cambridge, MA: Massachusetts Ave, Norris St, Shea Rd, Locke St and Woodbridge St

Pilot report 1 | Walk recorded October 3, 2026 | Public version, October 30, 2026
Prepared by Uri Kartoun, PhD, Founder, DBbun LLC, Cambridge, MA | uri.kartoun@dbbun.com | dbbun.com

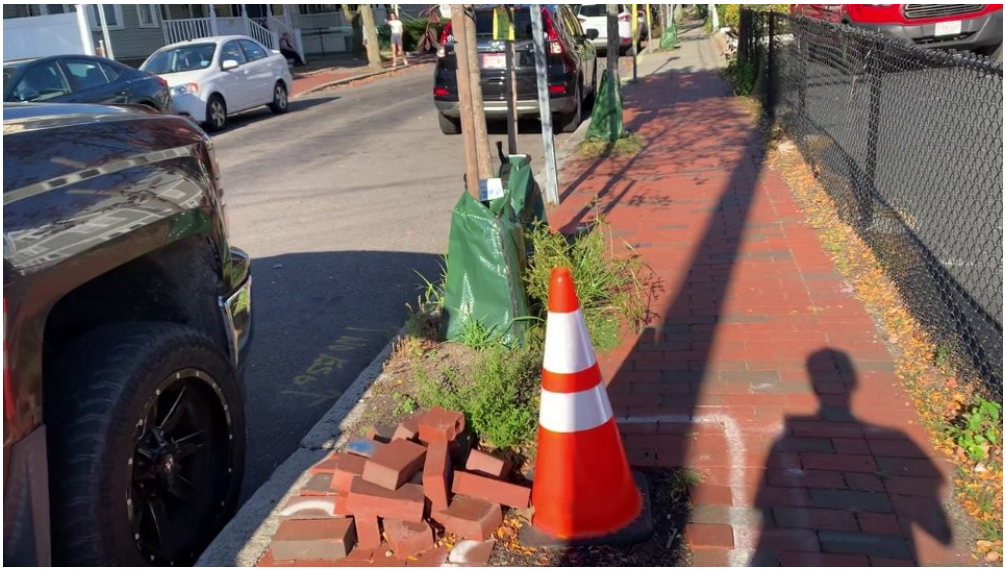
Figure 1. Mass Ave crossing at Shea Rd / Norris St: curb ramp with tactile warning strip and a bollard (positive), at the location where fast-turning traffic was flagged (barrier 1).

Figure 2. Displaced granite curbstone at the curb edge next to the Mass Ave travel lane (barrier 10).

Figure 3. Missing bricks, a pile of loose bricks and a traffic cone narrowing the brick sidewalk (barrier 2).

Figure 4. Tree-root heave with broken pavement and exposed dirt along a picket fence (barrier 3).

Figure 5. Utility pole next to the curb ramp landing and cracked, faded crosswalk markings (barrier 4).

Figure 6. Temporary no-parking cones and signs placed on the sidewalk (barrier 5).

Figure 7. Utility pole within the walking path at the curb-ramp approach; a wheelchair user would need to enter the road (barrier 6).

Figure 8. Heaved bricks near a tree, already marked with paint (barrier 8).

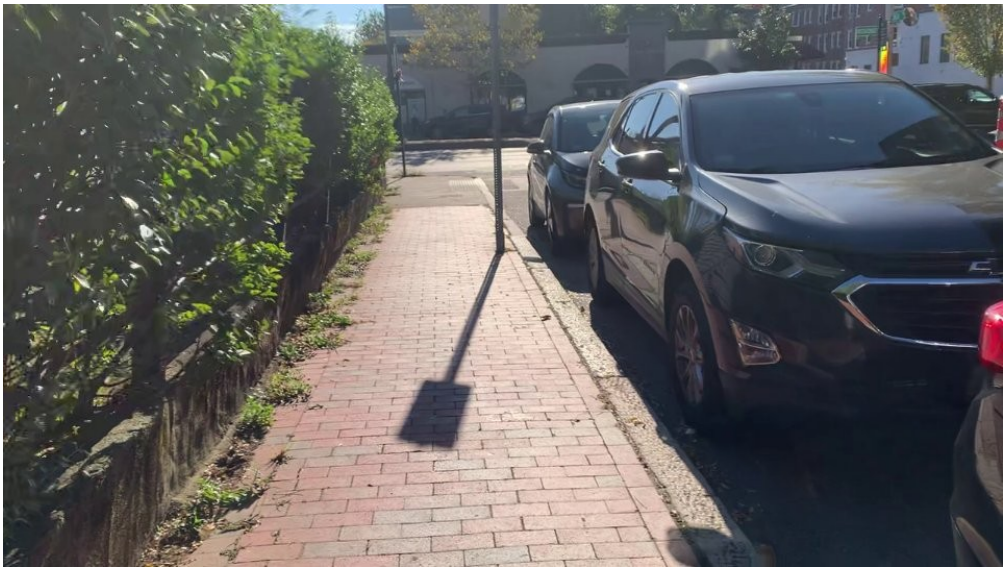
Figure 9. Hedge overgrowth narrowing the sidewalk on Shea Rd (barrier 9).

Figure 10. Returning to Mass Ave: curb ramp with tactile warning strip and marked crosswalk (positive).
