Narrated Accessibility Walk

CHA Cambridge Hospital (1493 Cambridge St), Cambridge, MA: approach from Spaulding, campus perimeter, main entrance and drop-off

Pilot report 5 | Recorded October 27, 2026

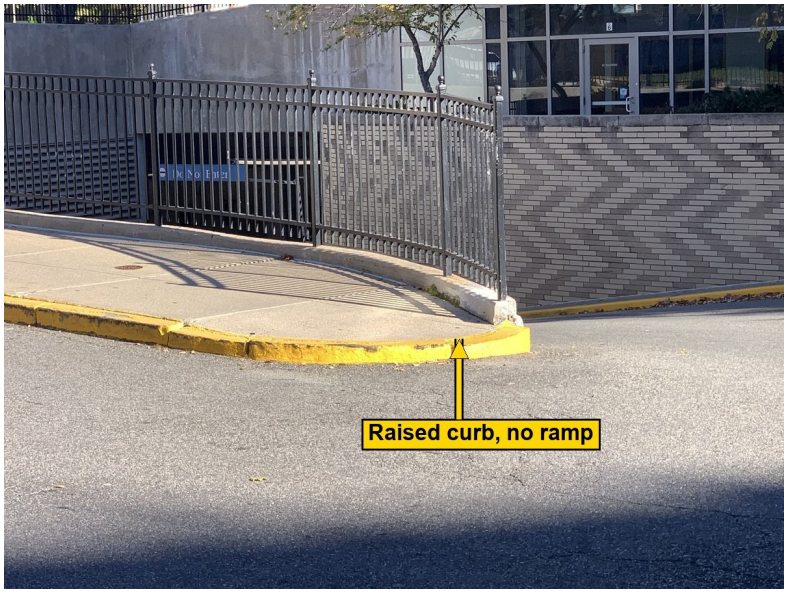
Figure 1. The raised curb with no ramp on the direct line from the entrance toward the garage and the other building, where a man with a rollator could not cross (item 15).

Figure 2. The same area from the entrance side: the marked crosswalk (right) and the curb toward the other building (left); fresh yellow utility markings on the road (items 15 and 25).

Figure 3. The traffic island in the entrance drive, with a “Keep right” sign, where people with canes cut across (item 16).

Figure 4. The drop-off loop: transport vans and cars stopped along the island in front of the entrance (item 17).

Figure 5. A car (the dark SUV) standing for several minutes in the travel lane beside the island, which is not a stopping area; the cars behind it and traffic leaving the garage could not get past (item 18).
