Narrated Accessibility Walk

Massachusetts General Hospital area, Boston, MA: Charles/MGH station, Cambridge St, 50 Staniford St, 101 Merrimac St and the Main Entrance (55 Fruit St)

Pilot report 2 | Recorded October 8, 2026 | Revised October 25, 2026
Prepared by Uri Kartoun, PhD, Founder, DBbun LLC, Cambridge, MA | uri.kartoun@dbbun.com | dbbun.com

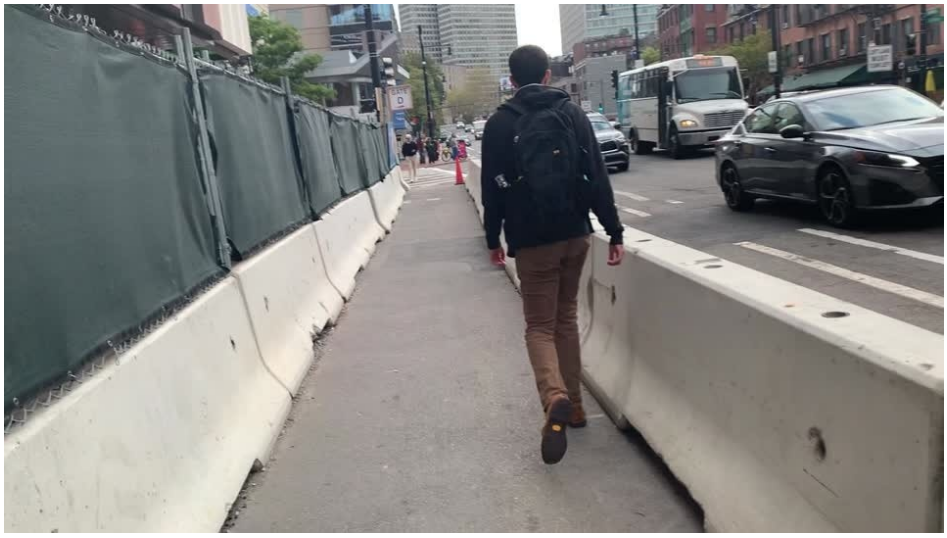
4	Corner near new tower / constructio n	Street furniture narrowing the path	Mailbox, trash compactor, lamp post and granite blocks clustered at the corner.	Wheelchair, low vision	H	Consolidate or relocate furniture
5	Cambridge St constructio n zone	Long, narrow temporary walkway (High, temporary)	Covered scaffold walkway, then a walkway between concrete barriers, estimated at about 4 ft wide; uneven joints; no rest points along its length.	Wheelchair, scooter, walker, energy-limited	M	Maintain at least a 4-5 ft clear path; smooth joints; add a rest point
6	Blossom St crossing	Cracked, sloped crosswalk	Cracked crosswalk with a slope; flaggers directing traffic.	Wheelchair	M	Repave; keep a level crossing path
7	Charles River Plaza	Garage driveway across sidewalk	Vehicles cross the sidewalk at the garage entrance. Marked accessible parking spaces nearby (positive).	All, esp. low vision	H	Exit warning signal or mirror at the driveway

Figure 3. Covered scaffold walkway in the Cambridge St construction zone (item 5).

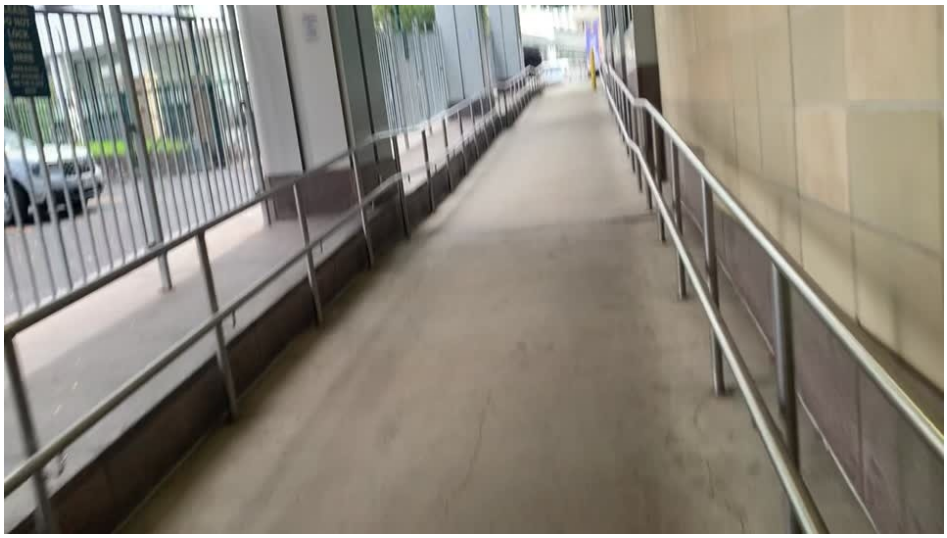
8	Charles River Plaza arcade (165 Cambridge St)	Steps with ramp; seating (positive)	Four steps with a ramp alternative; broken bricks at the ramp landing. The covered arcade offers public seating and a van/ambulance drop-off bay; seasonal displays and ladders narrow the arcade.	Wheelchair, low vision	H	Repair landing bricks; keep displays clear of the walking path
9	Ramp toward 50 Staniford St	Long ramp with handrails	Long ramp with handrails on both sides (positive); the walker perceived it as steep (not measured).	Manual wheelchair users, energy-limited	M	Measure slope; add an intermediate resting landing if needed

Figure 6. Public seating in the covered arcade, with a drop-off bay at left (item 8, positive).
