Narrated Accessibility Walk

North Cambridge to Davis Square, Somerville, MA: Shea Rd, Kingston St, the Community Path and Davis Square, by day and at night

Pilot report 3 | Recorded October 23 (day) and October 24 (night), 2026
Prepared by Uri Kartoun, PhD, Founder, DBbun LLC, Cambridge, MA | uri.kartoun@dbbun.com | dbbun.com

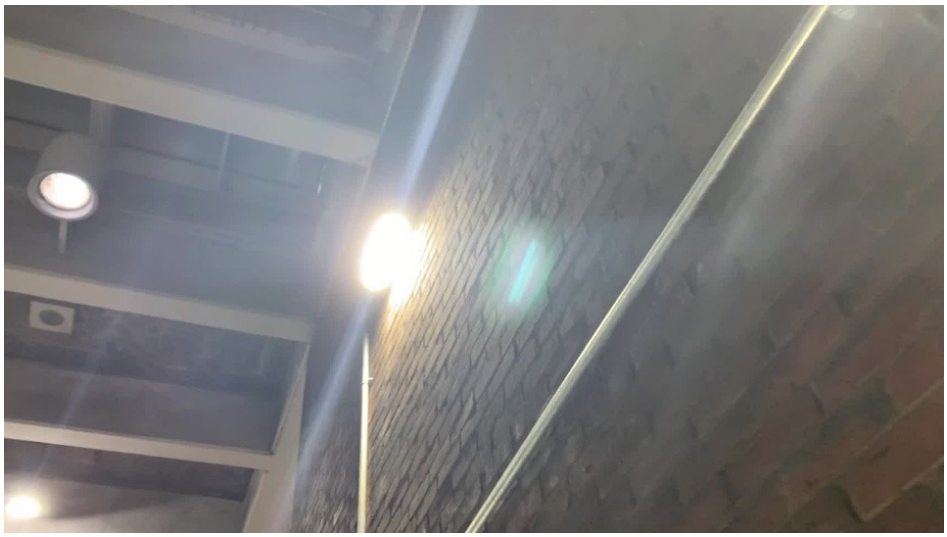
26	College Ave station elevator	Works, but unpleasant and no feedback	The elevator worked. No visible indication after pressing the call button; a strong smell of urine inside.	Anyone who depends on the elevator; people with chemical or smell sensitivity	M	Call-button acknowledgment light; regular cleaning

Figure 11. Night: the College Ave elevator at Davis station; it worked, but gave no visible response to the call button (item 26).
