Narrated Accessibility Walk

Davis Square to Assembly Square, Somerville, MA: College Ave, Powderhouse Square, Broadway, Winter Hill, Mystic Ave and under I-93

Pilot report 7 | Recorded November 1, 2026

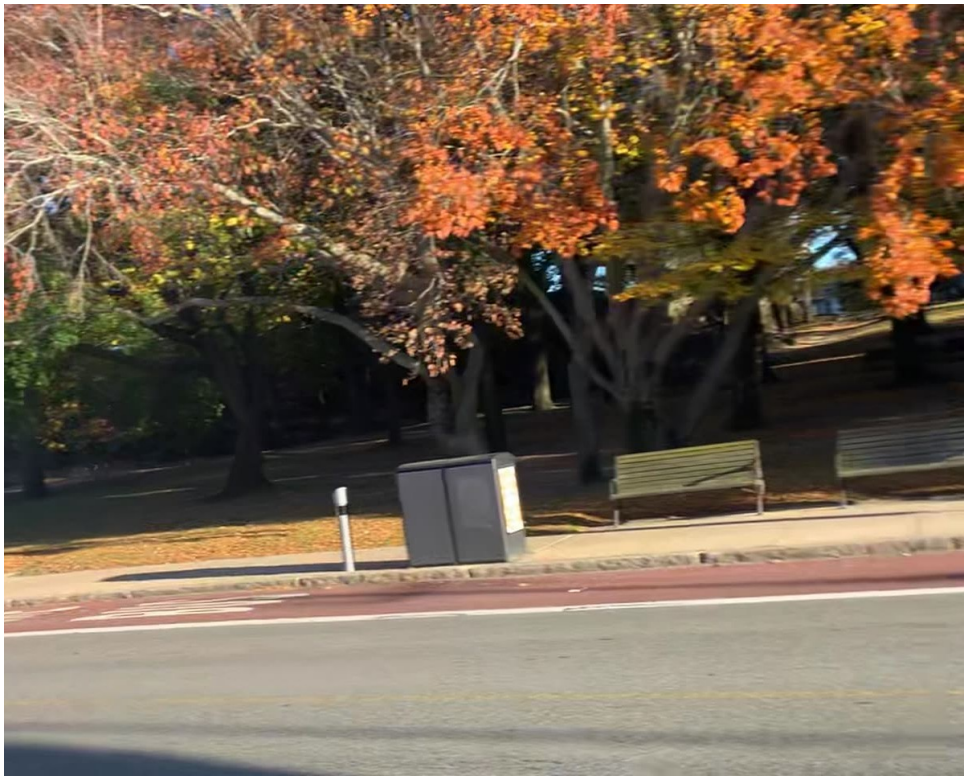
ID	Place	What was seen	Most affected	Rating	Conf.	Suggested fix
C1	Broadway crossing, Winter Hill	The signal for blind pedestrians said "wait", but it was hard to hear over traffic.	Blind and low-vision people	Medium	M	Check the volume setting
C2	Broadway	Construction beside the sidewalk; the crossing was still possible.	–	Low	M	Keep a step-free, signed path during the works
C3	A side street off Broadway	A curb ramp somewhat steep.	Manual wheelchair users	Low	M	Measure on a later visit
C4	Broadway toward Mystic Ave	No benches noticed on this stretch.	People who need to rest	Low	M	Seats where possible
C5	Temple St at Mystic Ave	A driver blocked the crosswalk during the walk signal; cones on the sidewalk edge.	Everyone crossing; worst for wheelchair users and slow walkers	Medium	M	Enforcement; "do not block the crosswalk" marking
C6	Mystic Ave under I-93	Detour signs on the sidewalk; new curb ramps with warning strips. The walk signal felt short (to be timed).	Slow walkers	Mixed	H	Time the signal on the re-check walk

Figure 7. The push button at the Broadway crossing on Winter Hill. Its spoken "wait" message was hard to hear over traffic (C1). The hand is the walker's.

- City of Somerville: could the pole base on Broadway east of the rail bridge (B2) be removed or covered, and the lighting there checked?
- City of Somerville: could the volume of the signal for blind pedestrians at the Broadway crossing on Winter Hill (C1) be checked?
