AI SITE HISTORY REPORT

502 Church Road, Taigum QLD 4018

Generated 07 Apr 2026 | Lat -27.333136, Lng 153.048862 | Confidence: High

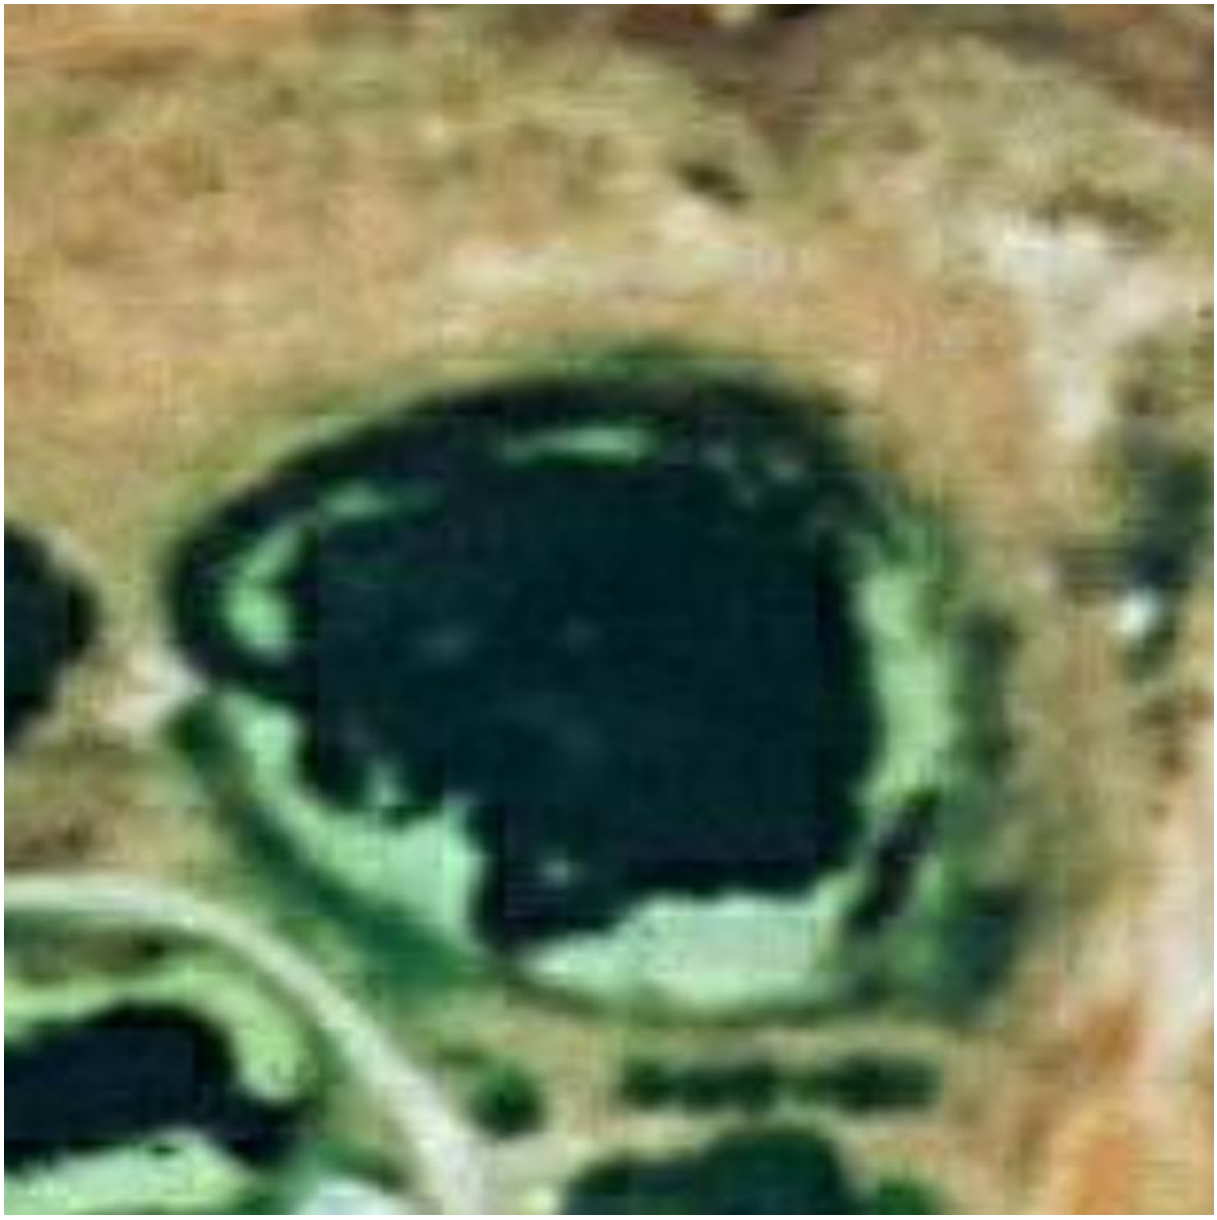
historical_qld_followup_1 — 1995 (1995-06-18)

Pond A — 1995: Pond present with water and intact berm structure.

• Historical images (1995, 2005, 2011) show pond present with water or wet soil centrally.
