AI SITE HISTORY REPORT

502 Church Road, Taigum QLD, Australia

Generated 07 Apr 2026 | Lat -27.333280, Lng 153.049080 | Confidence: High

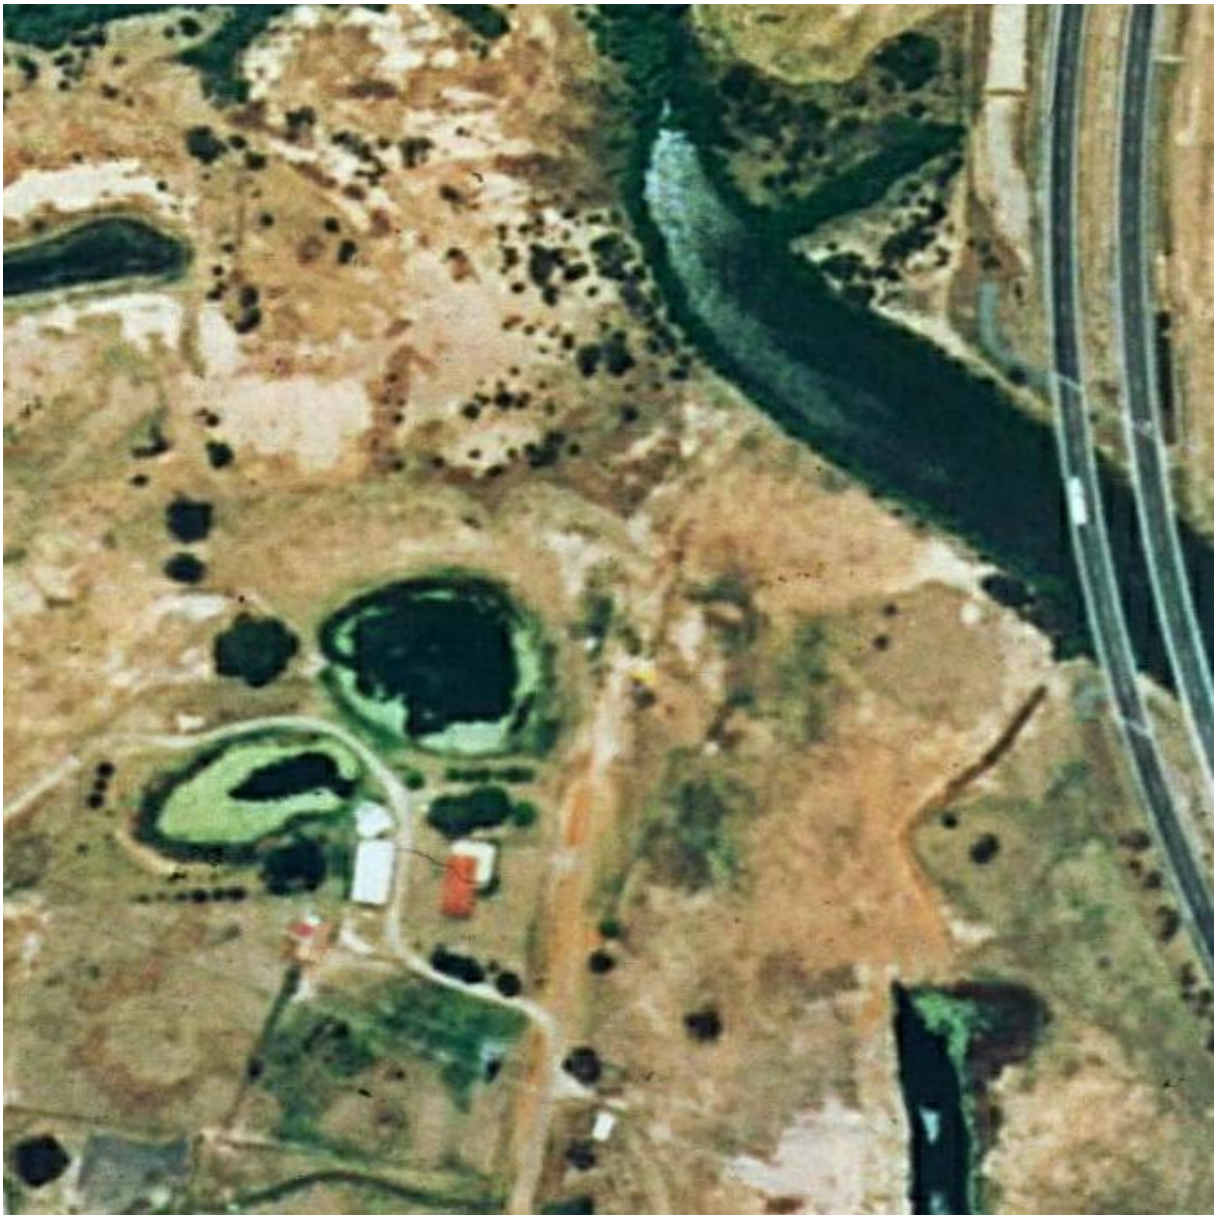
historical_qld_followup_1 — 1995 (1995-06-18)

Former Pond A — 1995: open water clearly visible

Probable Former Pond B — 1995: faint water or moist soil signature
