Dale Automation

Friction drive spiral (Cooler - Double drum)

Report #: Dale Automation 2773
Location:
Inspection Date: 16-Sep-2026 07:32 AM
Inspector Name: Kyle Kingma

Asset Category : 8000 LPH Double Drum Spiral Cooler
Asset Name : Albany Pietermaritzburg
Asset # : DSS 211-8
Meter Reading: 0 Hours
Model/Year: Dale Automation

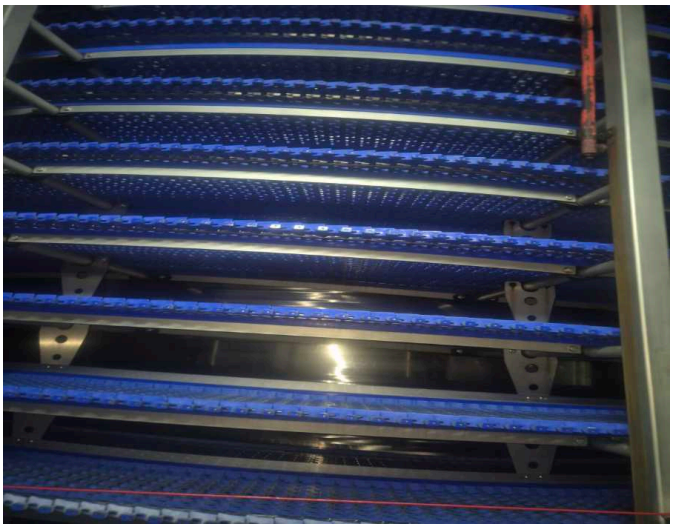
1. Free of major damage

SN	Inspection Item	Note	Good	Repair	Replace	NA
1	Free of major damage	Belt is free of major damage	✓	○	○	○
2	No Broken links	Few broken links found.	○	✕	○	○
3	Belt clips in place	Not all clips are in	○	✕	○	○
4	Ensure belt safe to start		✓	○	○	○

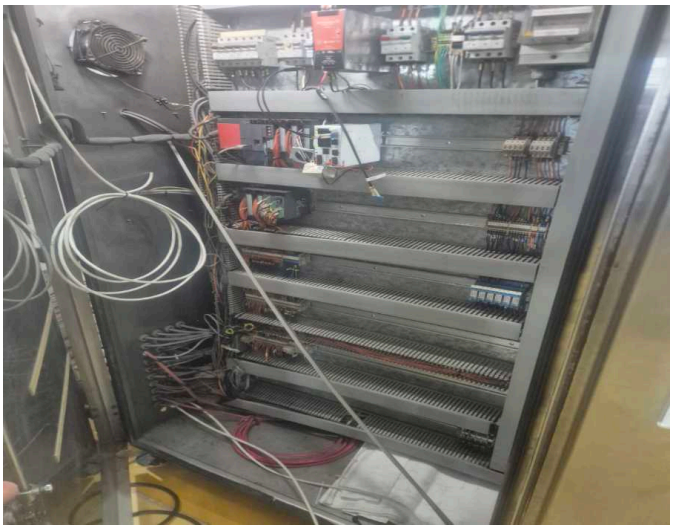
24. Connections

SN	Inspection Item	Note	Good	Repair	Replace	NA
24	Connections	Connections are good. There was another contractor working in the panel.	✓	○	○	○
25	Temperature display		○	○	○	⊖
26	Panel fans		✓	○	○	○
27	Panel door seals		✓	○	○	○
28	Door locks		✓	○	○	○
29	Panel neatness		✓	○	○	○
30	Panel drawings		✓	○	○	○

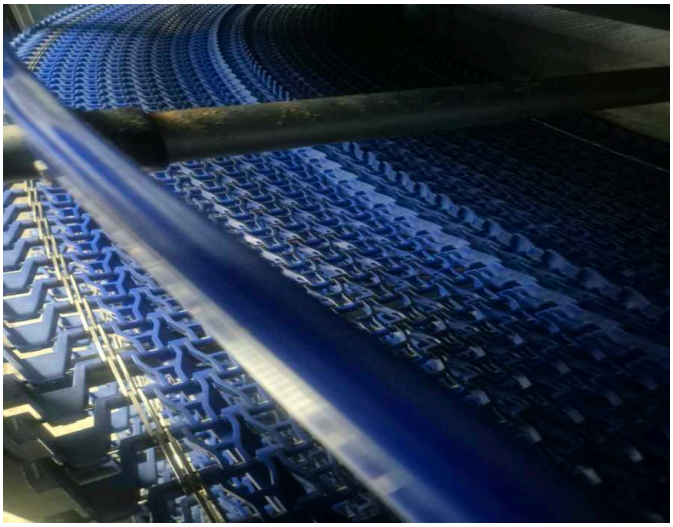
31. Wear strips

SN	Inspection Item	Note	Good	Repair	Replace	NA
31	Wear strips	Wearstrip is a little worn.	✓	○	○	○
32	Guides	Guides are in place	✓	○	○	○

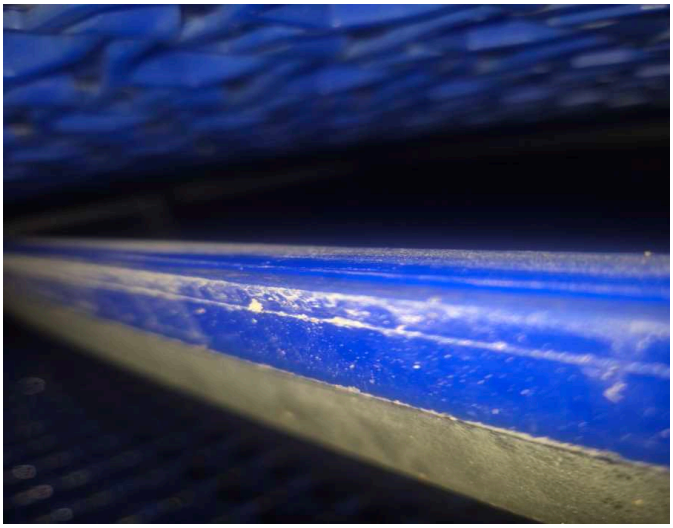
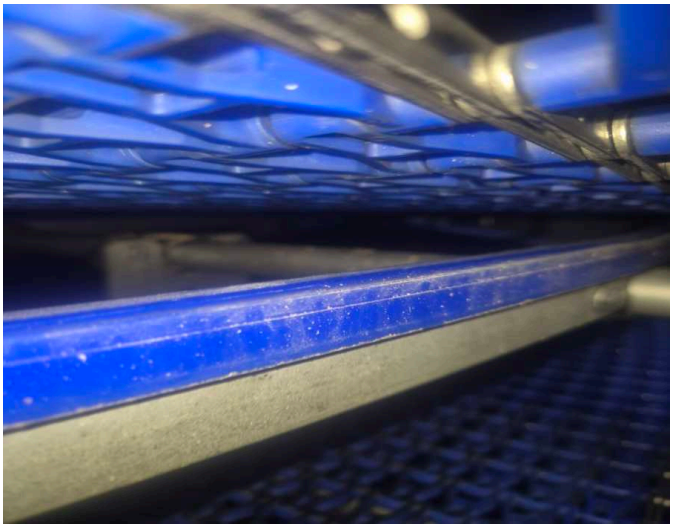
40. Rail wear strips

SN	Inspection Item	Note	Good	Repair	Replace	NA
40	Rail wear strips	Wearstrip in good condition. Need to fix oiler.	✓	○	○	○
41	Support arms	Rail arms in good condition. All straight	✓	○	○	○
42	Rail arm supports (Plastic or welded tabs)	Plastic tabs installed. No broken tabs found	✓	○	○	○
43	Hold down rail	All old down rails in place	✓	○	○	○
44	Tier lift switches	All sensors working amd stopping belt.	✓	○	○	○
45	Motor and gearbox		○	○	○	⊖
46	Sputnik		○	○	○	⊖
47	Internal drum bolts	All bolts to be replaced as they are badly rusted	○	○	✗	○
48	Top Centre shaft bearing	Centre bearing in good condition and greased	✓	○	○	○
49	Drum rings and internal drive spokes	Welds on rings need to be repaired	○	✗	○	○
50	Drum bar wear strips		○	○	○	⊖

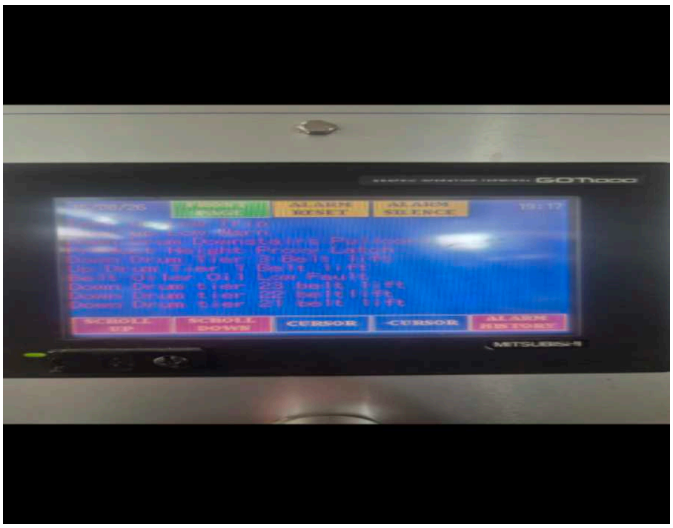
53. Safeties

SN	Inspection Item	Note	Good	Repair	Replace	NA
51	Lighting	All lights working	✓	○	○	○
52	Cables and connections		○	○	○	−
53	Safeties	All safeties working and appearing on hmi	✓	○	○	○
54	Tier lifts	All sensors working and stopping cooler	✓	○	○	○

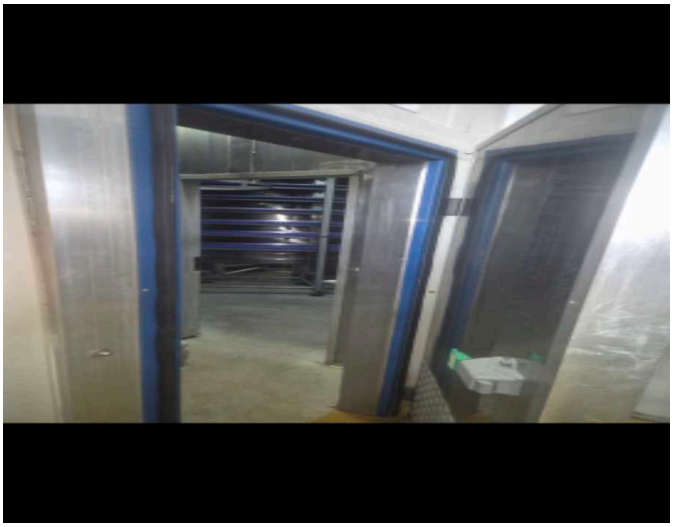
55. Condition

SN	Inspection Item	Note	Good	Repair	Replace	NA
55	Condition	Enclosure is in good condition.	✓	○	○	○
56	Main door seal - Sliding	Main door seal in good condition.	✓	○	○	○
57	Temperature probes		○	○	○	−
58	Internal doors	Internal door broken and handle broken	○	○	✗	○
59	Flashings		○	○	○	−
60	Drains		○	○	○	−

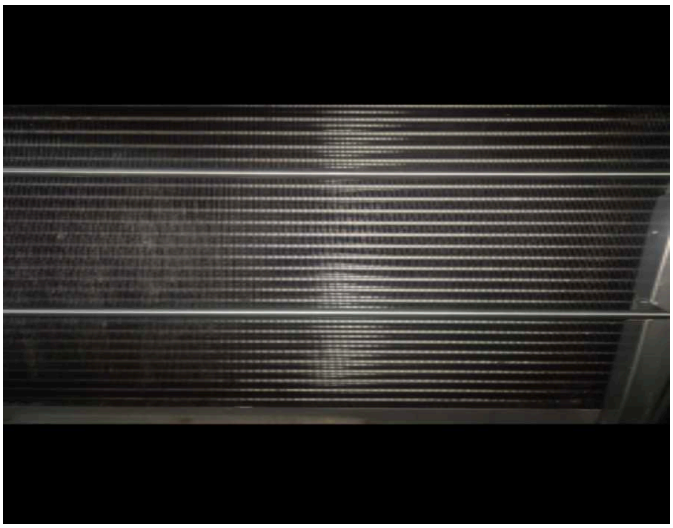
61. Air flow

SN	Inspection Item	Note	Good	Repair	Replace	NA
61	Air flow	Airflow is good.	✓	○	○	○
62	Cleanliness	Coils are very clean	✓	○	○	○
63	Corrosion		○	○	○	−
64	Filters	Filters are in very bad condition and need to be replaced	○	○	✗	○
65	Drains	Drains are open and water flows easily	✓	○	○	○

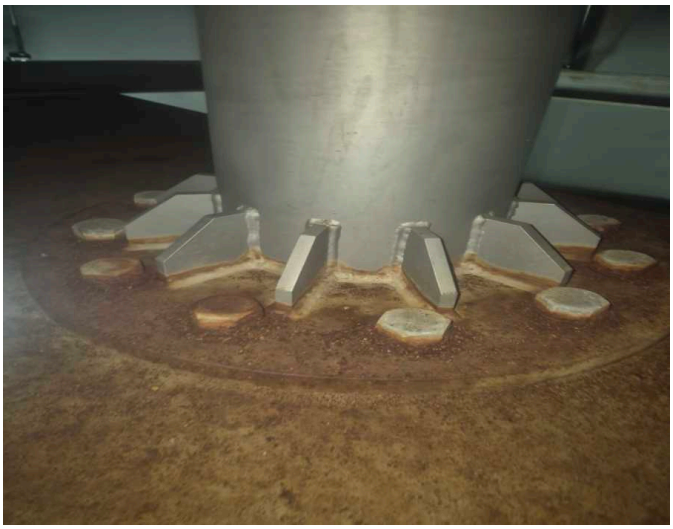
71. Leaks

SN	Inspection Item	Note	Good	Repair	Replace	NA
70	Oil levels	Oil level is correct on up drum and down drum gearbox	✓	○	○	○
71	Leaks	No leaks on up drum gearbox. Small leak found on uo drum reduction gearbox.	✓	○	○	○
72	Gearbox noise	No noise found on both gearboxes	✓	○	○	○
73	Coupling and fasteners	Everything in place. No cracks found on coupling	✓	○	○	○

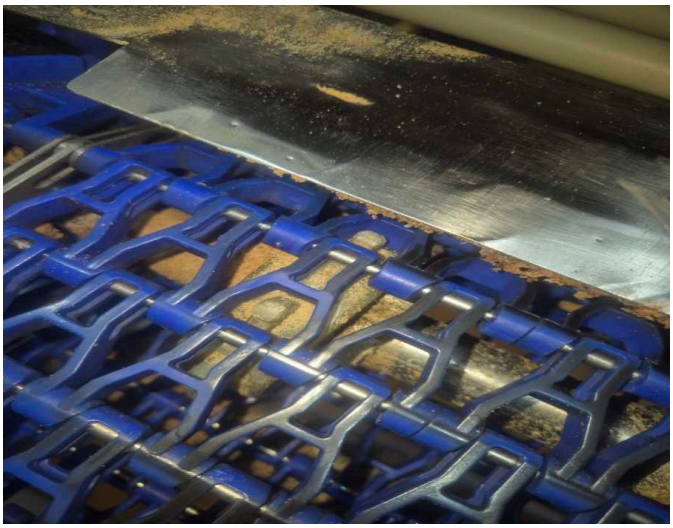
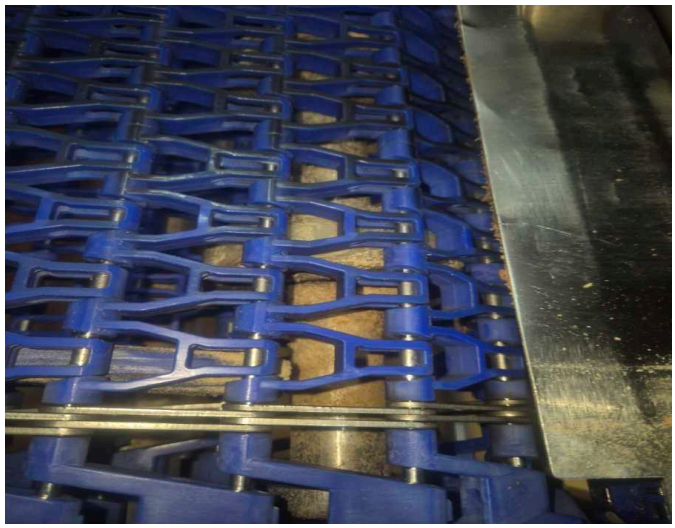
75. Bearings

SN	Inspection Item	Note	Good	Repair	Replace	NA
75	Bearings	Bearings need to be greased	○	✕	○	○
76	Sprockets wear/ alignment	Sprocket and rollers in good condition	✓	○	○	○
77	Belt guides	Belt guides in place	✓	○	○	○
78	Condition of rail wear strips	Wearstrip is very worn	○	○	✕	○
79	Operation of product height sensor		○	○	○	−
80	Compare product height, level with first tier height		○	○	○	−
81	Infeed E-stop	E stop trios spiral when pressed	✓	○	○	○

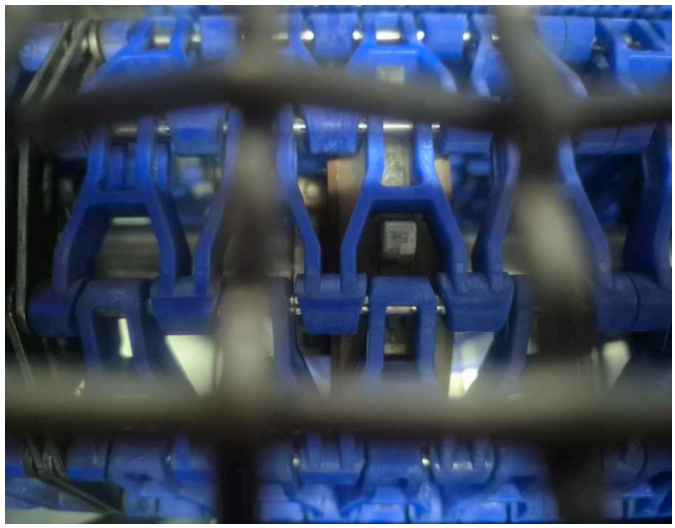
82. Bearings

82	Bearings	Bearings greased amd in good condition	✓	○	○	○
83	Sprocket alignment and wear	All sprockets are aligned and in good condition. Sprocket needs to hook at the back of a rod	✓	○	○	○
84	Belt side guides		○	○	○	−
85	Rail wear strip		○	○	○	−
86	Take-up switches	All sensors working .	✓	○	○	○
87	Overdrive	No leaks found on gearbox	✓	○	○	○

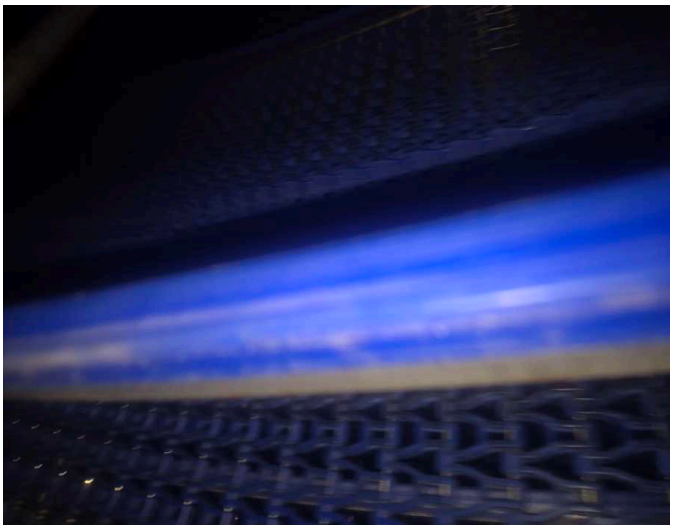
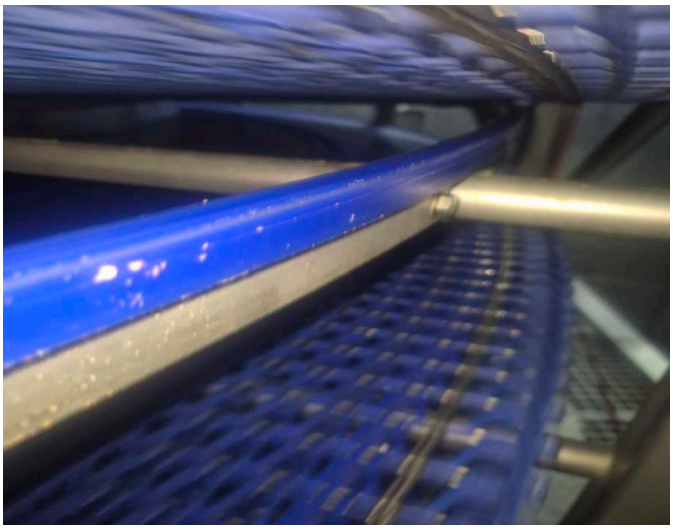
90. Rail wear strips

SN	Inspection Item	Note	Good	Repair	Replace	NA
90	Rail wear strips	Wearstrip is still in good condition. Need to fix oiler otherwise Wearstrip will start to wear and cause problems	✓	○	○	○
91	Support arms	All support arms are level . No cracks found on support arms.	✓	○	○	○
92	Rail arm supports (Plastic or welded on steel tabs)	Plastic tabs installed. No broken tabs found. All tabs are level	✓	○	○	○
93	Tier lift switches	All tier lift switches working and stopping cooler.	✓	○	○	○

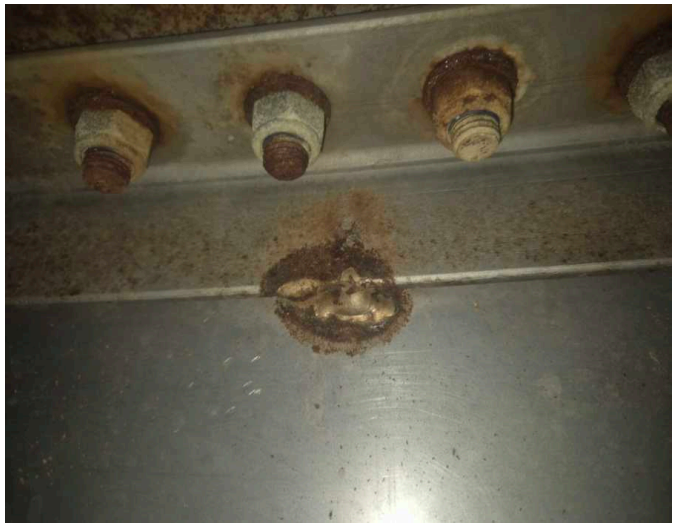
97. Drum internals - Drive spokes, intermediate spokes and rings

94	Motor and gearbox		○	○	○	−
95	Sputnik		○	○	○	−
96	Drum internals - Bolts	Full drum bolt change to be done. All bolts are badly rusted	○	○	✕	○
97	Drum internals - Drive spokes, intermediate spokes and rings	Spokes are in good condition. Welds on Drive and intermediate rings broke off. Need to do a proper weld	○	○	✕	○
98	Top Centre bearing	Center bearing in good condition and greased.	✓	○	○	○
99	Drum bar wear strips		○	○	○	−
