Dale Automation

Edge Drive Spiral Cooler

Report #: Dale Automation 2798

Asset Name : Blue Ribbon Mthatha

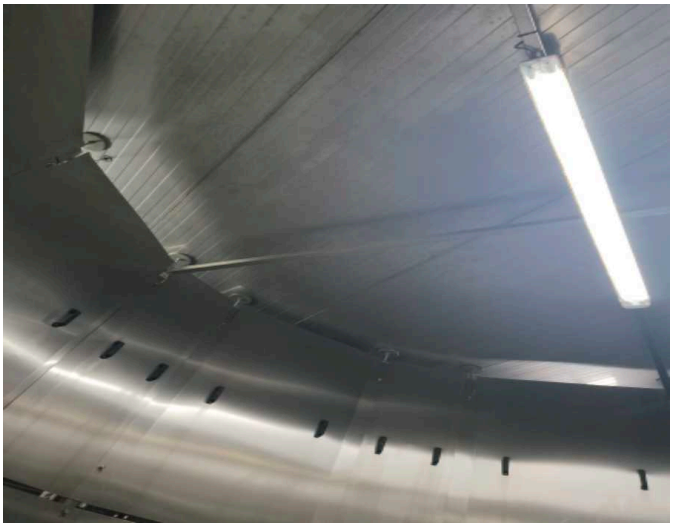
4. Down Drum internal hook on baffles

SN	Inspection Item	Note	Good	Repair	Replace	NA
1	Up drum sliding baffles	Up drum sliding baffles in place	✓	○	○	○
2	Up drum internal hook on baffles	Hook in baffles in place	✓	○	○	○
3	Down drum sliding baffles	All baffles in place	✓	○	○	○
4	Down Drum internal hook on baffles	Baffles are there , 2 are off	✓	○	○	○

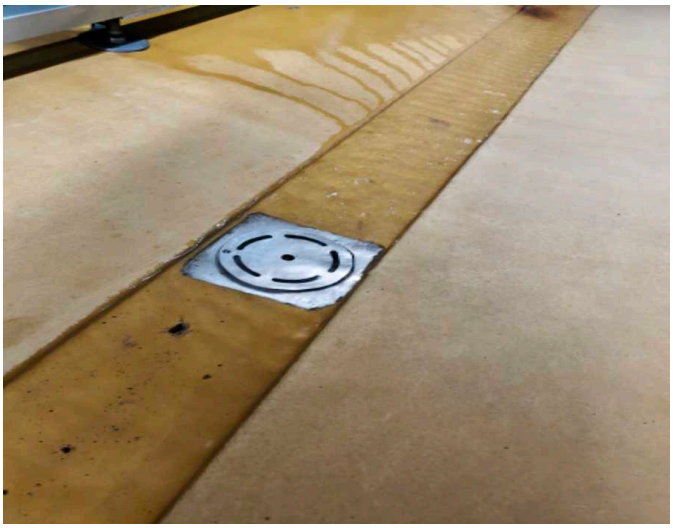
29. floor drains

SN	Inspection Item	Note	Good	Repair	Replace	NA
24	Coil fins	Coil fins are in good condition	✓	○	○	○
25	Coil flashings		○	○	○	−
26	Piping and lagging	Piping and lagging in good condition	✓	○	○	○
27	Filters and frames	Filters are very clean and in good condition	✓	○	○	○
28	Drip trays	Drip trays are not blocked and allows water to flow	✓	○	○	○
29	floor drains	Floor drains are blocked	○	✕	○	○

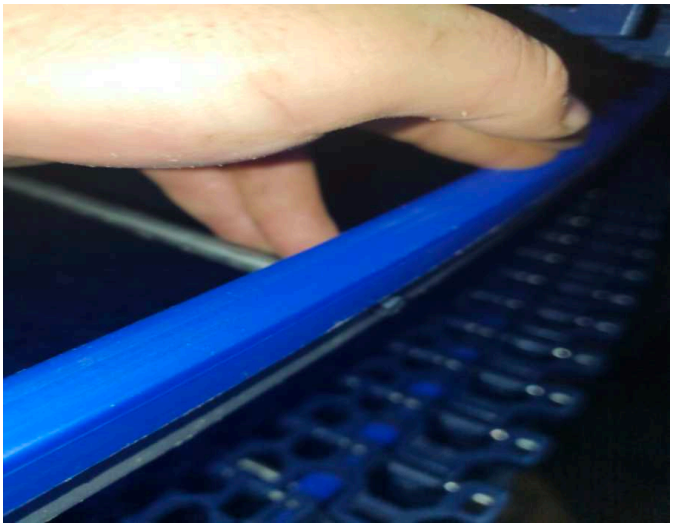
45. Rail wear strips

SN	Inspection Item	Note	Good	Repair	Replace	NA
45	Rail wear strips	Wearstrip is worn. The oil doesn't carry from one rail to another due to the design	○	○	✕	○

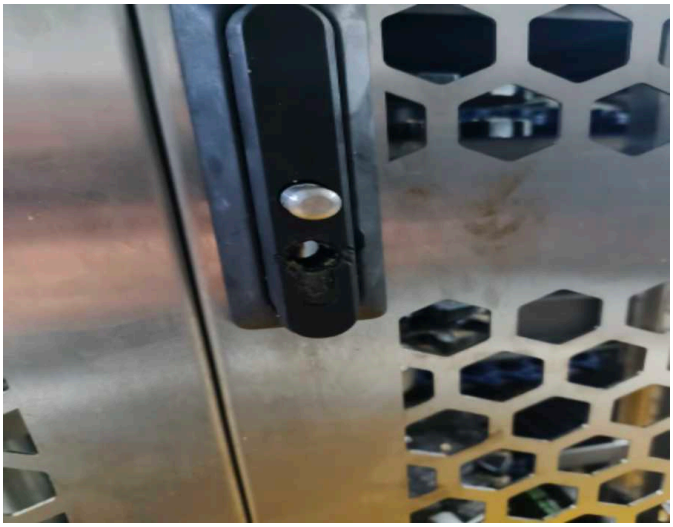
66. Lockable tower doors

SN	Inspection Item	Note	Good	Repair	Replace	NA
60	Sprockets	Sprockets in very good condition. No play found	✓	○	○	○
61	Bearings	Bearings in very good condition and being greased	✓	○	○	○
62	Chain couplings	Chain couplings in good condition	✓	○	○	○
63	Drive shafts	Drive shaft is aligned	✓	○	○	○
64	Spur gears	Spur gears in good condition. Engaging correctly	✓	○	○	○
65	Encoder	Encoder is secure and not loose	✓	○	○	○
66	Lockable tower doors	Locks are broken out	○	○	✗	○

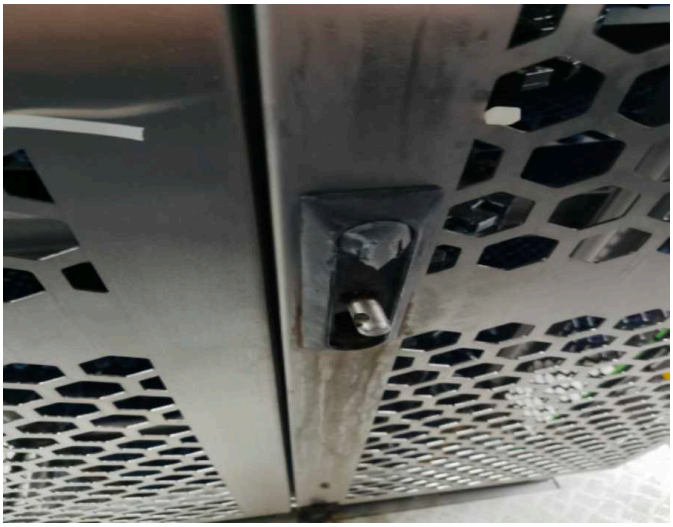
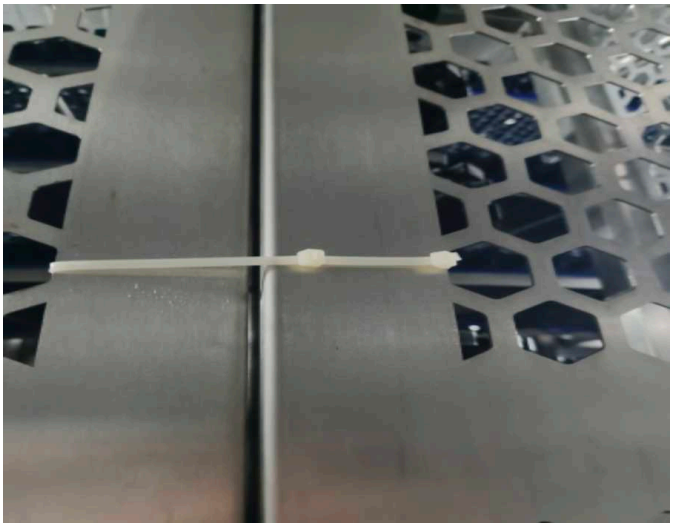
73. Lockable tower doors

SN	Inspection Item	Note	Good	Repair	Replace	NA
67	Sprockets	No wear in sprockets and no play	✓	○	○	○
68	Bearings	Bearings are greased and in good condition	✓	○	○	○
69	Chain coupling	Chain couplings in good condition and showing no signs of wear	✓	○	○	○
70	Drive shafts	Drive shaft in good condition	✓	○	○	○
71	Spur gears	Spur gears are in good condition and no wear	✓	○	○	○
72	Encoders	Encoder is secure	✓	○	○	○
73	Lockable tower doors	Locks are broken and held on with cable ties	○	○	✗	○

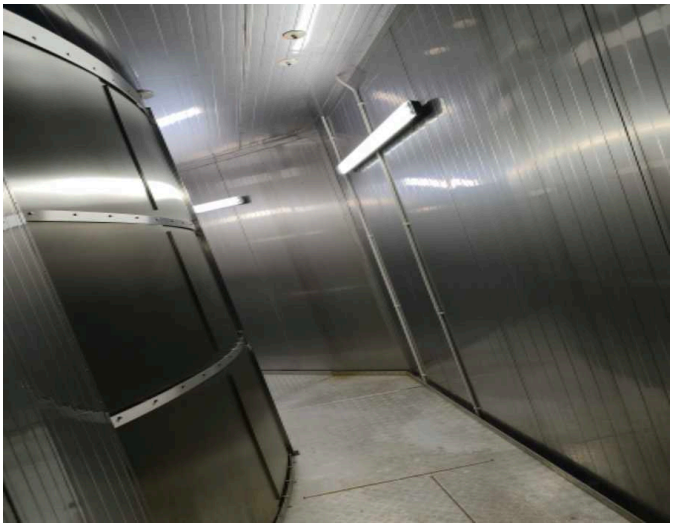
89. Lights

SN	Inspection Item	Note	Good	Repair	Replace	NA
89	Lights	All lights working in enclosure	✓	○	○	○
