Dale Automation

Blue Ribbon Aeroton Prover Factory Inspection

Report #: Dale Automation 2747
Location: South Africa
Inspection Date: 15-Aug-2026 10:16 AM
Inspector Name: Victor

Asset Category : Prover
Asset Name : Blue Ribbon Aeroton
Asset # : DSS 397-4
Meter Reading: 0 Hours
Model/Year: 2024

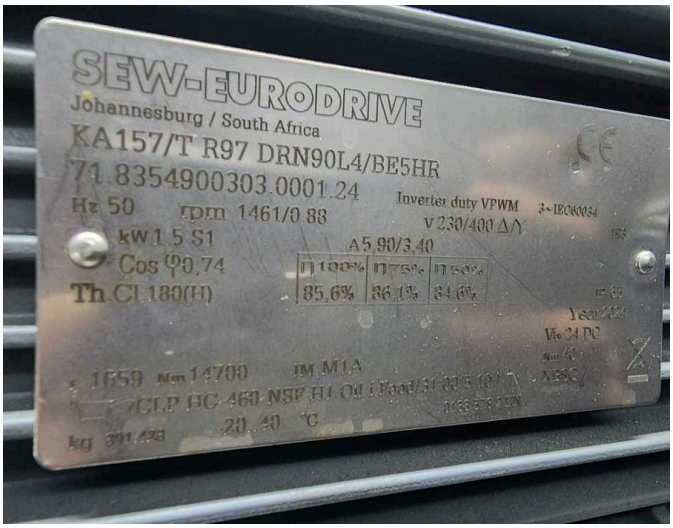
2. Material Type

SN	Inspection Item	Note	Good	Repair	Replace	NA
2	Material Type	-Rust deposit found on top two rails for chain -missing bolts on discharge conveyor -noisy motor on main drive gearbox -Broken light bracket inside prover -Chain oiler brush not touching the chain	◯	✕	◯	◯

Additional Note
Replace some missing bolts on covers
