Dale Automation

Friction Drive Spiral (Freezer)

Report #: Dale Automation 2738
Location: South Africa
Inspection Date: 10-Aug-2026 08:58 AM
Inspector Name: Raynard Kruger

Asset Category : Spiral freezer
Asset Name : Goldi Standerton
Asset # : DSS 176
Meter Reading: 107100 Hours
Model/Year: Spiral Friction Drive Freezer

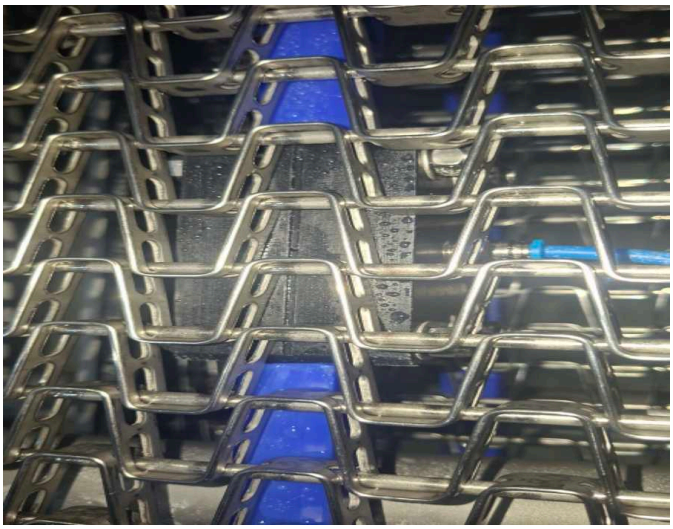
4. BELT WIDTH

3	STEEL OR BLUE BELT		Ashworth steel belt
4	BELT WIDTH		1060
5	TIERS		36 Tiers
6	PITCH		N/A
7	DESIGN		Ashworth steel belt design

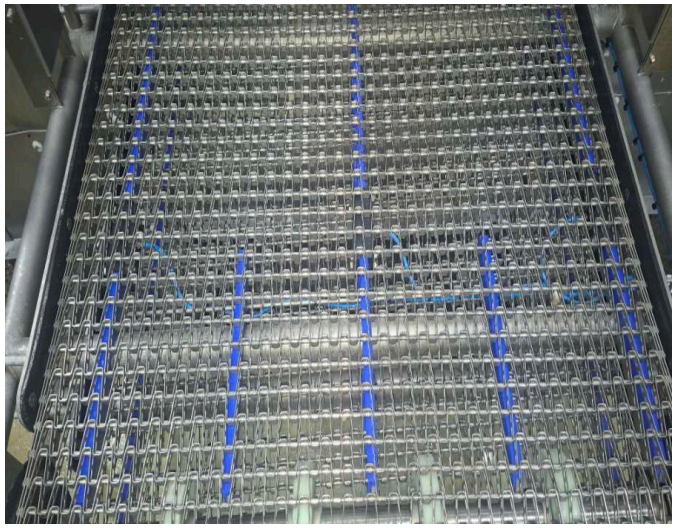
8. BELT OILER BLOCKS

SN	Inspection Item	Note	Good	Repair	Replace	NA
8	BELT OILER BLOCKS	Belt oiler blocks are not blocked.	✓	○	○	○
9	BELT OILER DIVIDER BLOCK	Belt oiler divider blocks is still in good working condition.	✓	○	○	○
10	BELT OILER PIPING	Belt oiler pipes are still in good condition	✓	○	○	○
11	MANUAL RUN OF OILER		○	○	○	−

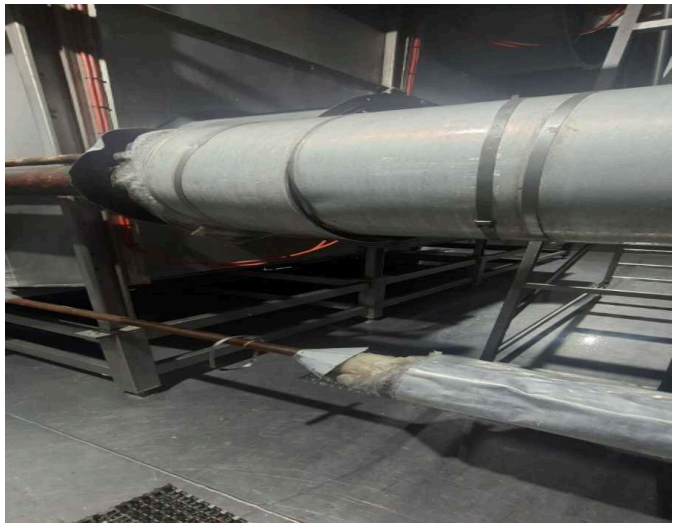
15. COIL CONDITION

SN	Inspection Item	Note	Good	Repair	Replace	NA
15	COIL CONDITION	A peace of the coil is damaged,but still in good working condition.	◯	✕	◯	◯
16	PIPE WORK & LAGGING	The covers on the piping need to be replaced or fixed	◯	✕	◯	◯

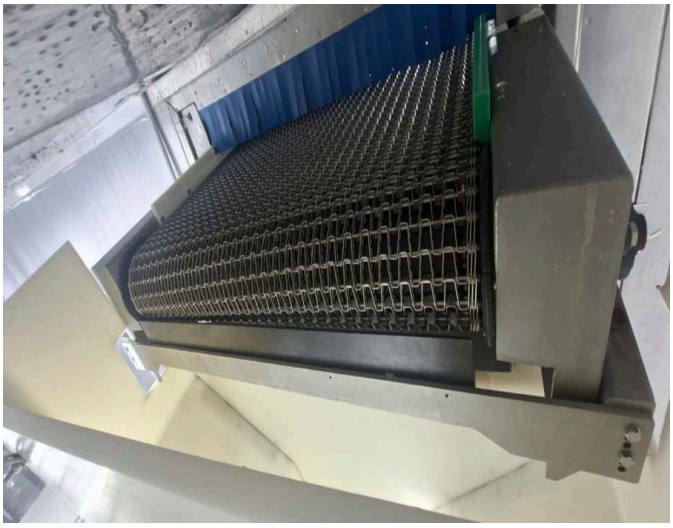
17. DISCHARGE SHAFT

SN	Inspection Item	Note	Good	Repair	Replace	NA
17	DISCHARGE SHAFT	Discharge shaft is in a very good condition.	✓	○	○	○
18	SCRAPER	Scrapper is in a good condition.	✓	○	○	○
19	BEARINGS	Bearings haven't been greased in a while.	○	✕	○	○
20	BELT GUIDES	Discharge belt guides are in good condition, but they are not the same please put the green wearstrip back	○	○	✕	○

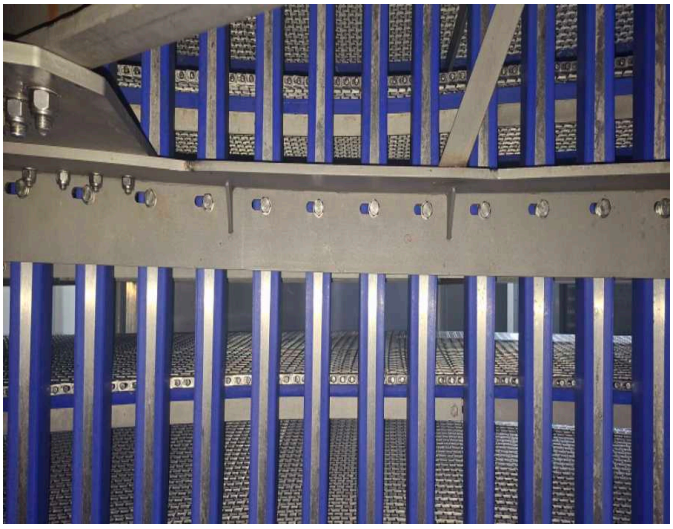
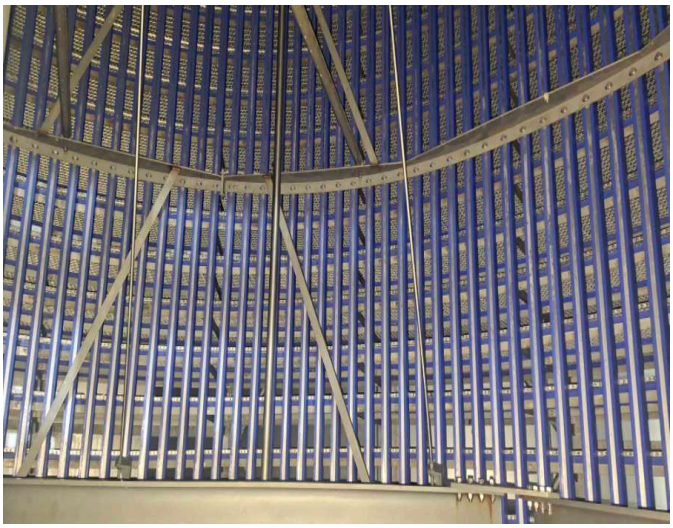
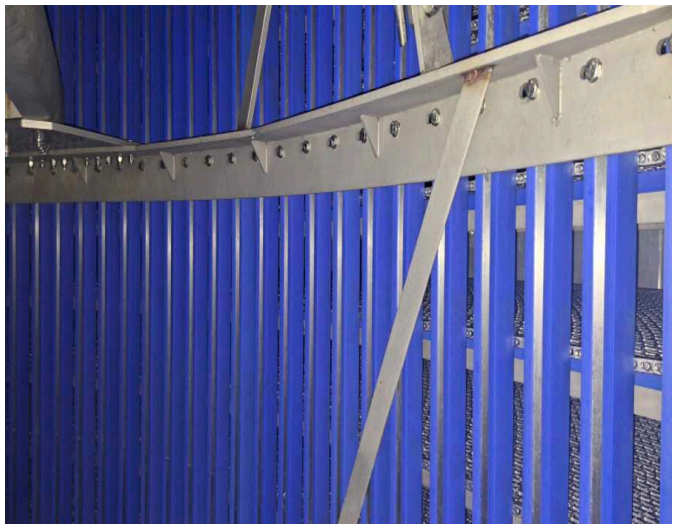
21. DRUM FASTNERS

SN	Inspection Item	Note	Good	Repair	Replace	NA
21	DRUM FASTNERS	Drum fasteners are in place and there are no missing fasteners.	✓	○	○	○
22	DRUM SUPPORTS (SPOKES & RINGS)	Drum supports and spokes are in good condition	✓	○	○	○
23	DRUM CENTER BEARING	Drum center shaft bearing is well greased. Please clean the over-grease off from bearing housing. Bearing size SF216	✓	○	○	○
24	TIE RODS	Tie rods are in good condition	✓	○	○	○
25	DRUM PULL CORD	Drum pull cord is in place	✓	○	○	○

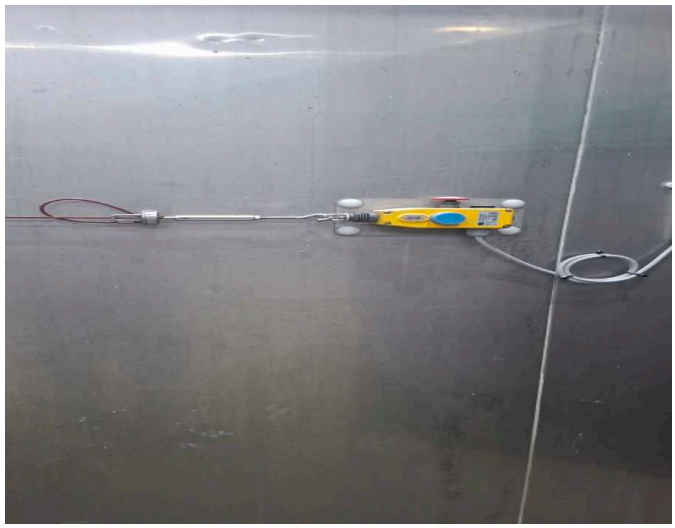
26. PULL CORDS

SN	Inspection Item	Note	Good	Repair	Replace	NA
26	PULL CORDS		✓	○	○	○
27	E-STOPS	All the E-Stops are in good working condition. Have tested and rested at the HMI	✓	○	○	○
28	LIGHTNING	All the lights are in good working condition.	✓	○	○	○
29	TEMPERATURE PROBES	Temperature probes need to be repositioned	○	○	✗	○

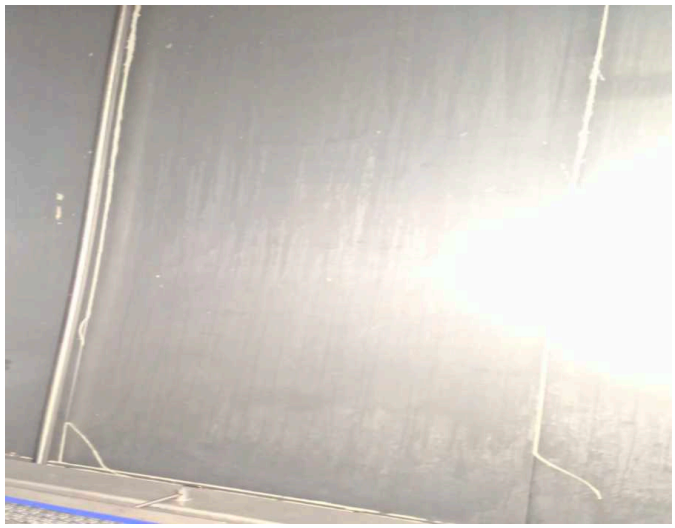
30. DOORS

SN	Inspection Item	Note	Good	Repair	Replace	NA
30	DOORS	Door seals are damaged and there is a peace missing	○	○	✕	○
31	FLASHINGS		○	○	○	−
32	WALL PANELS	Wall are in good condition	✓	○	○	○
33	INFEED AND DISCHARGE CURTAINS	In-feed curtains are in place and in good condition. Discharge curtains are in place and in good condition	✓	○	○	○
34	FLOOR	Floor is inngood condition there are no open or broken floor panels.	✓	○	○	○
35	MESS FLOOR	Some places of the mess floor need to be supported	○	✕	○	○
36	INTERNAL DOORS	Internal doors are in a good condition.	✓	○	○	○
37	ENCLOSURE DRAINS	Drains are in good condition	✓	○	○	○
38	CAT LADDER.	Cat ladderbis secure and safe to use	✓	○	○	○

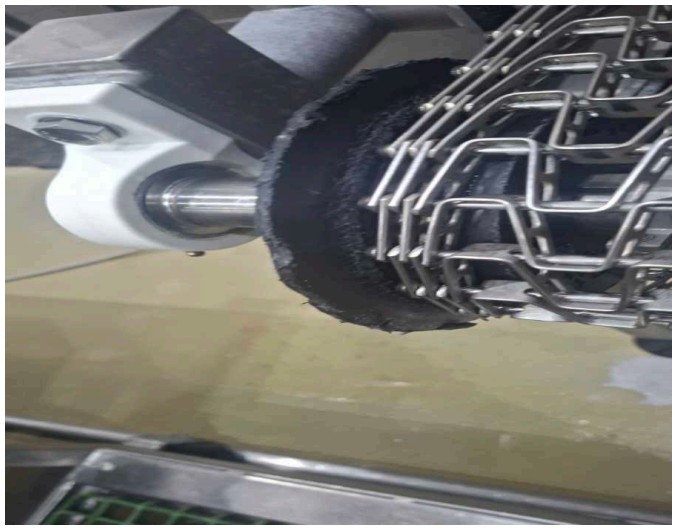
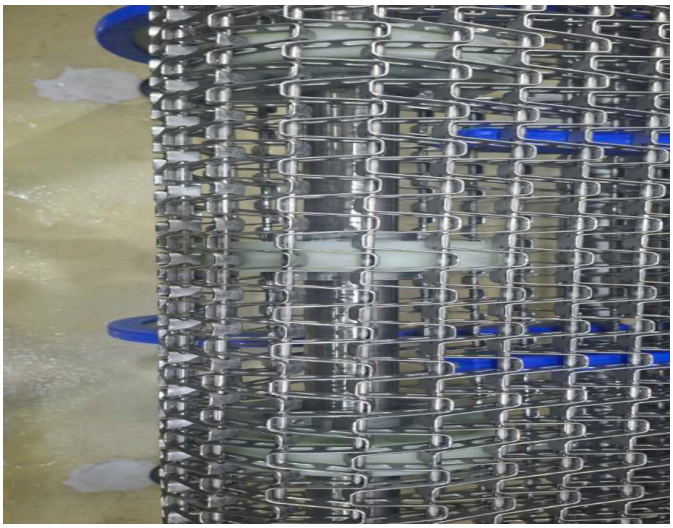
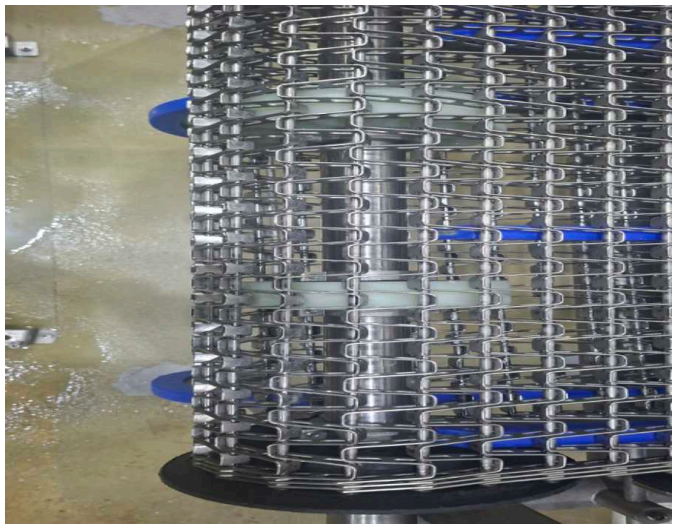
44. INFEED SHAFT

SN	Inspection Item	Note	Good	Repair	Replace	NA
44	INFEED SHAFT	Infeed shaft flange roller is damaged please replace.	○	○	✕	○
45	BELT GUIDES	Belt guides are in place and in good condition	✓	○	○	○
46	PRODUCT HEIGHT	Product height is in good working condition. Have tested and resetted at the HMI	✓	○	○	○
47	IN-FEED RETURN SHAFTS	In-feed return shaft is in good condition.	✓	○	○	○
48	BEARINGS	Bearings are running dry please grease. Bearing size P206	○	✕	○	○

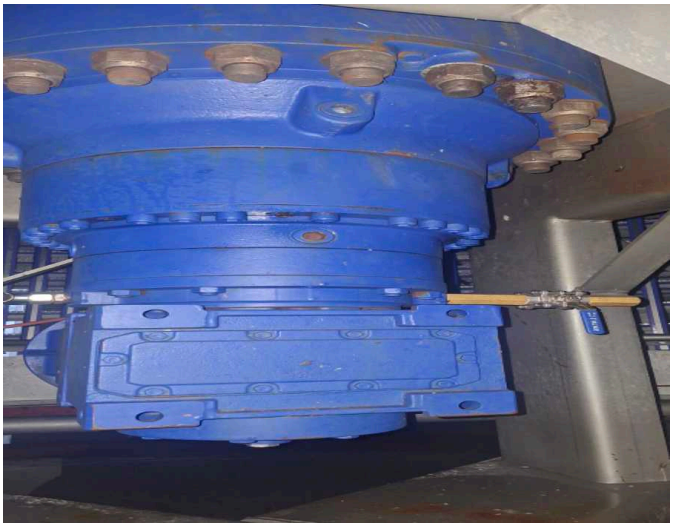
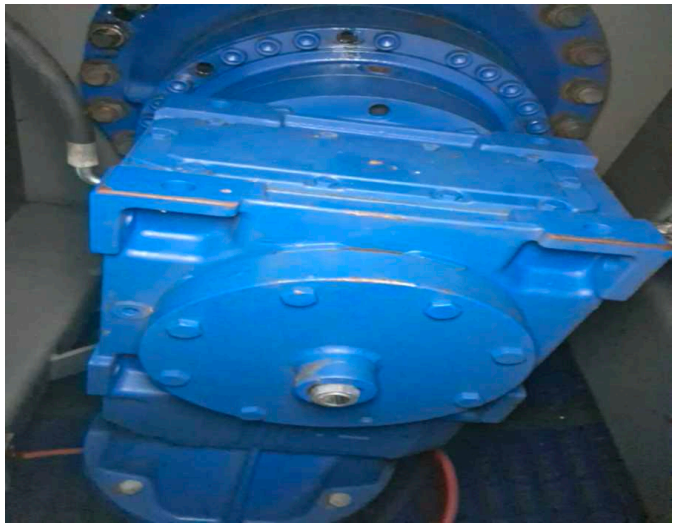
49. MAIN DRIVE GEARBOX

49	MAIN DRIVE GEARBOX	Main drive gearbox is in a good condition there are no visible oil leaks from the gearbox and from the motor	✓	○	○	○
50	HEADER TANK	Header tank is in good condition,there are no visible oil leaks.	✓	○	○	○
51	MAIN DRIVE ELECTRICAL MOTOR	Main drive electrical motor is in good working condition and there are no visible oil leaks from the motor side	✓	○	○	○

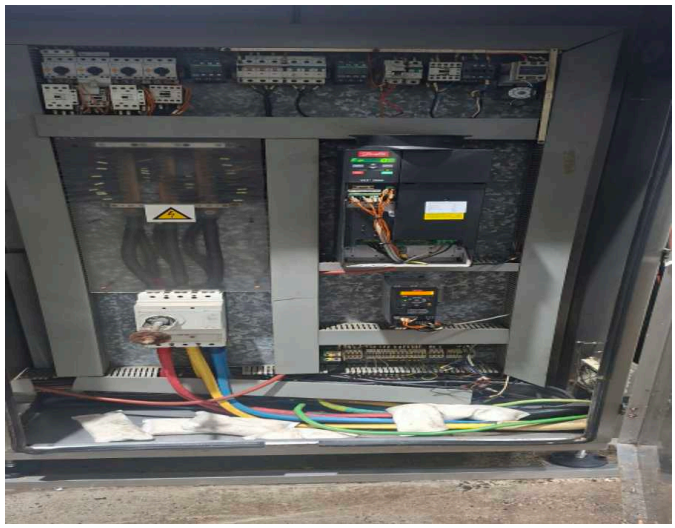
52. PANEL CONDITON

SN	Inspection Item	Note	Good	Repair	Replace	NA
52	PANEL CONDITON	The control panel is in a good condition	✓	○	○	○
53	HMI	HMI screen is clear and visible also in a good condition	✓	○	○	○

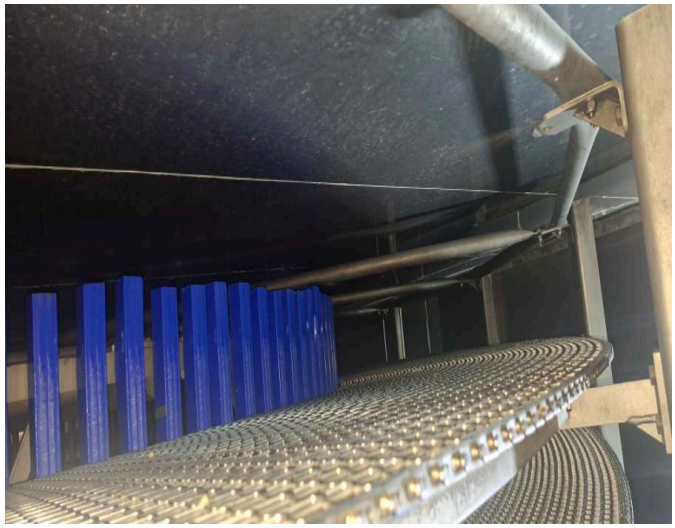
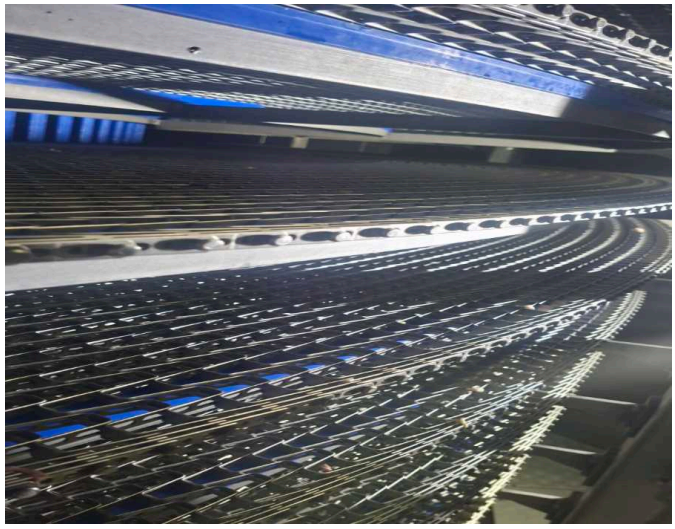
54. RAIL ARMS & RAILS

54	RAIL ARMS & RAILS	Rail arms and rails are in good condition. There are no bent arms or missing rails	✓	○	○	○

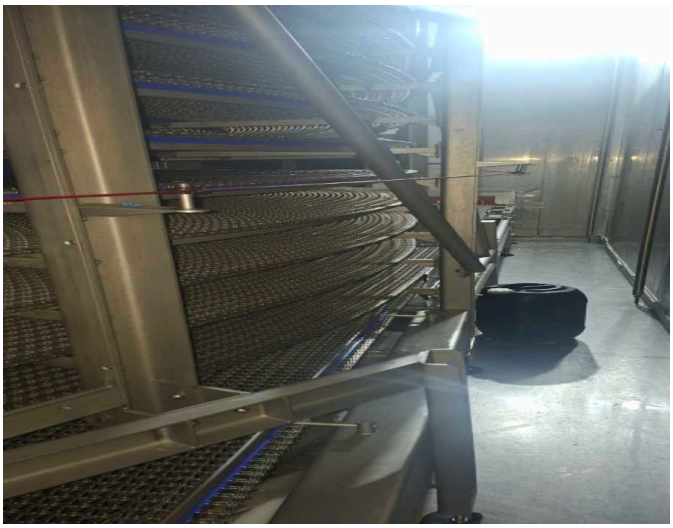
55. TEST RUN SPIRAL

SN	Inspection Item	Note	Good	Repair	Replace	NA
55	TEST RUN SPIRAL	Did run the freezer spiral. There are no hooking or other noises.	✓	○	○	○

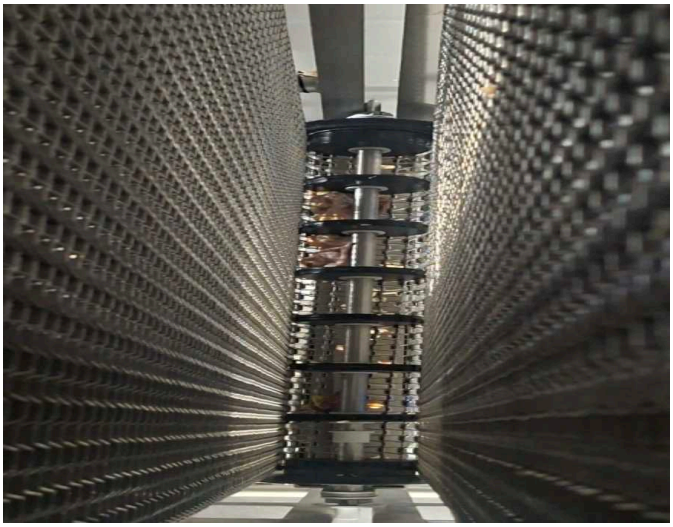
59. OVER DRIVE GEARBOX & MOTOR

SN	Inspection Item	Note	Good	Repair	Replace	NA
58	OVER DRIVE SHAFT	Over drive shaft bearings,roller,collars,sprockets and flanges are still in a good condition.	✓	○	○	○
59	OVER DRIVE GEARBOX & MOTOR	Overdrive gearbox is leaking from output shaft seal	○	○	✗	○
60	TAKE-UP IDLER SHAFTS	Take up idler shaft bearings,rollers,collars and flanges are still in good condition. Please clean old grease off from bearing housing. Bearing size FL206	✓	○	○	○
61	WEIGHTED ROLLER & WEIGHT BOX	Weighted rollersf,flanges are in good condition.	✓	○	○	○
62	ELECTRICAL	There are no loose or open connections cables are still in good condition.	✓	○	○	○

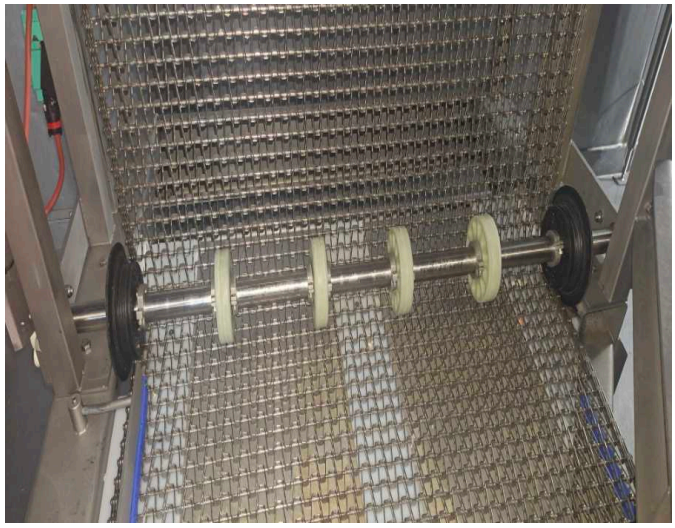
63. TAKE UP RETURN STATION

63	TAKE UP RETURN STATION	Take up return station is in good condition bearings are well greased. Bearing sizes FL206	✓	○	○	○
64	BELT GUIDES ON TAKE-UP AND RETURN	Belt guides are in place and in good condition.	✓	○	○	○

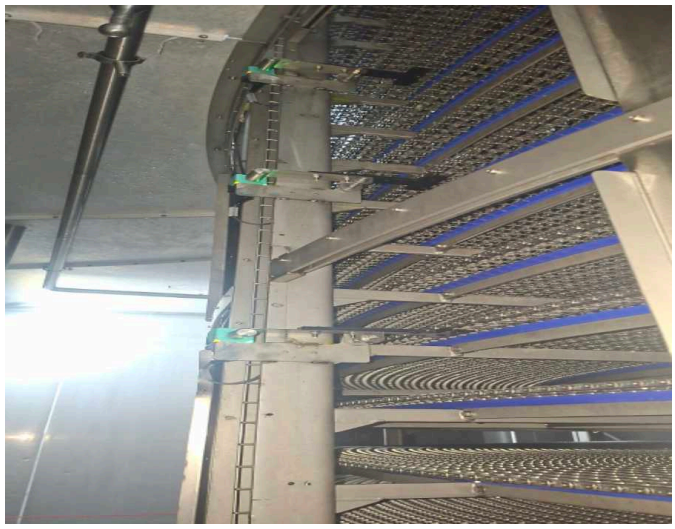
66. FLIP FLOPS

SN	Inspection Item	Note	Good	Repair	Replace	NA
66	FLIP FLOPS	Flip-flops are in good working condition.	✓	○	○	○
67	TIER LIFT SENSORS	Tier lift sensors are all working and in place.	✓	○	○	○

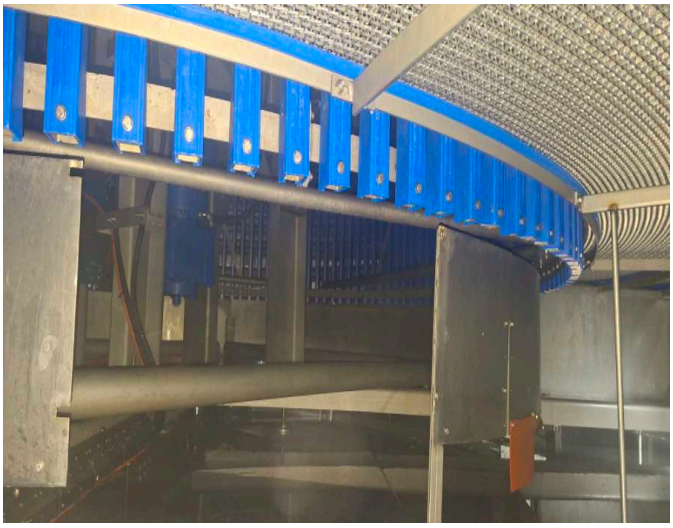
68. DRUM BAR WEAR-STRIP

68	DRUM BAR WEAR-STRIP	Drum-bars wearstrips are still in place and in good condition.	✓	○	○	○
69	RAIL WEAR-STRIP	Rail wearstrip is still in good condition. There are no missing wearstrips.	✓	○	○	○
