Dale Automation

Belt replacement Pre-inspection

Report #: Dale Automation 2750
Location: South Africa
Inspection Date: 20-Aug-2026 11:19 AM
Inspector Name: Raynard Kruger

Asset Category : Bakery
Asset Name : Snackworks Dryer Spiral
Asset # : DSS 331-9
Meter Reading: 0 Hours
Model/Year: Dale

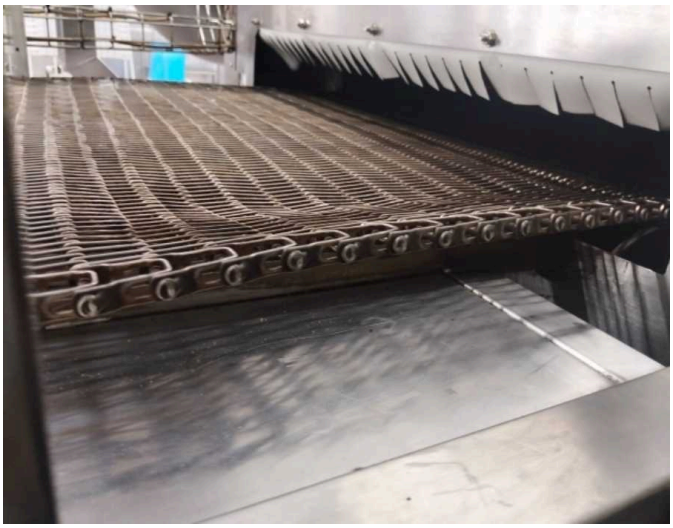
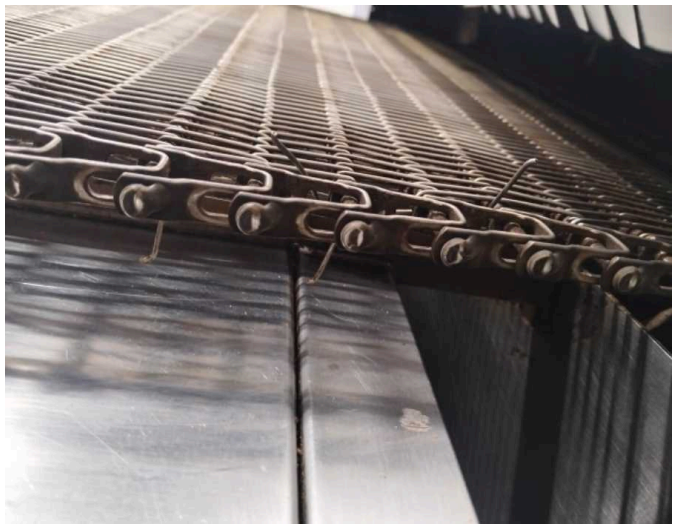
3. Belt condition

SN	Inspection Item	Note	Good	Repair	Replace	NA
1	Belt width		○	○	○	⊖
2	Belt type		○	○	○	⊖
3	Belt condition	Belt is 8 years old Belt has been turned once and due to distortion and damage as per the photos in this report Dale Automation strongly suggests replacing the belt as there is no guarantee how long the belt will operate before failing.	○	○	⊗	○

Additional Note
Belt is 8 years old Belt has been turned once and due to distortion and damage as per the photos in this report Dale Automation strongly suggests replacing the belt as there is no guarantee how long the belt will operate before failing.

Overall Condition:	Major Repair required
Asset Safe to Use:	**Yes**
Maintenance Required:	Yes
Asset Status	Maintenance Required
Maintenance Priority:	High
