Dale Automation

Oven General Inspection

Report #: Dale Automation 2743
Location: South Africa
Inspection Date: 12-Aug-2026 09:38 AM
Inspector Name: Raynard Kruger

Asset Category : 8000 Oven
Asset Name : Sunbake Benoni
Asset # : DSS 269-2
Meter Reading: 0 Hours
Model/Year: Dale Bakermation

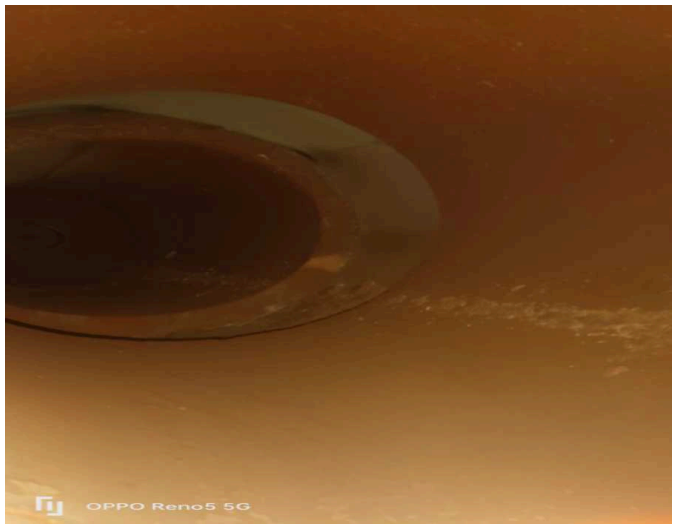
21. Flame tubes

SN	Inspection Item	Note	Good	Repair	Replace	NA
18	Pressure Chambers		○	○	○	⊖
19	Inspection Doors		○	○	○	⊖
20	Burners		○	○	○	⊖
21	Flame tubes	The flame tubes refractory is busy breaking apart from the flame tubes replace the flame tubes Flame tubes length is 2.4 meter.	○	○	✕	○
22	Circulation Fans		○	○	○	⊖

Additional Note
Equipment is in operation, but tube integrity is compromised and not running in an efficient manner. Replace flame tubes
