Test and Chemical Report					
Code: FM-15-30		Version Version				2384	
GENERAL DATA							
Customer	FORD	FO Chrome	1010234	Chrome date	23-01-25	Rack	0
Reference	SL18543156AA-C1	FO Injection	2411025	Download time		Type	Validation
Denomination	EXPEDITION RR EXPE APPLIQUE			Request Documentation		N/A	
Aspect	OK	Traceability	OK	Valuation	Accepted	Approved	
Previous information Validation parts Satin Chrome SM322				Final valuation The pieces are in accordance with the specifications required by the client, so the conformity is "Accepted"			
Quick adhesion test							
Responsible				N/A			
Result				N/A			
Tests							
Test 1 WSS-M1P83-E2 - 3.5.1 Grind Saw Test							
Responsible	Start date	Start time	Finish Date	Finish time	Actual valuation date		
Karla	24-01-25	12:00	24-01-25	13:00	24-01-25		
Equipment	State		Valuation				
Saw	Finalized		OK				
Characteristic							
No evidence of peeling, flaking or lifting of the electroplate from the substrate or between the plating layers.

THICKNESS TEST REPORT

REFERENCE	SL1BS43156AA-C1
DENOMINATION	EXPEDITION RR "EXPE" APPLIQUE
OF	1010234
PRODUCTION DATE	23/01/2025

S.T.E.P. TEST REPORT

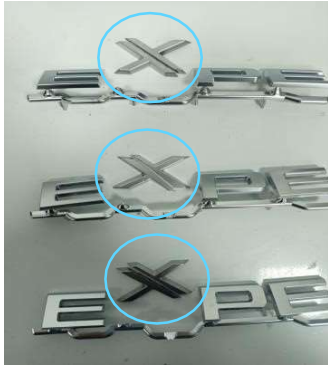
Result							
The pieces do not show detachment after testing							
Observations							
Evidence

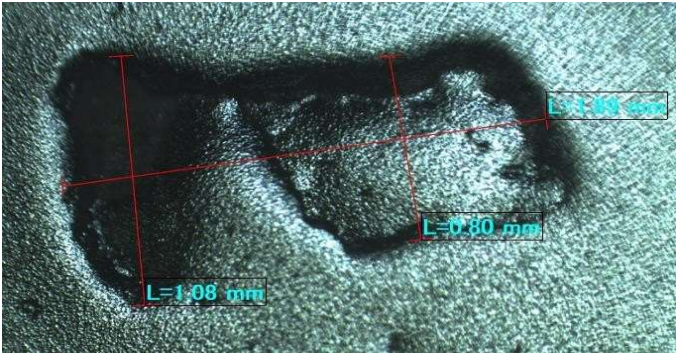
Test 2 WSS-M1P83-E2 3.6.1 Stone Chip (23 °C & -20°C)							
Responsible	Start date	Start time	Finish Date	Finish time	Actual valuation date		
Karla	27-01-25	11:00	27-01-25	16:00	27-01-25		
Equipment	State		Valuation				
Gravelometer	Finalized		OK				
Characteristic							
Rating 5B min							
Result							
Rating 5B							
Observations							
According to the specification required by the client, the average chip size is between 1-3 mm and the quantity is 25-49, the maximum chip size is 1.80 mm, so the result is acceptable.							
Evidence

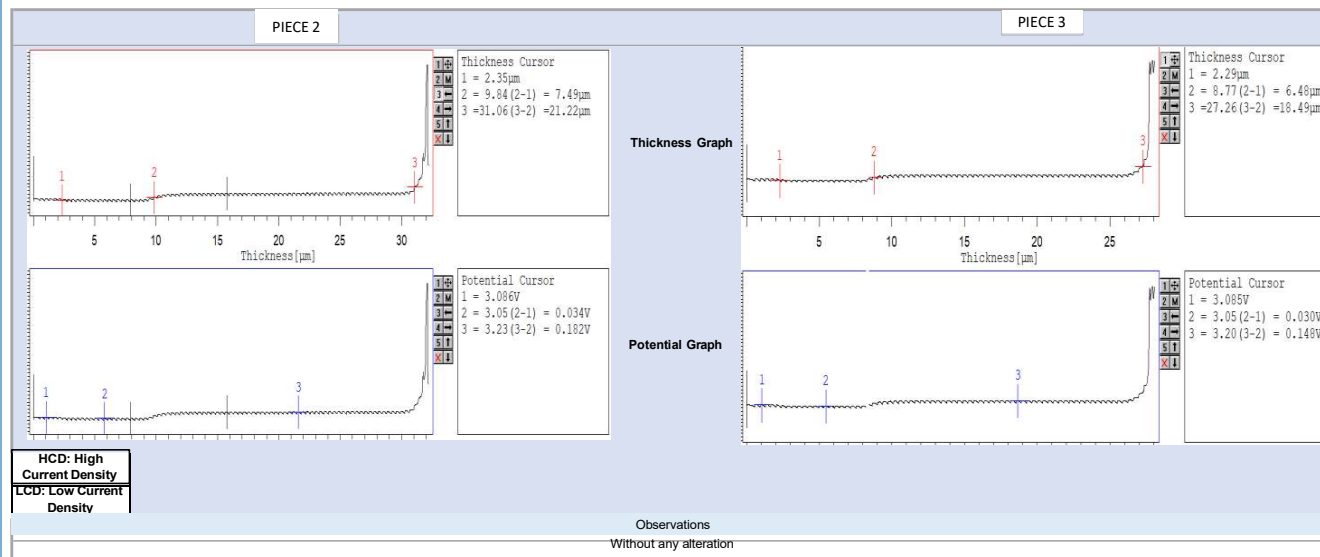
STEP TEST					
PIECE 2 (EXPE Rack position FB31) LCD					
	Multithickness measurement (Thickness graph)		Potential Measurement (Potential graph)		
measurement point	Nickel SB Thickness ($\geq 15 \mu\text{m}$)	Br Nickel Thickness ($\geq 6 \mu\text{m}$)	MPS Nickel Thickness (N/S)	$\Delta P(\text{NIMPS-NIB})$ (20-90 mV)	$\Delta P(\text{NIB-NISB})$ ($\geq 100 \text{ mV}$)
1	21.22	7.49	2.35	34	182

STEP TEST PIECE 3					
PIECE 3 (EXPE Rack position FB34) LCD					
	Multithickness measurement (Thickness graph)		Potential Measurement (Potential graph)		
measurement point	Nickel SB Thickness ($\geq 15 \mu\text{m}$)	Br Nickel Thickness ($\geq 6 \mu\text{m}$)	MPS Nickel Thickness (N/S)	$\Delta P(\text{NIMPS-NIB})$ (20-90 mV)	$\Delta P(\text{NIB-NISB})$ ($\geq 100 \text{ mV}$)
2	18.49	6.48	2.29	30	148

PIECE 2 PORE COUNT
(EXPE Rack position FB31) LCD:
15,600 Pores

PIECE 3 PORE COUNT
(EXPE Rack position FB34) LCD:
22,400 Pores

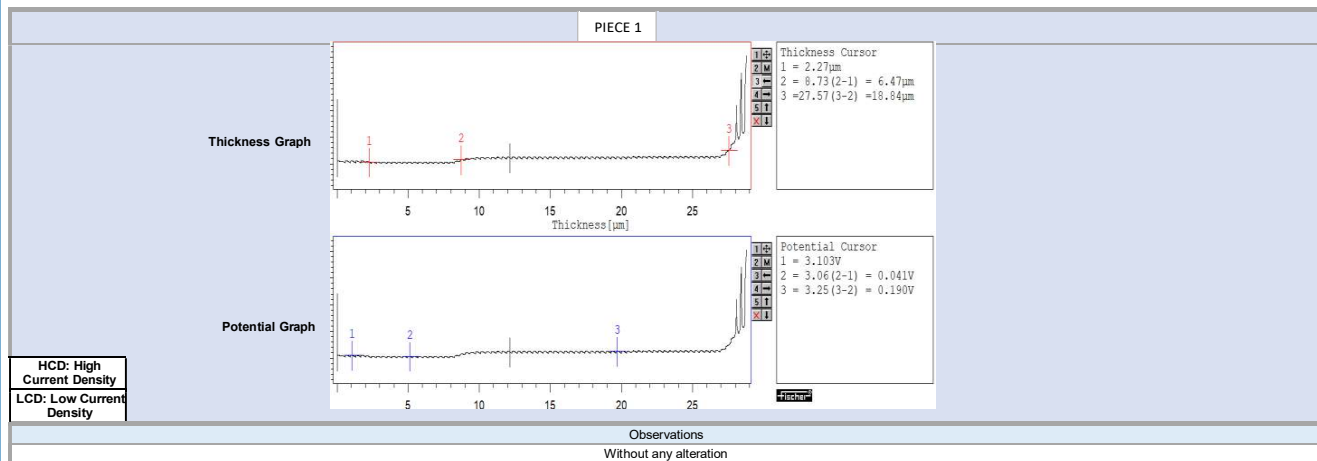
STEP TEST					
PIECE 1 (EXPE Rack position FA3) HCD					
	Multithickness measurement graph		(Thickness)	Potential Measurement (Potential graph)	
measurement point	Nickel SB Thickness ($\geq 15 \mu\text{m}$)	Br Nickel Thickness ($\geq 6 \mu\text{m}$)	MPS Nickel Thickness (N/S)	$\Delta P(\text{NIMPS-NIB})$ (20-90 mV)	$\Delta P(\text{NIB-NISB})$ ($\geq 100 \text{ mV}$)
2	18.84	6.47	2.27	41	190

PIECE 1 PORE COUNT
(EXPE Rack position FA3) HCD:
19,200
