Axis Plumbing NSW BW-24187	INSPECTION & TEST PLAN	ITP NUMBER: 023	Revision No: A	Potable Cold Water
	Approved for use by Darren Shoobridge, Project Manager	ITC # 000002	Revision Date: 24/09/2026	
	Riverside Precinct — Building A	Progress 100% · Reviewed & approved

Drawing Number	HC-201 REV C	Area	Level 3 — Cold Water Reticulation — Level 3, Grid 1-7
Location / Loc.Ref	CONTROLD0C > HYDRAULICS > POTABLE COLD WATER

ITP 023 — Potable Cold Water · Level 3 — Cold Water Reticulation · Level 3, Grid 1-7

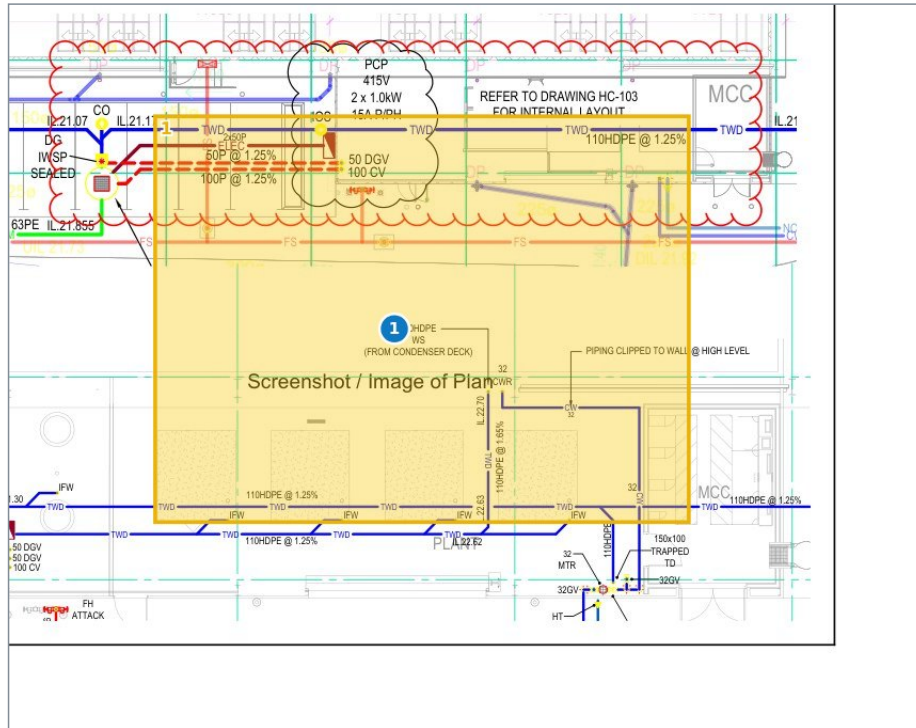
Plan extract — HC-201 REV C · Level 3 hydraulic services — layout · 1 highlighted extent, 1 location marked

1. Yellow area — Cold water reticulation, grid 1-7
1. CW riser take-off, isolation valve CW-V03 (1 photo)
