Projection handoff

R4 / Consolidated edition 2 / November 13, 2026

Frozen AV Project Summary

Walnut Street Theatre • November 13, 2026

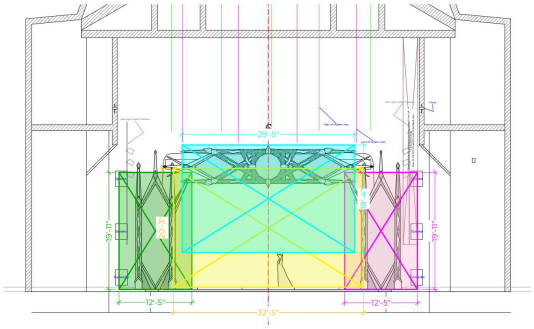
Scenic portals and stage opening during setup. Interpretation of the photograph and plot suggests that their depth and repeated framing affect coverage and masking.[P1][P2]

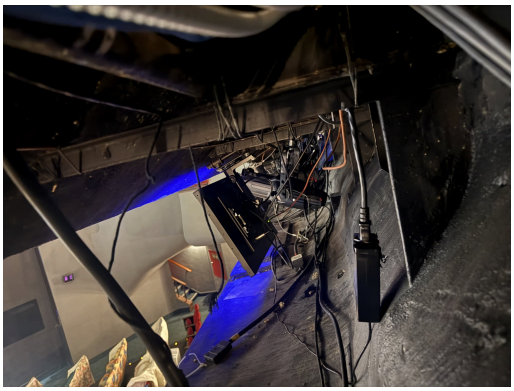
Booth network patching and a cove projector connection, photographed November 4. Port identities, extender models and cable labels remain part of the final trace.[P4][P5][5]

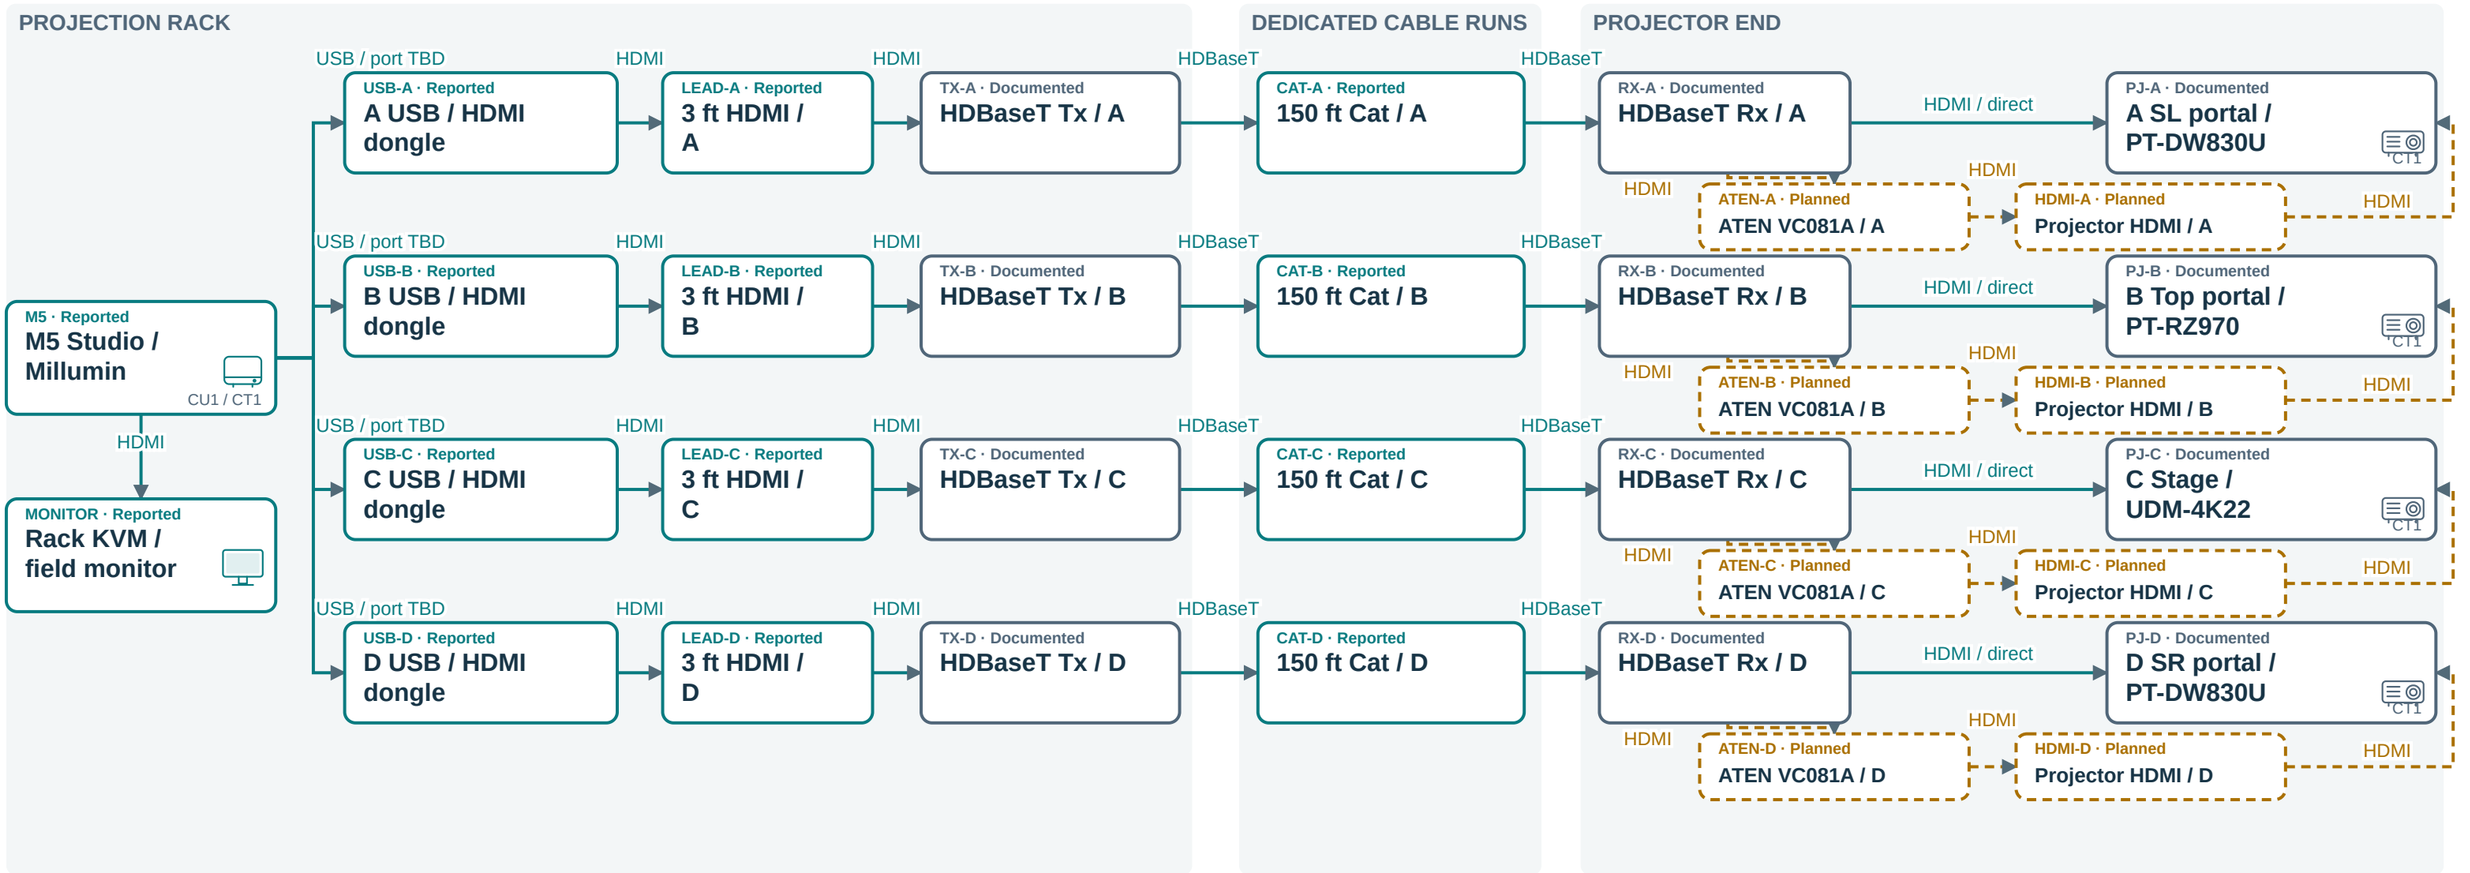
AV1 / Projection and operator display

Four reported 1920 x 1200 feeds; direct HDMI operation and planned display-end ATEN branches.

Solid direct RX-to-projector routes reflect the reported ATEN-removed configuration. Amber branches show planned ATEN insertion.
Projector addresses are control-LAN references. Refresh and physical output acceptance remain pending.

Check	State	Owner / date
Label all sockets, adapters and cable ends	Pending	TBD / TBD
Confirm received refresh, mapping and recovery	Pending	TBD / TBD
Learn/test one ATEN route and record final installed state	Pending	TBD / TBD

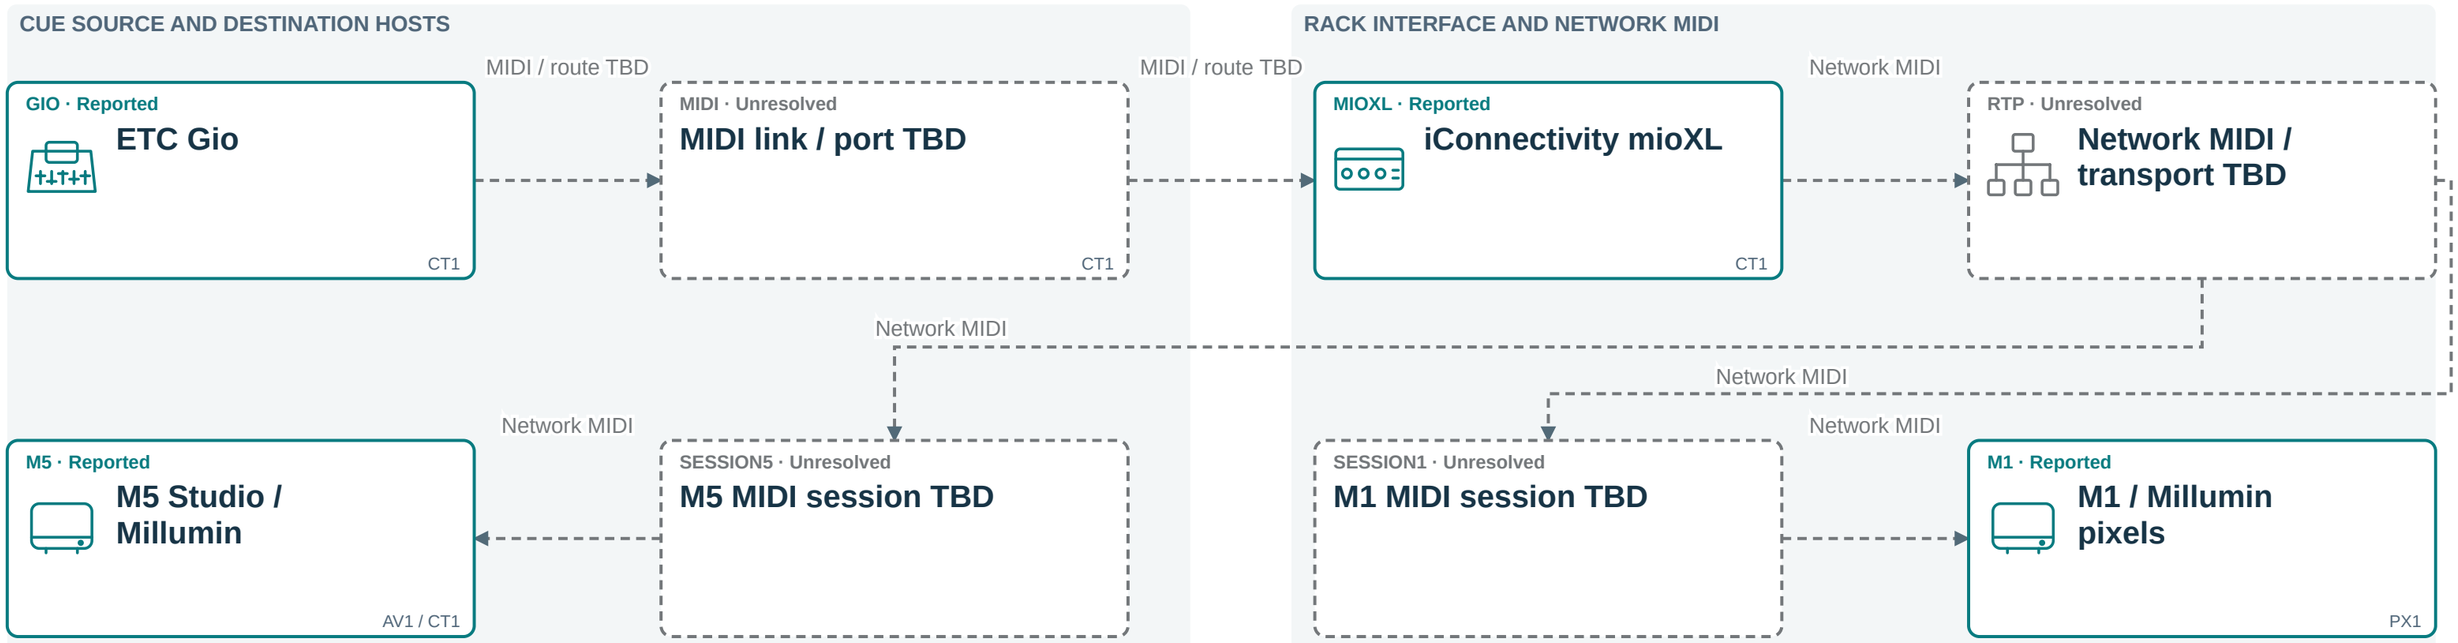
CU1 / Gio and network MIDI cues

Recorded cue destinations; unresolved physical connections and sessions are dashed.

Millumin on the M1 drives pixels. Millumin on the M5 drives the four projector picture feeds.
The mioXL photo confirms model identity; it does not confirm the routed ports or active sessions.
A1/audio cue dependencies and coordinated cue replay remain to confirm with the house team.

Check	State	Owner / date
Trace Gio physical connection and mioXL ports	Pending	TBD / TBD
Read network transport, session names and reconnect behavior	Pending	TBD / TBD
Witness one coordinated cue and audio-safe recovery	Pending	TBD / TBD

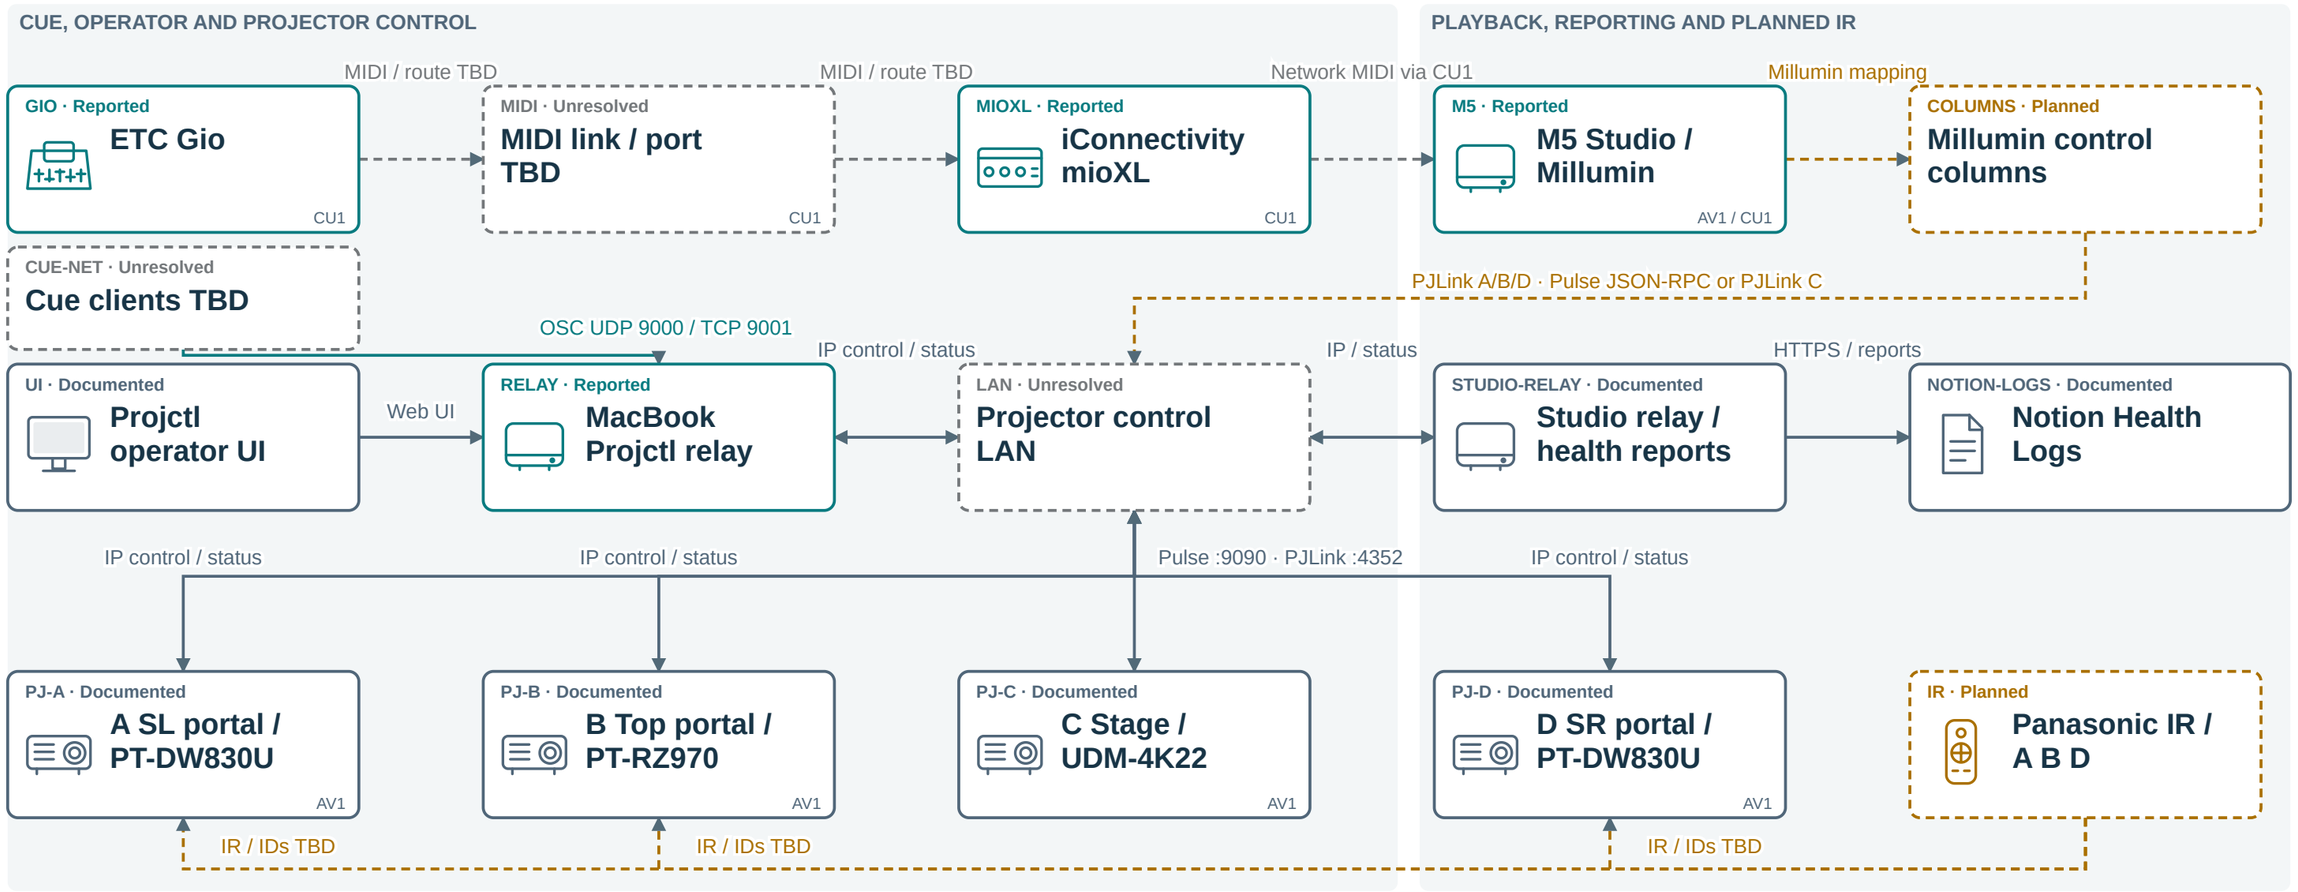
CT1 / Projector commands and monitoring

PJLink for A/B/D, Pulse JSON-RPC or PJLink for C, and the Projctl manual/monitoring path, independent of picture transport.

LAN links carry outbound commands and returning status. The drawing does not establish current telemetry.
C records Pulse JSON-RPC :9090 and PJLink :4352. The saved Current Rig file uses Pulse. Validate both routes independently and record the selected route and resulting state for each cue.
Projctl Show Lock applies to its own command path. Independently issued Millumin projector commands (PJLink or Pulse) remain separate.
November 13 hub records both relays. MacBook is the selected control surface; Studio 60 s polling is a pending change. Read current settings before use.

Check	State	Owner / date
Confirm active relay arrangement and live endpoints	Pending	TBD / TBD
Verify power/shutter per lane; record C route (Pulse or PJLink)	Pending	TBD / TBD
Record Show Lock scope and approved cue recovery	Pending	TBD / TBD
Read cue listener source restrictions and approved hosts	Pending	TBD / TBD

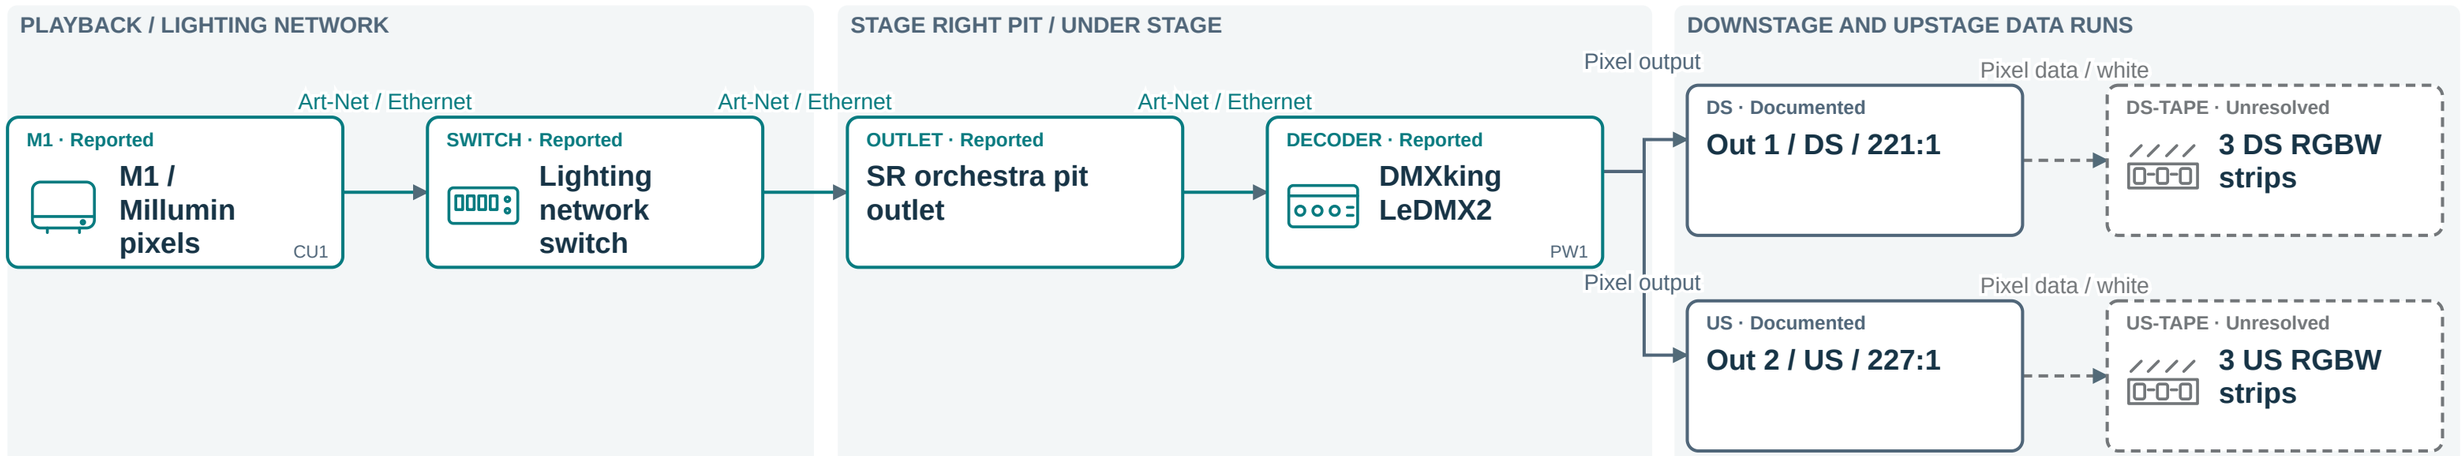
PX1 / Pixel data and addressing

Recorded Millumin Art-Net unicast target Private LAN (the November 7 OCTO bench address); LeDMX2 IP readback pending. Two recorded 300-cell RGBW lines.

Bench reel label: ENTTEC 8PXB60-RGBW-12V-W; installed strips not yet matched. Three physical LEDs per RGBW cell; four channels per cell. A full 5 m reel has 100 cells / 400 channels.
Each port has 300 cells / 1200 channels. Universe remapping is recorded off; installed numbering requires readback.

Check	State	Owner / date
Read LeDMX2 IP, firmware, port settings and numbering	Pending	TBD / TBD
Trace six physical strips to the twelve slices	Pending	TBD / TBD
Witness RGBW order, white, blackout and restore	Pending	TBD / TBD

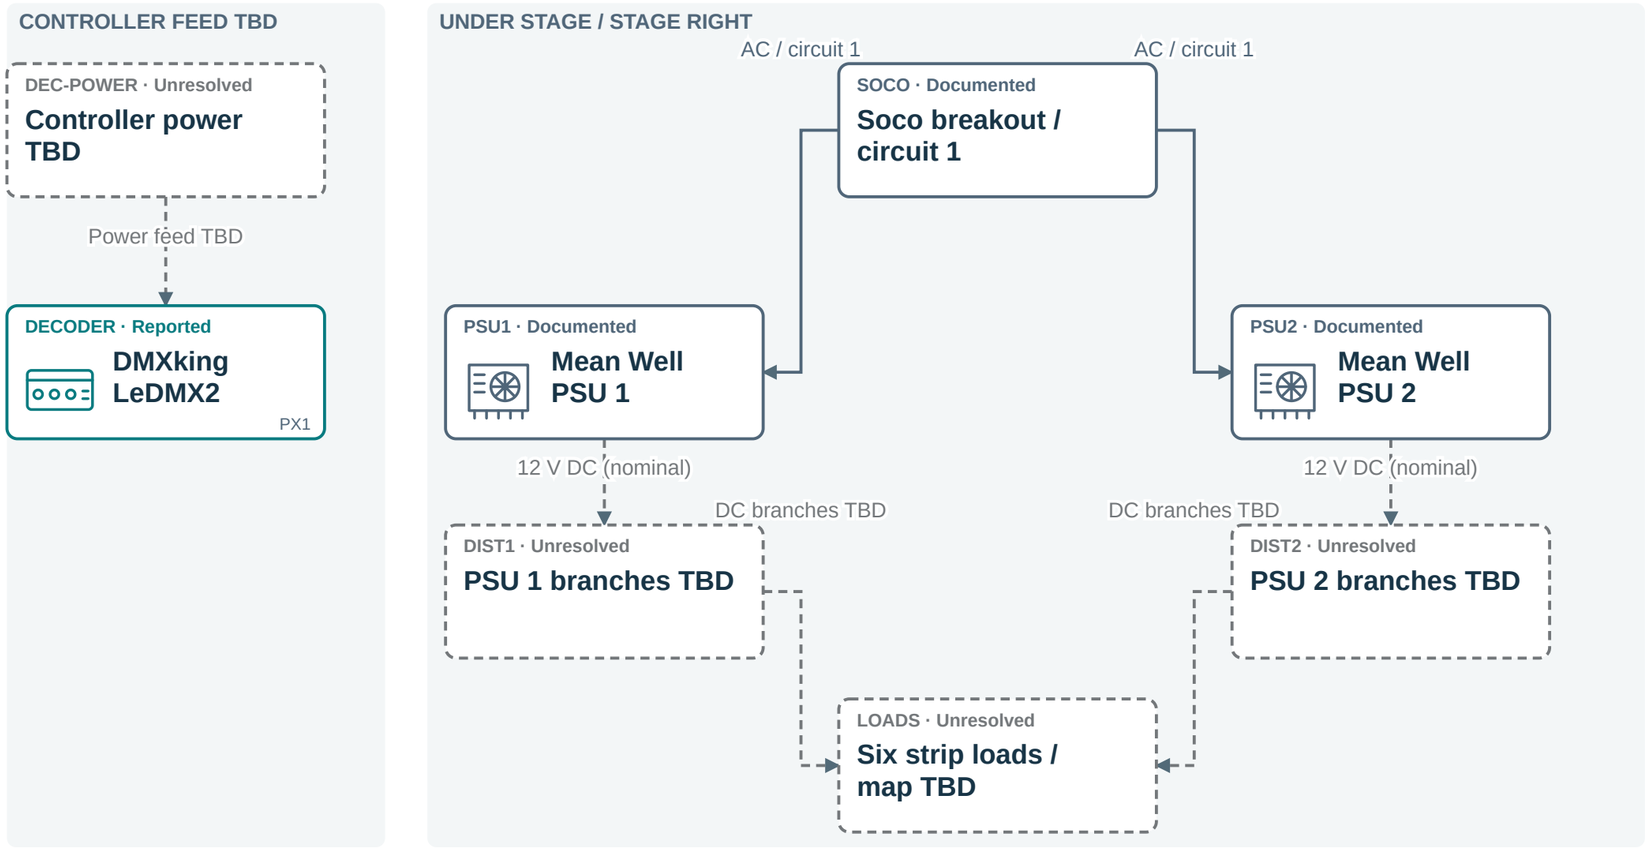
PW1 / Pixel power and unresolved feeds

Recorded two-supply arrangement and explicit controller power gap.

Decoder and supplies recorded under stage, wall-mounted stage right at the far side of the orchestra pit.
Separate branch nodes avoid implying paralleled PSU outputs. Actual strip assignments and returns require tracing.
Notion retains an unresolved electrician inspection item for exposed strands at PSU terminals.
Signal schematic, not to scale. Electrical capacity, protection and operational acceptance remain open.

Check	State	Owner / date
Record electrician inspection outcome	Pending	TBD / TBD
Trace each DC branch, return and injection point	Pending	TBD / TBD
Confirm controller power and intended maximum load	Pending	TBD / TBD
