SERVICE PROCEDURE

G-06509-R1 October 2006

SUBJECT: REVISED SAFETY RECALL (U.S., EXPORT)

ADJUSTABLE TORQUE ROD ENDS on certain 5000 and 7000 models built 9/13/2006 thru 9/29/2006 with Chalmers® Rear Suspensions

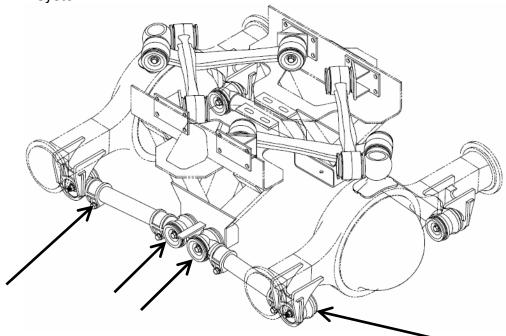
Figure 1 – Generally on Left Side of vehicle, but may be on Right side.

1. Locate the lower *adjustable* torque rods of the rear suspension system.
