SERVICE PROCEDURE

G-05514-R2 February 2006

SUBJECT: SAFETY RECALL (U.S., EXPORT)

BATTERY CABLES on 9000 models built 4/1/2002

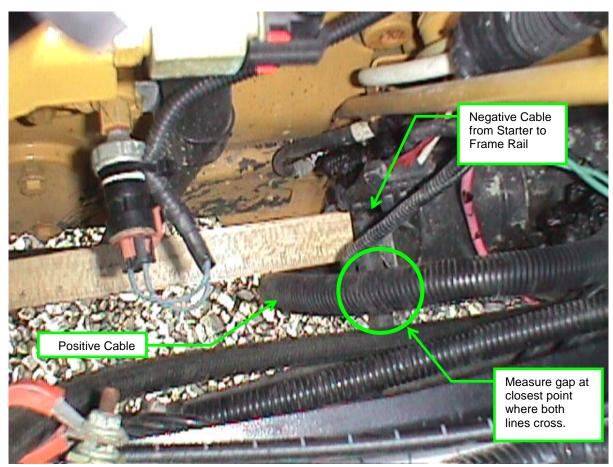
Figure 1 – Gap Measurement

- 1. For Cummins ISM w/ fuel filter, do not perform the gap measurement, skip to the **BATTERY CABLE INSPECTION PROCEDURE**.
- 2. For Caterpillar, Cummins ISX, and Cummins ISM w/o fuel filter, perform the following gap measurement.
- 3. Measure the smallest gap between the positive cable's conduit and the closest point to the negative cable bolted to the frame rail. See Figure 1.

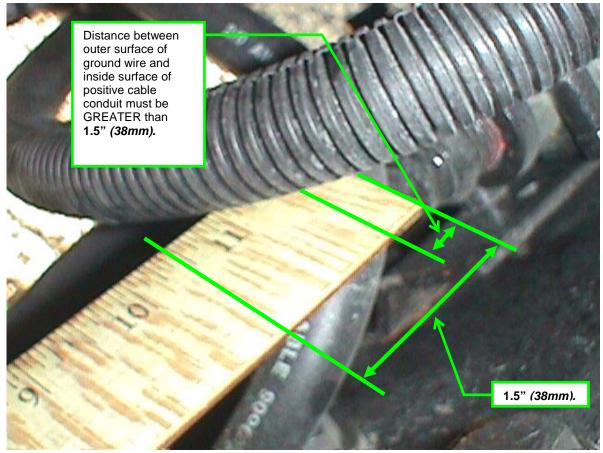
Figure 2 – Saddle Clamp Installation REQUIRED

4. If the smallest gap is less than 1.5 inches (38mm) continue on to **BATTERY CABLE INSPECTION PROCEDURE**.

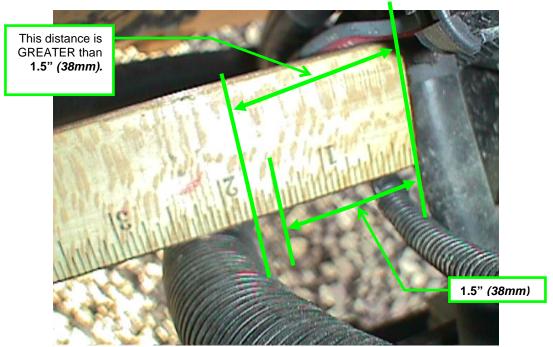
Figure 3 - No Saddle Clamp Necessary - Skip to FINAL INSPECTION

5. If the smallest gap is 1.5 inches (38mm) or LARGER, then no saddle clamp installation is necessary, skip to *FINAL INSPECTION*.

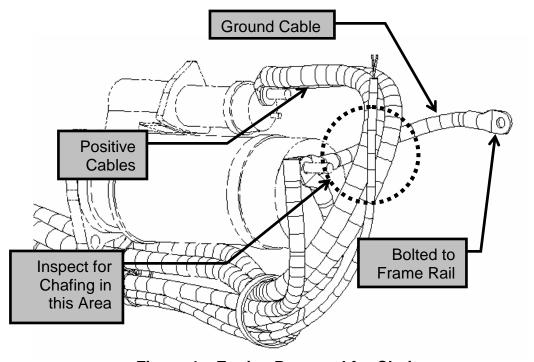
Figure 4 – Engine Removed for Clarity

- 6. For ALL suspect vehicles, if the gap measured above is less than 1.5 inches (38mm), perform the following battery cable inspection procedure.
- 7. Inspect positive (red) battery cables, conduit and ground cable (black) in areas indicated below:

- 8. If ANY indication of chafing or rubbing is evident, replace any affected cables and continue to step 11.
- 9. If there is NO indication of chafing or rubbing, continue on to **SADDLE CLAMP INSTALLATION.**

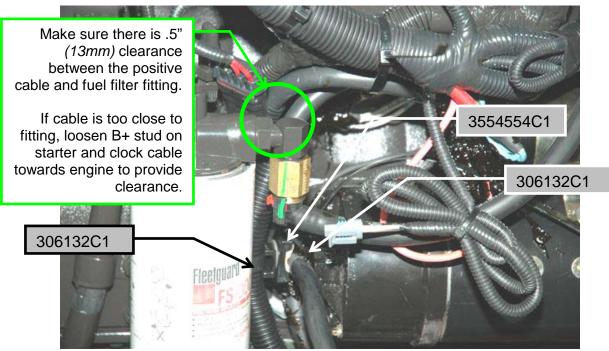
NOTE: Ensure battery cables do not touch fuel filter assembly or fittings.

Figure 6 - Cummins ISM w/Fuel Filter

- 13. Install saddle clamp and strap locks as indicated below.
- 14. Re-route battery cables between the fuel filter and engine block.

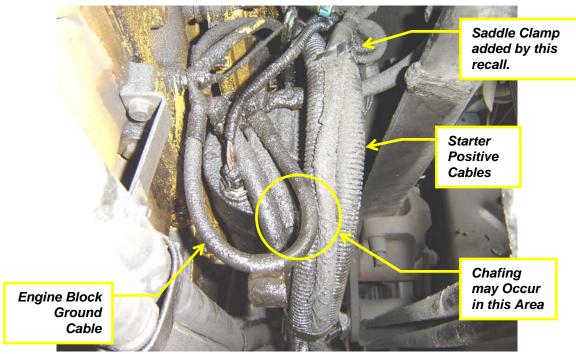
TO PREVENT CHAFING OF THE **POSITIVE** CABLES AGAINST THE **ENGINE** BLOCK GROUND CABLE (SEE FIGURE 7), PLEASE ENSURE **ENGINE** BLOCK GROUND CABLE IS CLOCKED IN THE DOWNWARD (6 O'CLOCK) POSITION, SEE FIGURE 8.

Figure 7 -Chafing may occur between Engine Block Ground and Newly Located
Positive cables.

• If rubbing or chafing of the ENGINE GROUND cable against the Battery Cables is present, rotate and tighten the new ground cable on the starter terminal so it is straight down (6 o'clock position) and not contacting the starter positive cables, see figure 8.

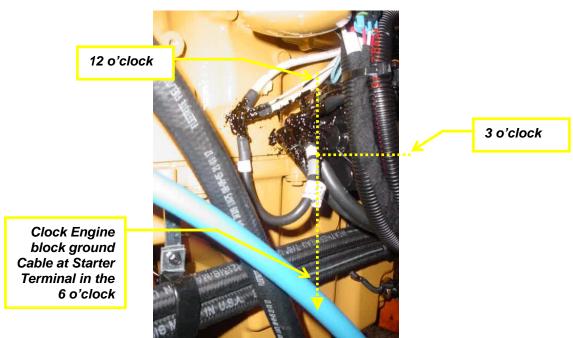
Figure 8 – Correct CAT (non-C15) engine block ground cable routing.

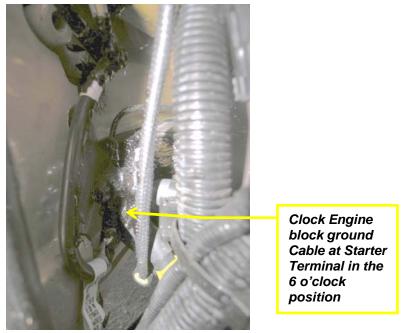
Figure 8a - Correct CAT C15 engine block ground cable routing.

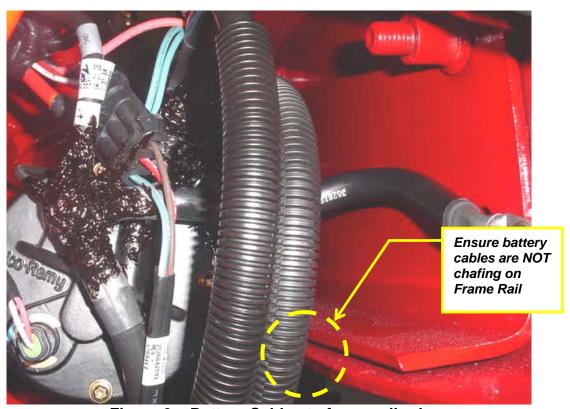
Figure 9 – Battery Cables to frame rail rub

- o Battery Positive Cable to FUEL FILTER housing.
- It may be necessary to loosen and/or remove a battery cable to re-orient it.
- It may also be necessary to loosen/replace routing/clipping points (p-clamps, extension clips, etc...) to facilitate a no-rub condition.

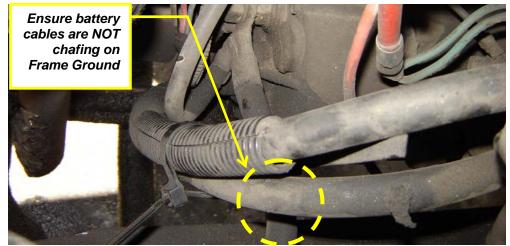
Figure 9a - Battery Cables to FRAME GROUND rub

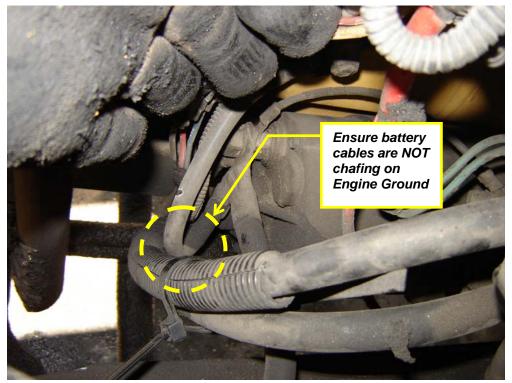
Figure 9b- Battery Cables to ENGINE BLOCK GROUND rub

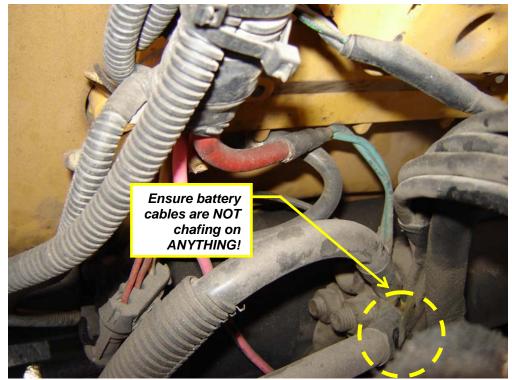
Figure 9c – Battery cables to starter case, starter terminal studs or other starter components and wiring.

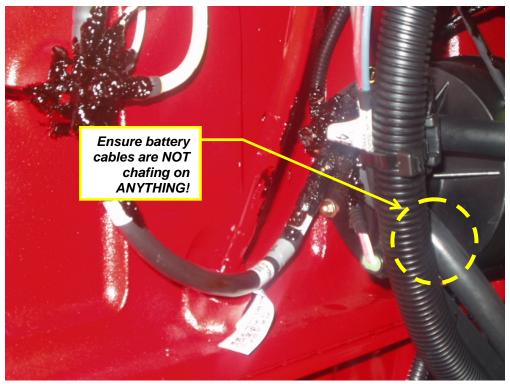
Figure 9d – Battery POSITIVE cables to Battery GROUND cables
