# **VEHICLE RECALL**

G-03514 September 2003

SUBJECT: SAFETY RECALL (U.S., EXPORT)

Air Tank Plumbing on 4200, 4300, and 4400 Family Models Built 8/27/2002 through 7/22/2003 with Side-by-Side Air Tanks, (Feature Code: 504602) at the Escobedo Assembly

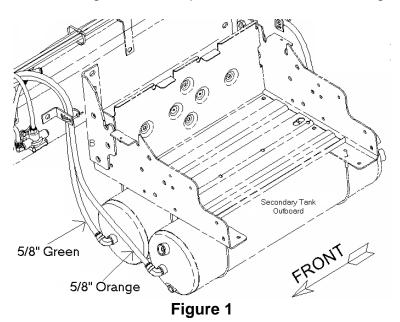
1. Verify green and orange hoses are plumbed as indicated in Figure 1.

- 2. If tanks are plumbed according to Figure 1, then brake system is plumbed properly. **NO** hose replacement is required and the Recall is complete.
- 3. If tanks are *not* plumbed according to Figure 1 and are reversed, then continue on to *Hose Replacement Procedure*.
