IC Corporation

SAFETY RECALL 05505

Recall Campaign # 05505 & SUBJECT (Engine Cover Retention Cable)

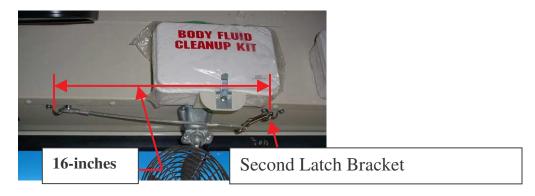
During pre-trip inspection or engine service, the engine cover lid can be opened until it leans against the instrument panel. There is no latching device to keep the lid open. When it is in the open position, the lid is slightly over center and can close if bumped, or if the bus is on a slight incline.

Without a retention device, when the engine cover lid is in the open position it can close without warning resulting in possible personal injury.

1. Mark the location of the first hole for the first latch bracket 4-inches to the right of the windshield center bar. Using the bracket as a template, align the bracket with the flange of the bulkhead to mark the location of the second hole. Slip one end of the cable onto the bracket before attaching the bracket to the bus body. Attach the bracket using the screws included in the kit. The picture below shows the result.
