Date: 10.11.2026
Delivery note: 2026-344819 (05.11.2026)
Your order confirmation: 2026-232475
Our purchase order: P00053

Quality report – MFJ 4.0 Unisex grey

Incoming goods inspection and photo documentation

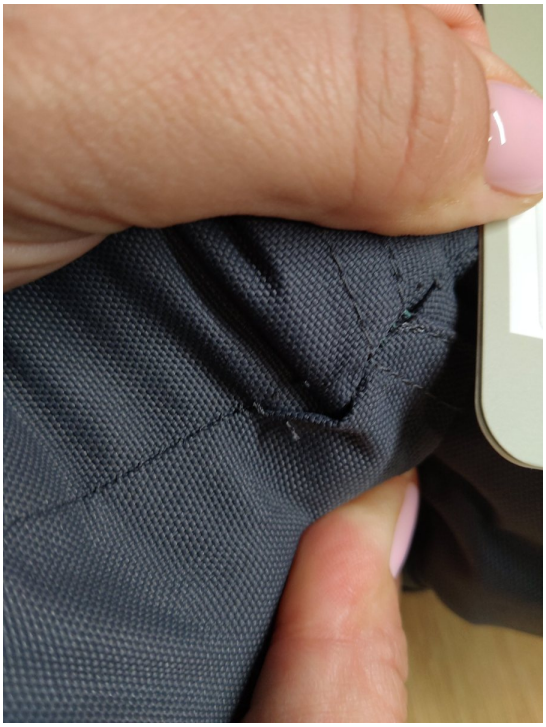
Colour	Size	Qty	Defect
Grey	S	1	Seams on the left sleeve not cleanly stitched.
Grey	S	1	Pocket flap corner: small hole, stitching at the corner not cleanly finished.
Total		**2**

Grey S (1) – Issue: seams on the left sleeve not cleanly stitched. Reason: visible seam defect, the seam is not secure – not acceptable for sale.

Grey S (2) – Issue: small hole at the corner of the pocket flap, stitching not cleanly finished. Reason: visible damage on the outer fabric – not acceptable for sale.

Our request: please review the 2 jackets listed above and let us know how you would like to proceed – repair, replacement or credit note. The jackets are ready for collection or return shipment at our warehouse.
