Date: 05.11.2026
Delivery note: 2026-344396 (28.10.2026)
Your order confirmation: 2026-232475
Our purchase order: P00053

# Quality report – MFJ 4.0 Women

Incoming goods inspection and photo documentation

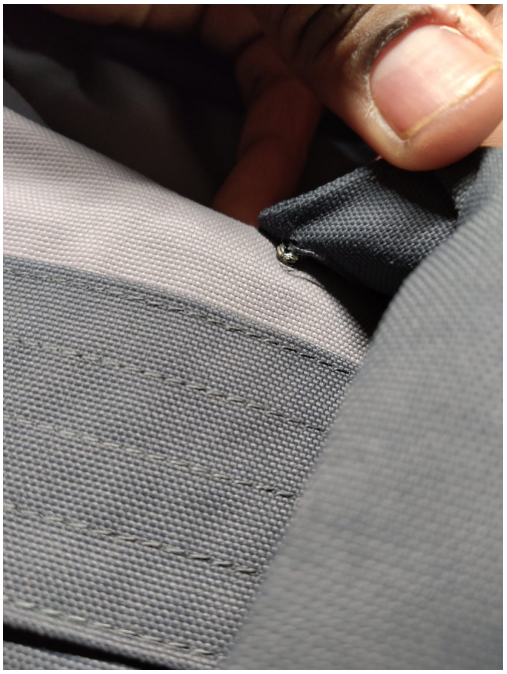
Grey | IQ patch: visible uneven stitching / edge.

Grey | Lower patch edge: uneven attachment.

Grey | Patch corner: loose edge and irregular stitching.

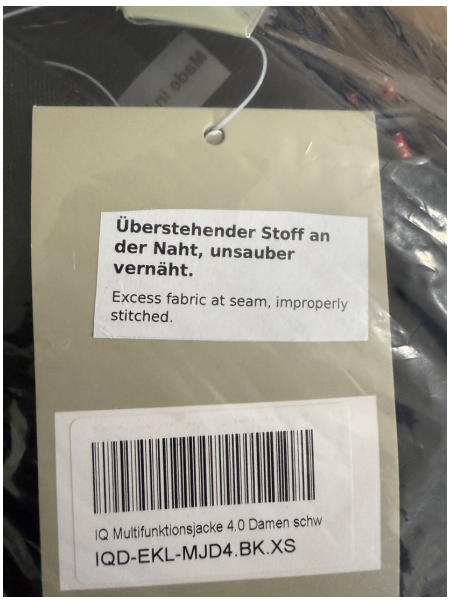
Black 4XL – Issue: small pocket and inner pocket damaged. Reason: functional defect on two pockets – not acceptable for sale.

Black M – Issue: IQ patch missing on one shoulder. Reason: product incomplete, branding element missing – not acceptable for sale.

Black XS – Issue: excess fabric at the seam, improperly stitched. Reason: visible seam defect, seam not cleanly finished – not acceptable for sale.

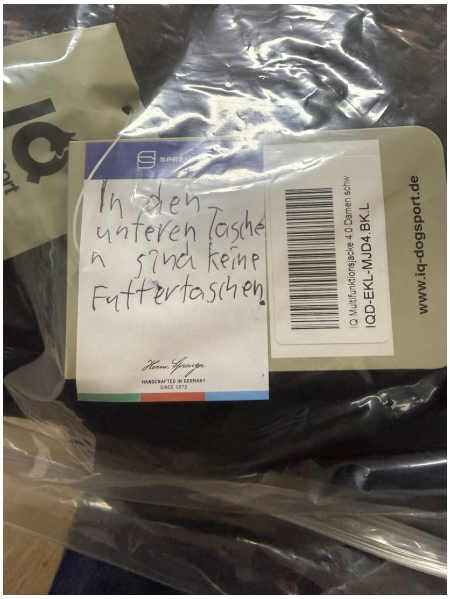
Tag only – the defect is inside the pocket.

Black L – Issue: the lower pockets have no lining pocket bags. Reason: pockets cannot be used, product incomplete – not acceptable for sale.

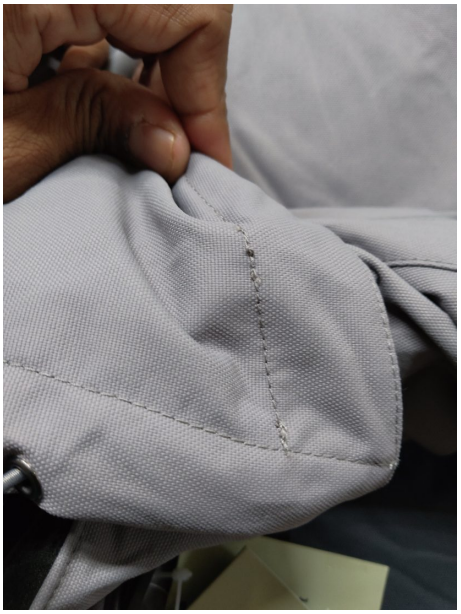
1 | Sleeve seam: uneven stitching.

2 | Seam with loose thread end.

3 | Seam edge: frayed / uneven stitching.

4 | Cuff edge: irregular finishing.

5 | Seam: irregular / skipped stitches.

6 | Seam: irregular / skipped stitches (detail).

7 | Loose thread ends removed during inspection.

8 | Seam at the end of the chest zipper frayed.

The following findings were also documented during the inspection. These jackets have been accepted and are going into sale. We kindly ask you to pay attention to these points in future production.
