Dominic Bowkett
BUILDING SURVEYS · ENERGY · RETROFIT

RETROFIT REPORT · ENERGY, CONDENSATION, VENTILATION AND INSULATION, WITH A PLAN FOR THE WORKS

Anonymised sample report

PREPARED FOR	VISIT	ISSUED	ASSESSOR
The client	Thursday 22 October 2026, 10.57am–1.00pm	23 October 2026	Dominic Bowkett

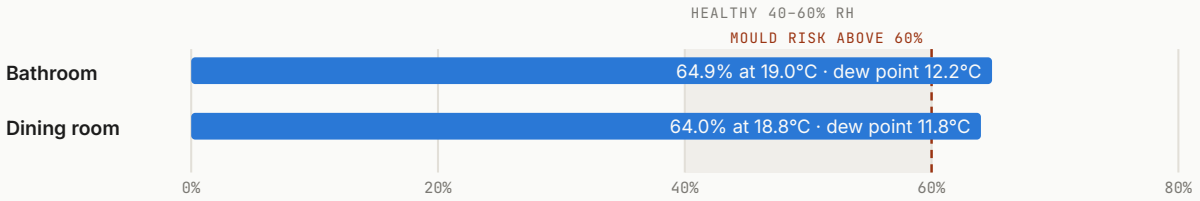
CONDENSATION POINT

~12°C

surfaces colder than this get wet (bathroom reading)

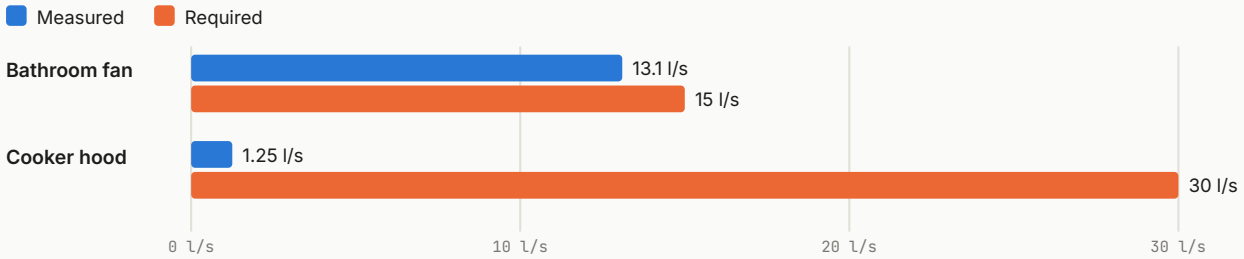
Extract measured against the rate required. Testo 417 readings on Thursday 22 October 2026 (bathroom A172, hood A242); required rates from Approved Document F Volume 1, Table 1.1 [1], taking the hood as extracting to outside (if it recirculates, a 60 l/s kitchen fan is needed instead). The bathroom fan reaches 87% of its rate (13.11 ÷ 15); the hood reading is indicative only, but far short of 30 l/s.

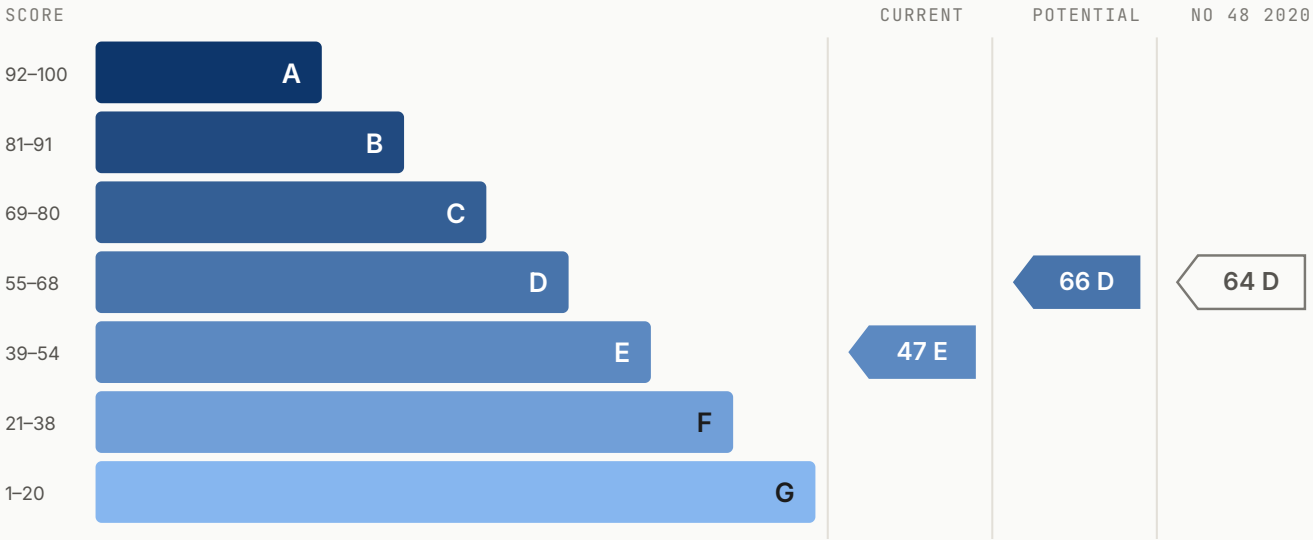
Where the house sits on the rating scale

The energy efficiency rating now and its potential. Current 47 (band E) and potential 66 (band D), from the assessment's summary page; the outline pointer is No a neighbouring house, rated 64 (band D) on the EPC register, registered 8 June 2020 – a detached house of the same age with a 250 mm loft.

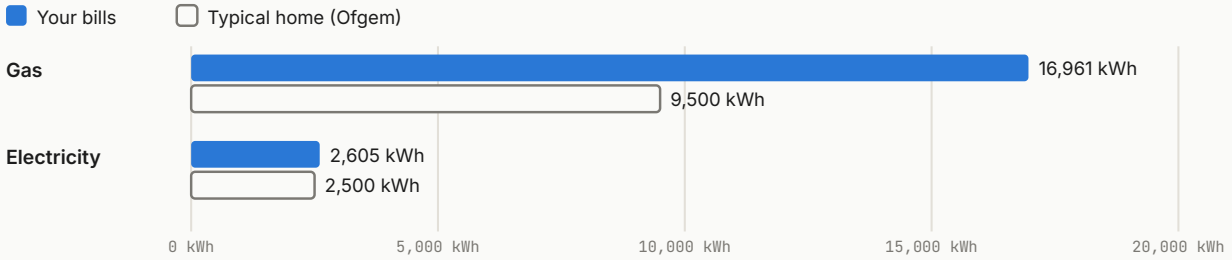
Your energy use against a typical home

Your annual gas and electricity use against Ofgem's typical medium values. Your use from your written brief (gas 1 July 2025 – 20 June 2026, electricity 1 October 2025 – 30 September 2026); typical values from 1 July 2026 [7]. Gas is about 79% above typical ((16,961 − 9,500) ÷ 9,500); electricity about 4% above.

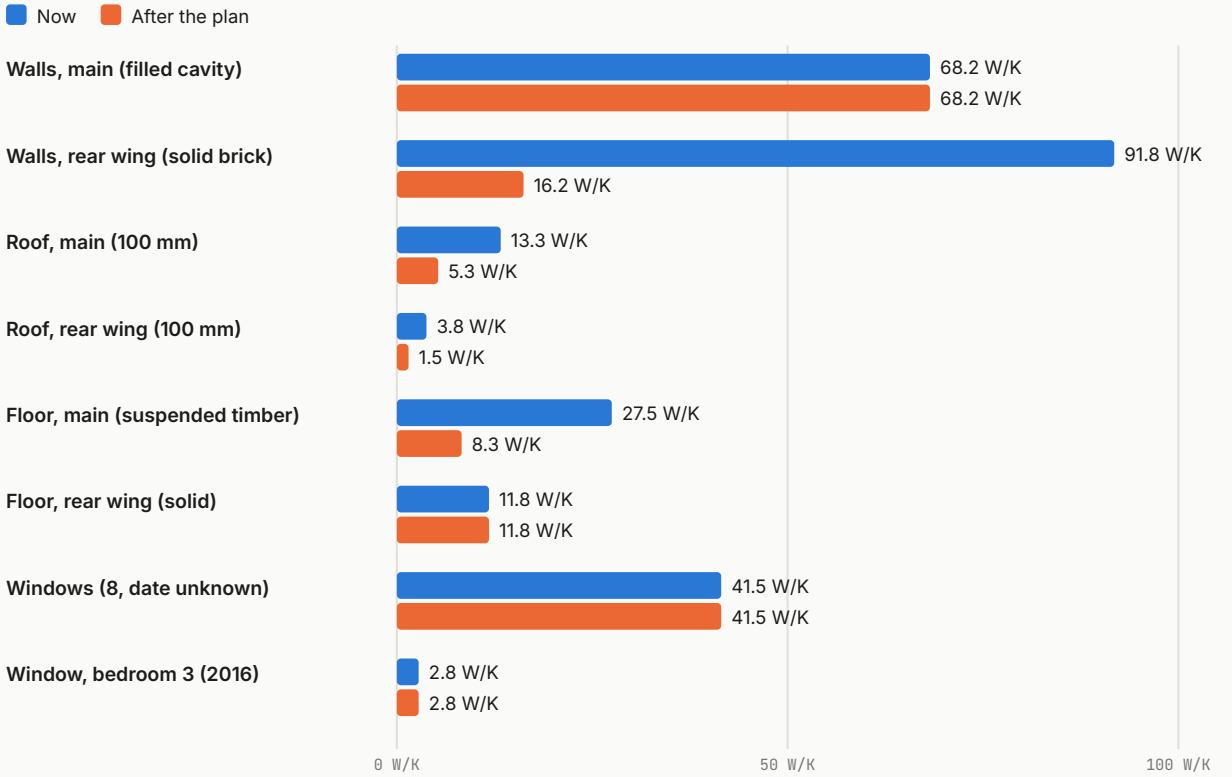
Where the heat goes

Indicative fabric heat loss by element, now and after the plan. Areas from the dimensions page and the assessment's window table; U-values are the method's assumed defaults (RdSAP 10 defaults (BRE, 2026, Tables 6, 13 and 16)) [3] or the values assumed in the assessment, not measured values; fabric elements only – ventilation, chimneys and draughts are not shown, and the one external door is left out because its area was not entered. The "after" values are the Approved Document L improved values [2] and the method's 270 mm loft value, cited in section 07.
