Dominic Bowkett
BUILDING SURVEYS · ENERGY · RETROFIT

RETROFIT PLAN · IMPROVEMENT OPTIONS EVALUATION & MEDIUM-TERM IMPROVEMENT PLAN

Anonymised sample report

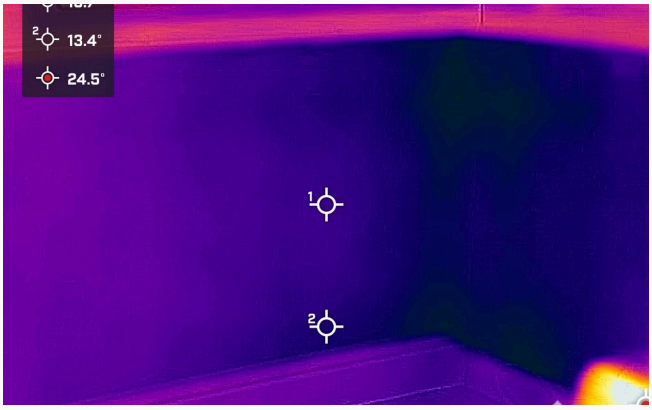
Through-lounge bay, from inside. The low wall under the bay windows is the darkest area, and a cold band runs along the skirting. The bright spots on the floor are plug-in appliances.
FLIR 09:32:31 · 16.0 / 17.5°C at the markers

What to do: seal the skirting-to-floor gap with a flexible sealant or a skirting draught strip, seal around the bay window frames, and insulate under the bay window with rigid foam board on battens behind plasterboard. That last one is the quick, high-impact win for this room (Stage 1 in section 11).

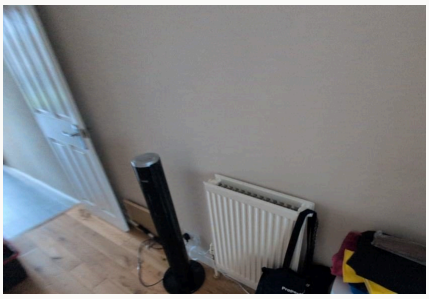
Bedroom radiator at 66–70°C, heating evenly across the panel.

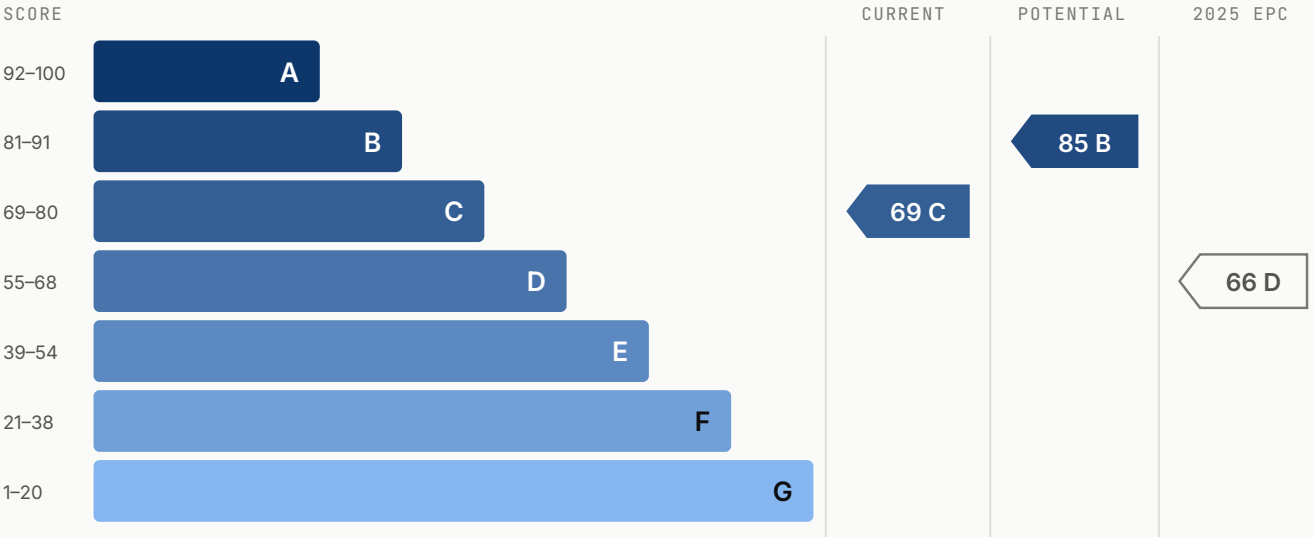
Where the house sits on the rating scale

The rating runs from 1 to 100; higher is better. The average for homes in England and Wales is band D, around 60. The 2025 EPC is shown in outline for comparison.

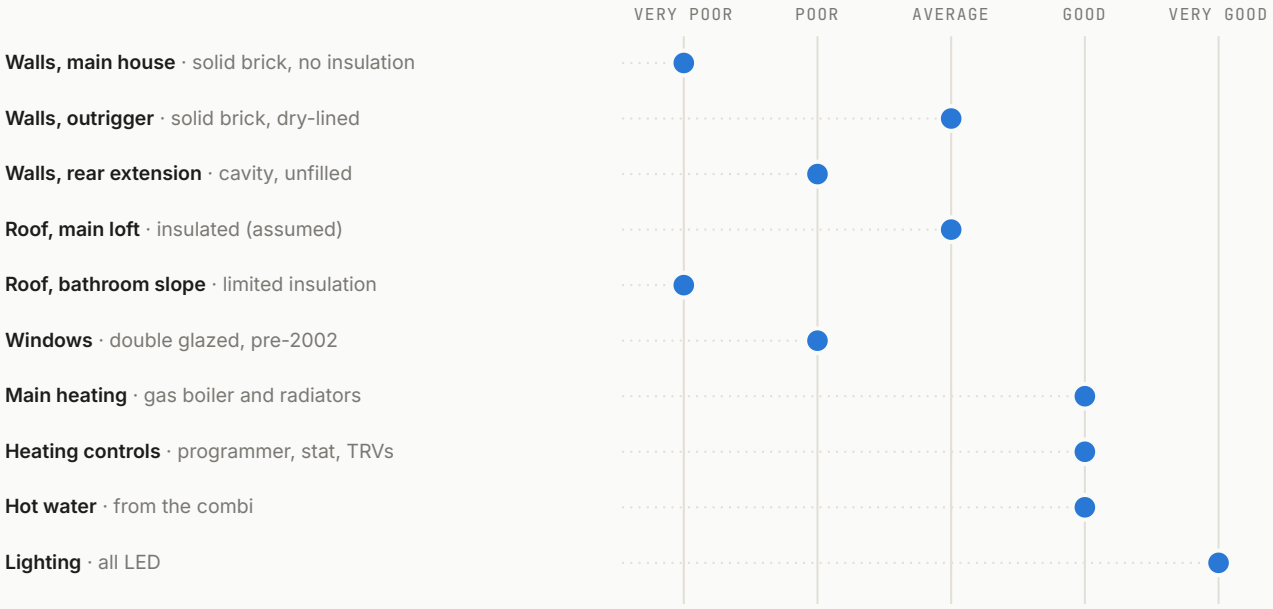
What each part of the house scores

The assessment rates each part of the house from very poor to very good for energy efficiency. This is the clearest picture of where the weak points are.

Floors are not given a rating by the method, but both the suspended timber floor and the solid floors are recorded as uninsulated. The weakest elements are the main walls and the sloping roof over the bathroom (rated on the method's default, as its insulation cannot be seen), followed by the windows and the rear extension walls. The heating, controls, hot water and lighting are already good.

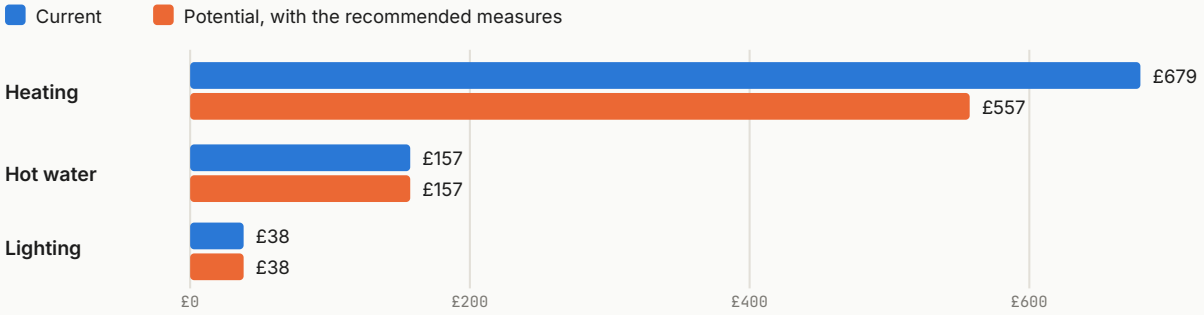
Estimated running costs

Heating is three-quarters of the estimated bill, so it is where the savings are. The £122 a year saving is all on heating. These figures assume a standard heating pattern and standard fuel prices; your own bills will differ with how you heat the house.
