Visit Report: Raipur Upazila Health Complex, Lakshmipur

Date of Visit: 12/09/22; Time: 9:00 AM.

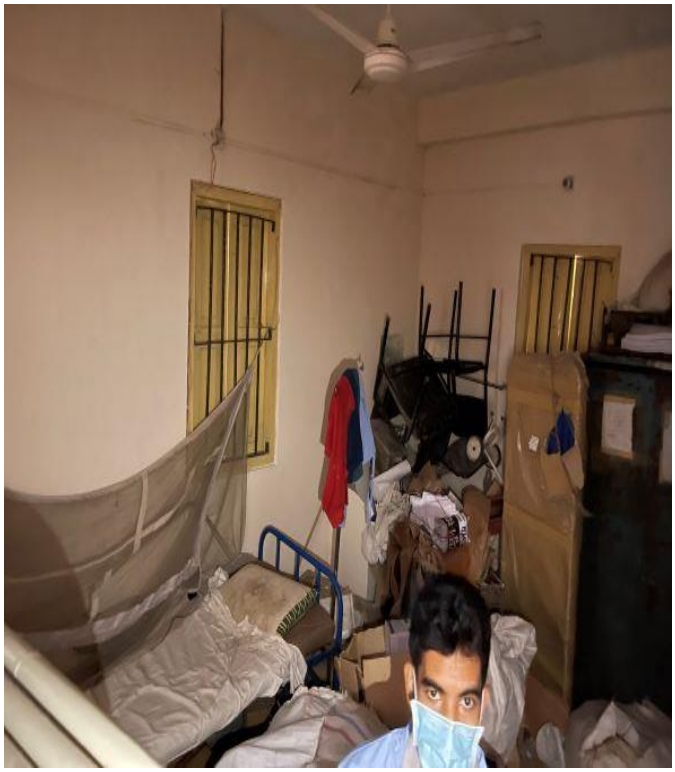
Fig-20: OT room; there are some unwanted items which occupy spaces, should be removed
