Health Economic Unit (HEU). Shasta Surakkha Kormochuci (SSK)

Visit Report: 100 Bedded Sadar Hospital, Lakshmipur.

Date of Visit: 14/09/22; Time: 9.00 AM.

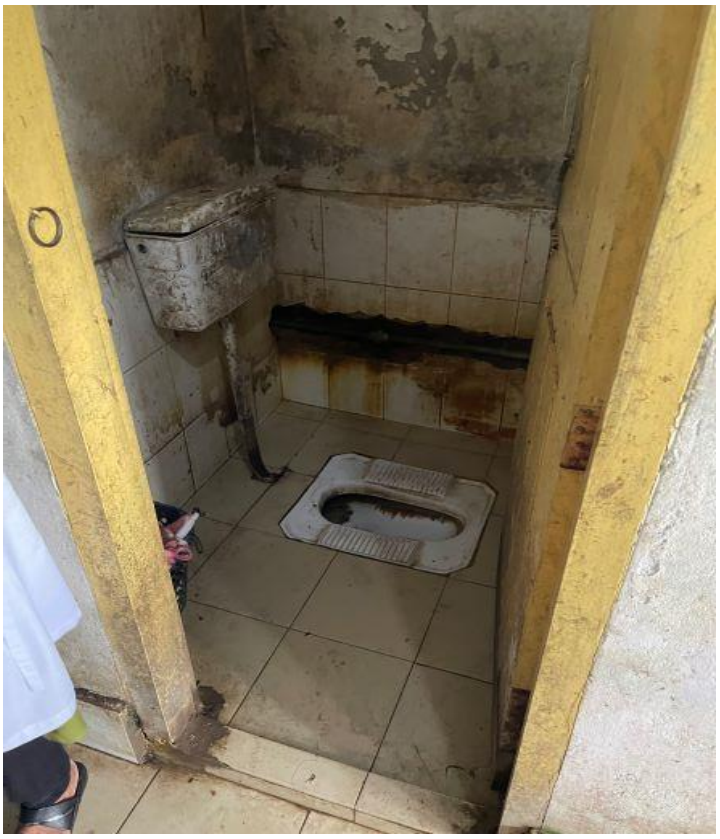
Fig-10: Unclean Toilet in outdoor

2. Cleaning and beautification is not up to the mark. For waste management, involvement of Pouroshova is necessary. Pouroshova can take part in providing cleaners for the hospital like other district hospitals of the country.

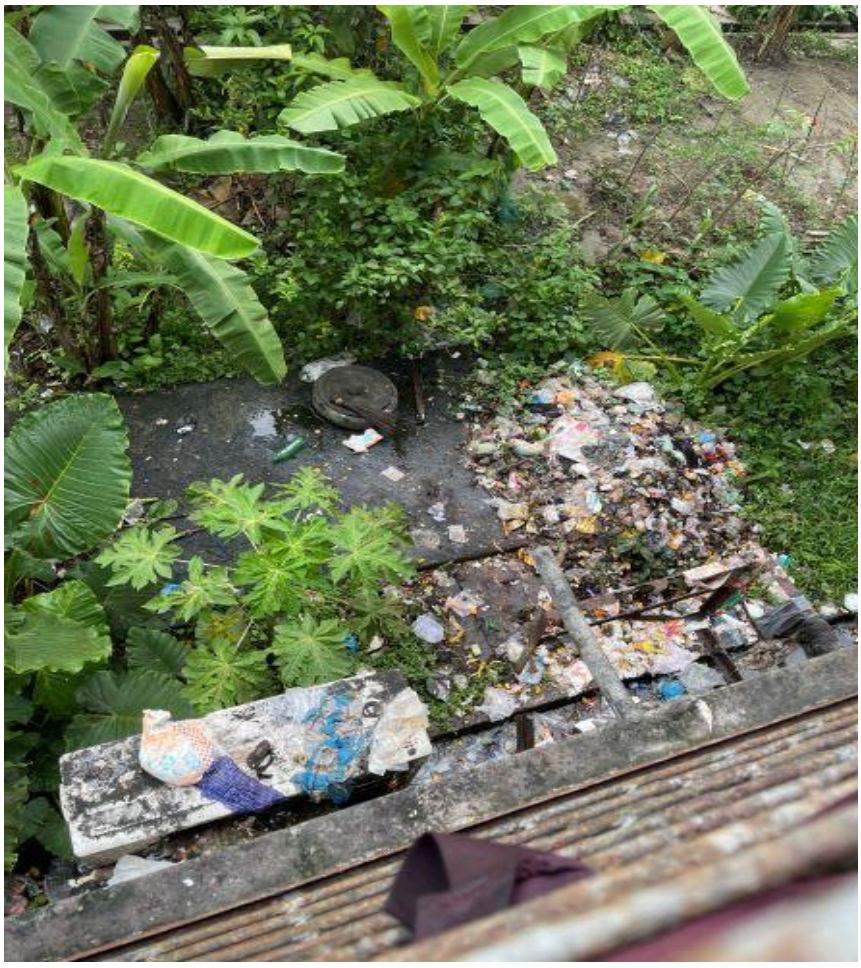
Fig-21: Weak waste management system beside the Hospital building
